# Ground Survey of Las Animas County for Methane Anomalies

June 30, 2015

Prepared by:

Prepared for:

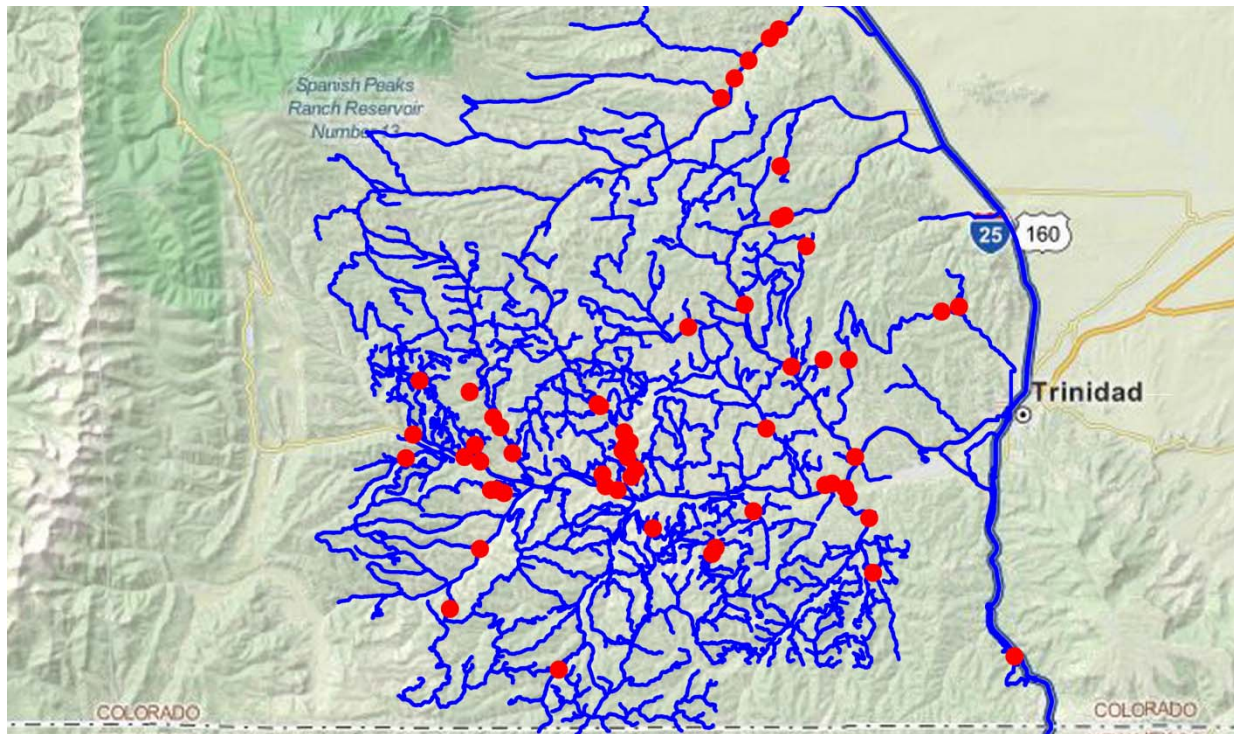
Figure 2. Map showing seeps detected during the 2015 survey (red boxes) and vehicle track (blue line).

The most obvious pattern to the methane seeps discovered in the Raton Basin is that they are continued to be clustered in the southern end of the Basin along the Purgatorie River valley through which Route 12 passes (Figure 2). This was also observed during the past two surveys.

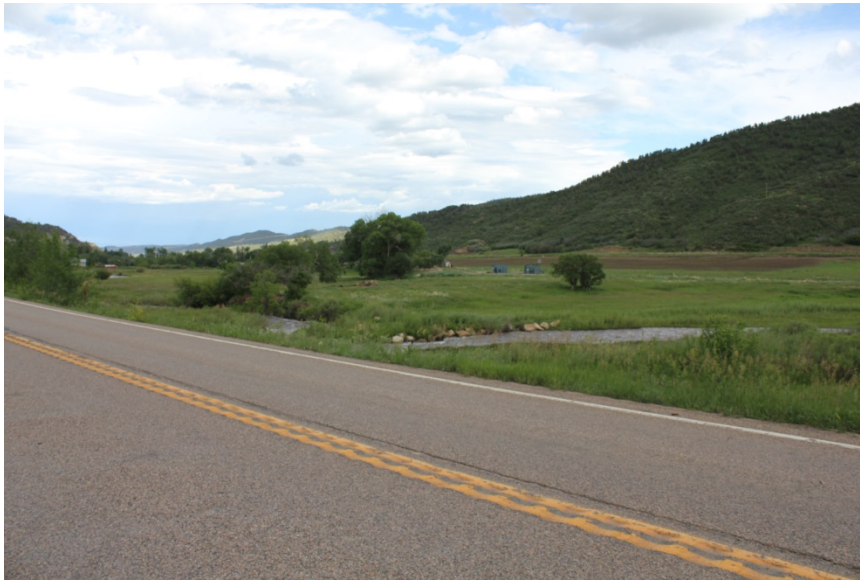
**Seep ID:** 1008

**Description:** An increase in ambient methane levels was detected south of CO Highway 12. Located south of the road is the Purgatoire River. Also, on the north shoulder of the road is a rock formation with visible coal seams. This seep is in the same location as a seep identified in the 2007 survey.

Looking at the Purgatoire River, just south of CO Highway 12.

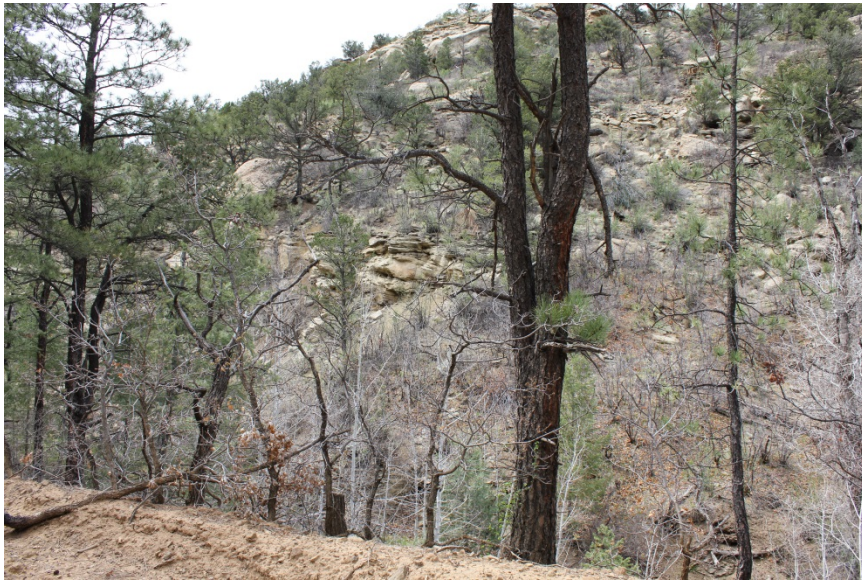
**Seep ID:** 1015

**Description:** An increase in ambient methane levels was discovered northwest of Timber Ridge Rd. in the area of a dry creek bed. No moisture was present at this time, so methane from a swampy environment can be ruled out.

Looking northwest from Timber Ridge Rd. with the creek bed down below.

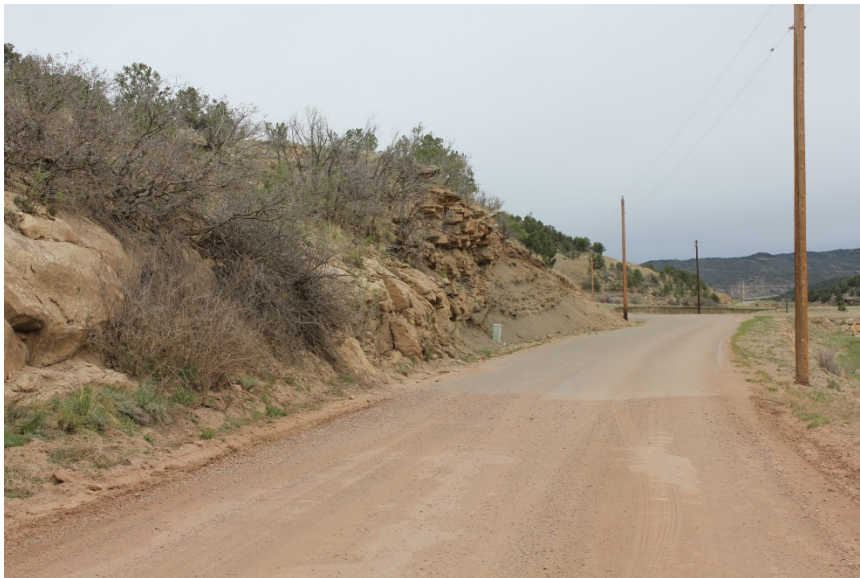
**Seep ID:** 1017

**Description:** An increase in ambient methane levels was detected near an embankment on the east side of County Rd. 31.9. A well pad is east of the seep approximately 0.15 miles. However, with trees in-between the pad and the seep location, as well as a narrow spike in methane, a seep is likely located along the road. This seep is also at the same location as a previous identified seep from the 2007 survey.

Looking south along Co Rd. 31.9 with the embankment on the left.

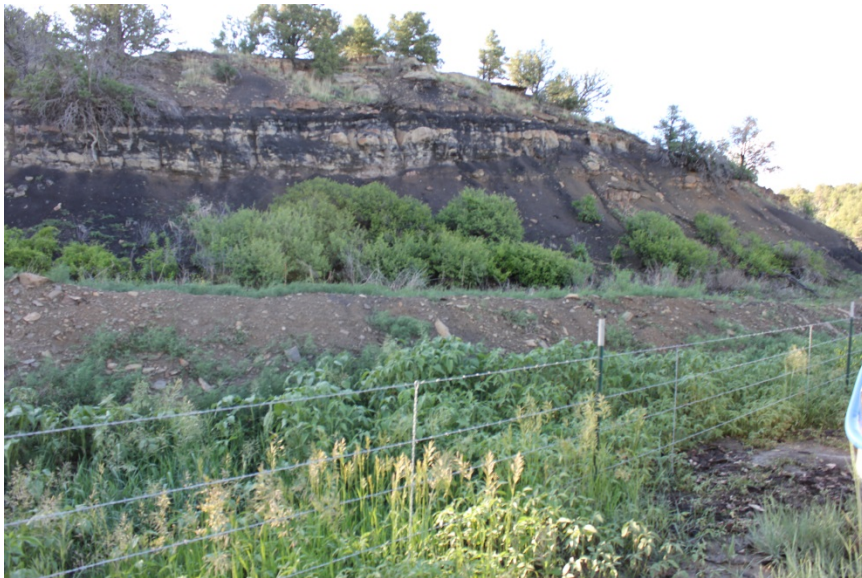
**Seep ID:** 1018

**Description:** An increase in ambient methane levels was detected coming from north of Highway 12. Located north of the road is a rock formation with exposed coal seams. Approximately 150ft. south of the highway is the Purgatoire River. This seep is at the same location as a previous identified seep from the 2007 survey.

Looking north at a rock formation/coal seams off of CO Highway 12.

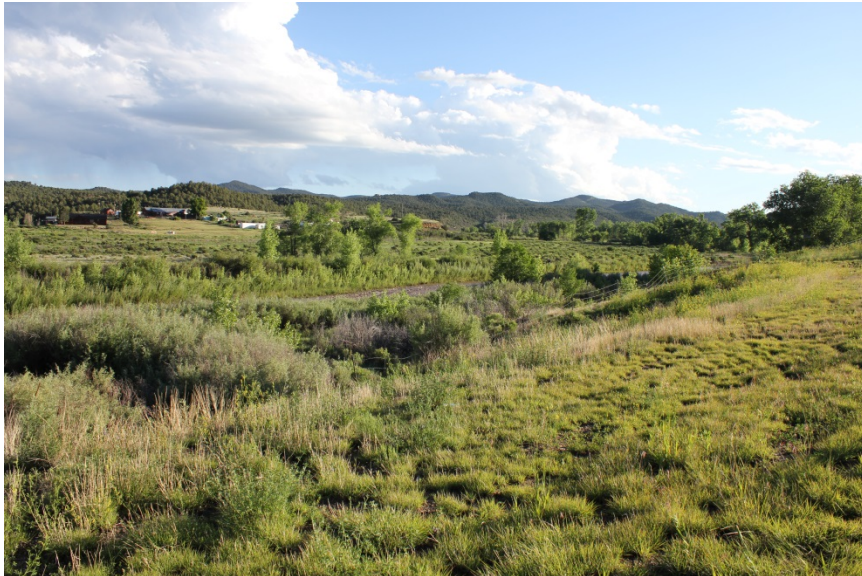
**Description:** An increase in ambient methane levels was detected along CO Highway 12. This potential seep is located just ¼ mile east of Seep ID 1018. Located south of the anomaly is the Purgatoire River. On the north shoulder of the highway is an exposed coal seam. This seep is at the same location as a previous identified seep from the 2007 survey.

Looking south of CO Highway 12 at the Purgatoire River.

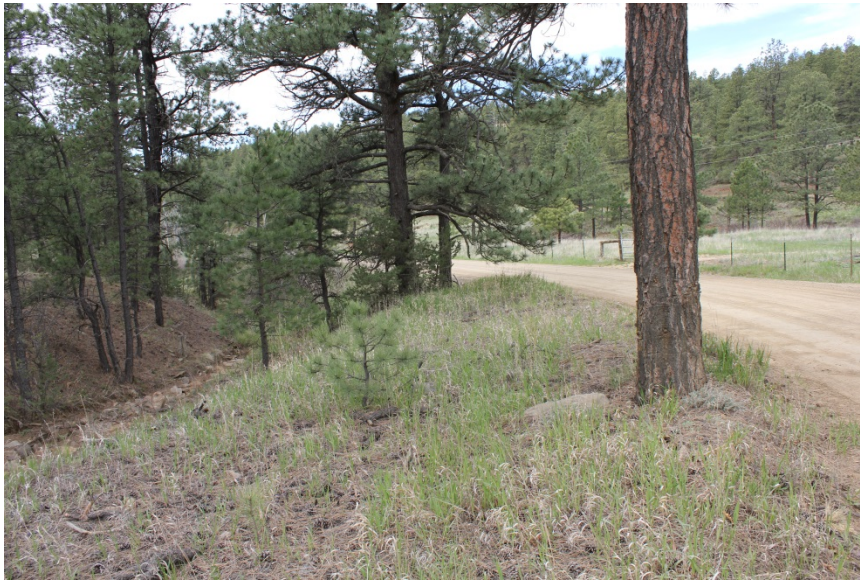
**Description:** An increase in ambient methane levels was detected in the proximity of a dry creek bed between a bend in Escondido Rd. This seep is at the same location as a previous identified seep from the 2007 survey.

A picture looking south of a dry creek bed which is in-between a bend on Escondido Rd.

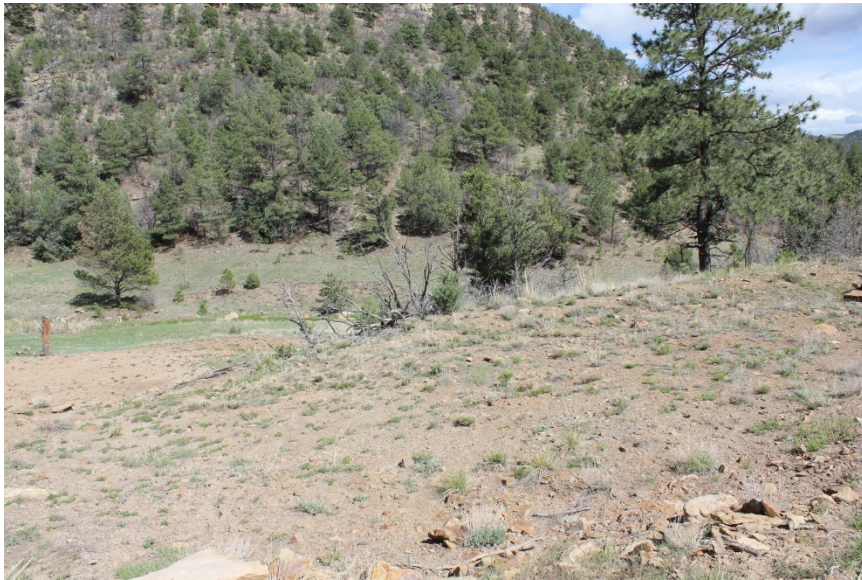
**Description:** An increase in ambient methane levels was detected west of an unnamed leased road. A compressor station is about 500ft south, and a well pad is located 360ft to the north west. Due to winds coming from the south west, a seep at this location is credible.

Looking southwest of the unnamed leased road were abnormal methane levels were detected.

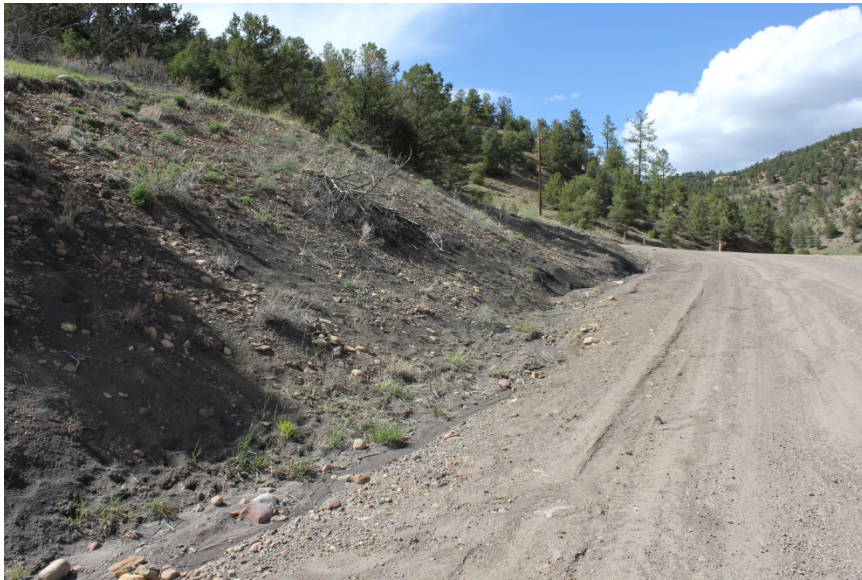
**Description:** An increase in ambient methane levels was detected near the side of a hill on the west side of an unnamed leased road. Exposed coal seams were visible on the hill.

Looking northwest on the unnamed leased road.

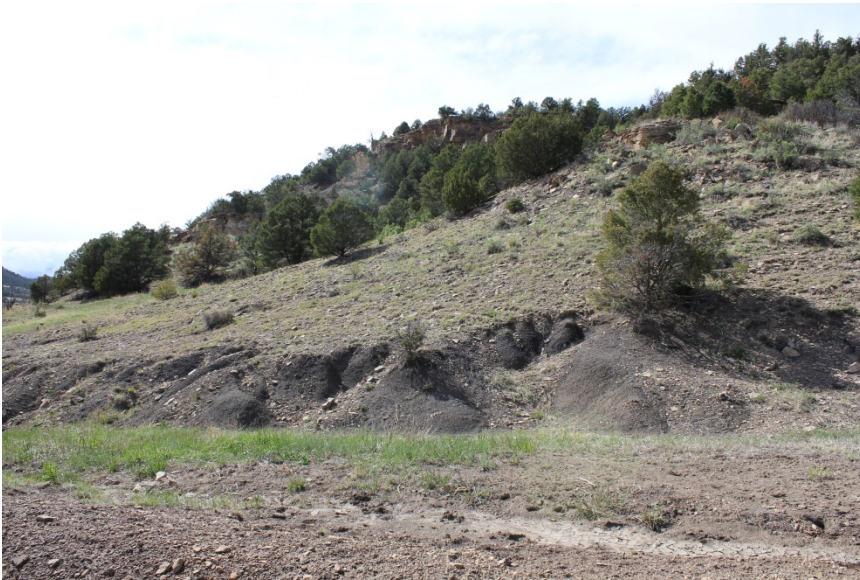
**Description:** Significant readings above ambient methane levels were detected on the west side of an unnamed leased road just north of CO Highway 12. On the west side of the road is a hill with exposed coal seams.

Looking west from the unnamed leased road in the vicinity where high methane levels were detected.

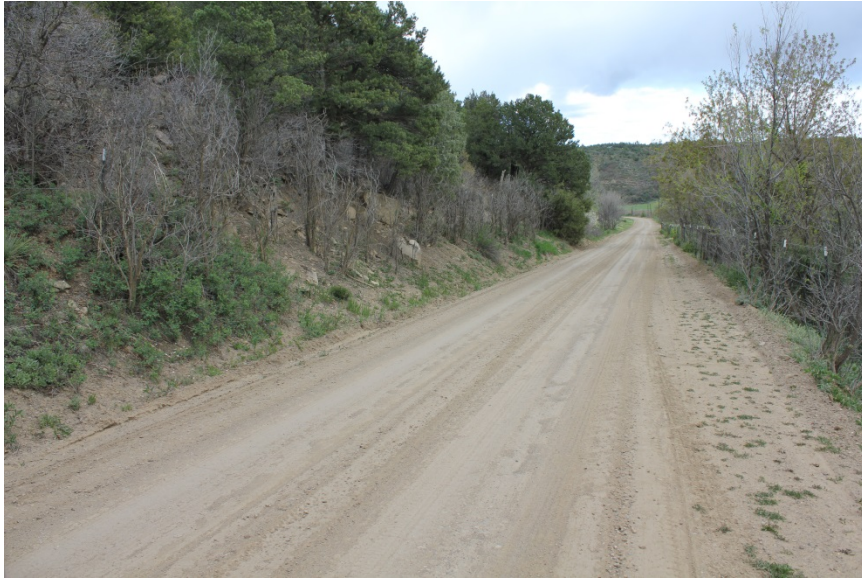
**Description:** An increase in ambient methane levels was observed coming from the southeast side of Trujillo Creek Rd. Thick brush and vegetation prevented any observation of distinguishing features. A dumpster is placed about 100ft to the west.

Looking southeast along Trujillo Creek Rd. where elevated methane readings were detected on the right side of the road.

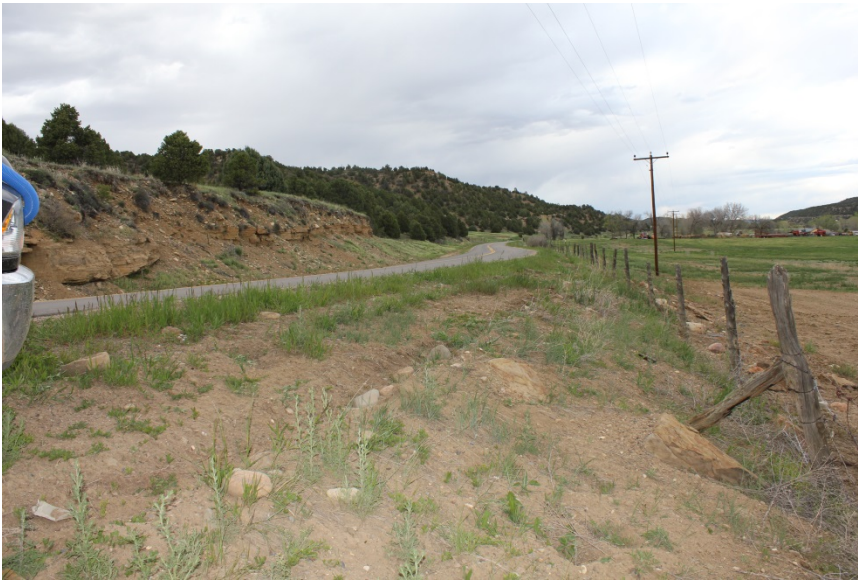
**Description:** Significant readings above ambient methane levels were detected on the northeast side of County Rd. 43.7. This seep is at the same location as a previous identified seep from the 2007 survey.

Looking north on County Rd. 43.7 where methane was detected on the east side of the road.

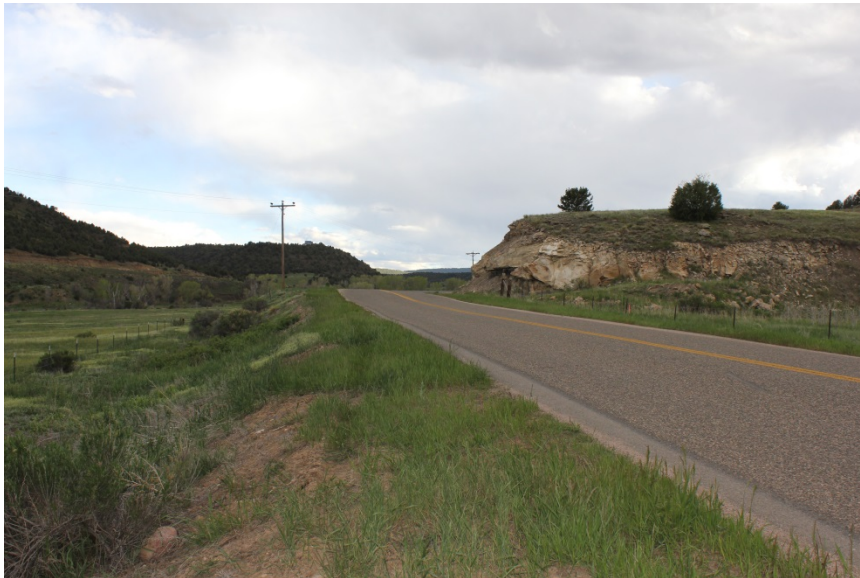
**Description:** An increase in ambient methane levels was detected on the northeast side of County Rd. 43.7. No suspect features were observed

Looking south on County Rd. 43.7 where elevated levels of methane were detected on the left side of the road.

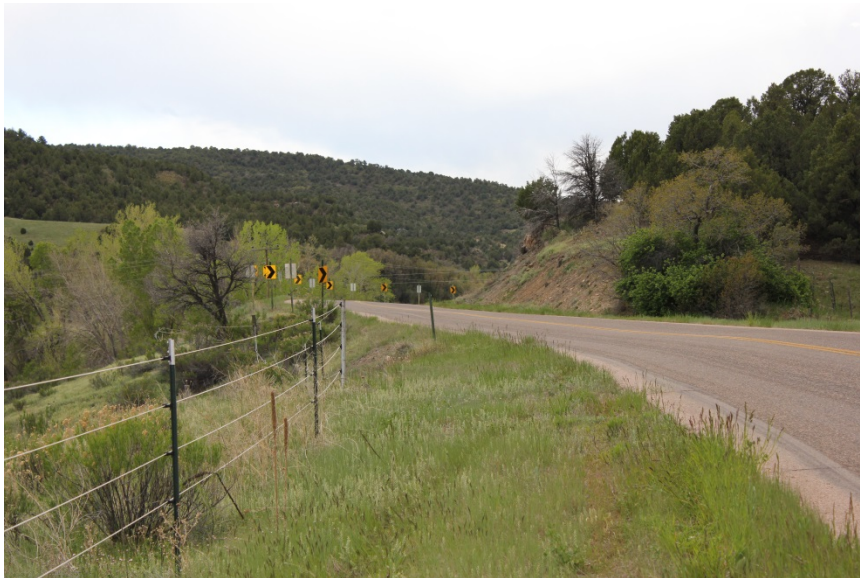
**Description:** An increase in ambient methane levels was detected on the northeast side of County Rd. 43.7.

Looking south on County Rd. 43.7. The elevated methane levels were detected on the left side of the road.

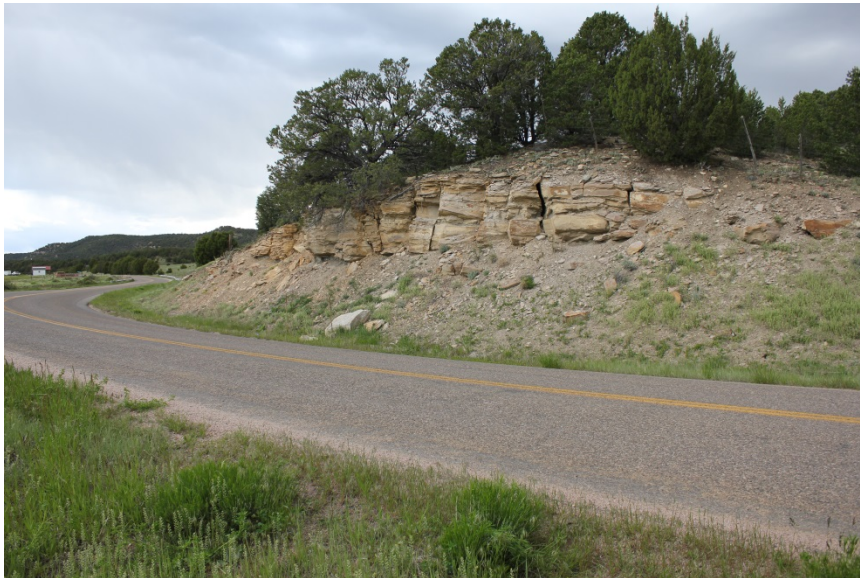
**Description:** An increase in ambient methane levels was detected on the southwest side of County Rd. 43.7. On the southwest side of the road is a rock formation with small fissures.

Looking at a rock formation on the southwest side of County Rd. 43.7 where elevated levels of methane were detected.

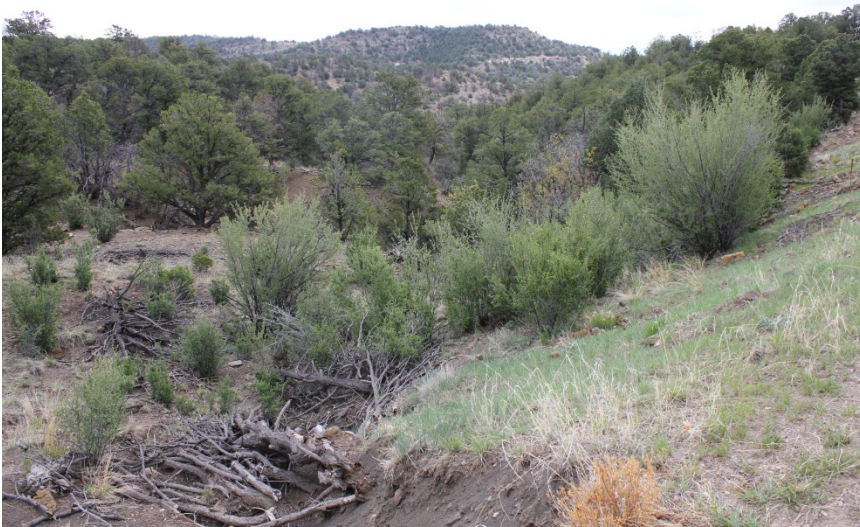
**Description:** An increase in ambient methane levels was detected on the northeast side of an unnamed leased road. On the northeast side of the road was a dry crevice with dead vegetation.

Over-looking the crevice located northeast of the unnamed leased road where the methane anomaly was recorded.

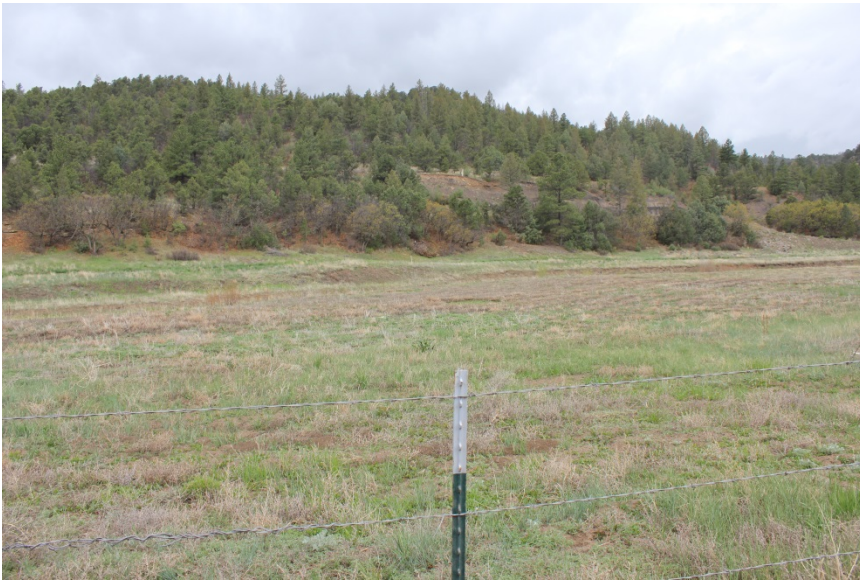
**Description:** A very small increase in ambient methane levels was detected in the vicinity of a dry creek bed southwest of County Rd. 31.9. This seep is at the same location as a previous identified seep from the 2007 survey.

A view of the dry creek bed located southwest of County Rd. 31.9 where the methane anomaly was detected.

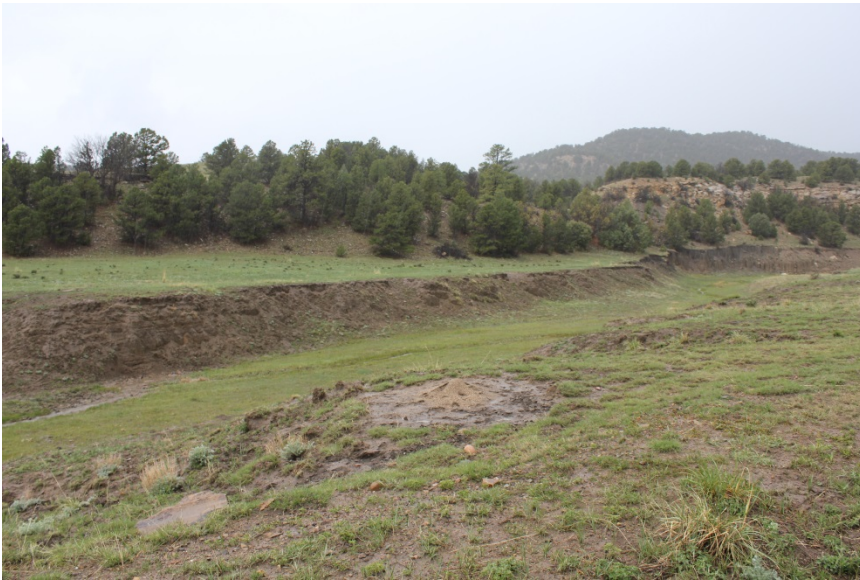
**Description:** An increase in ambient methane levels was detected in the vicinity of a dry creek bed southwest of County Rd. 31.9. This is the same creek bed as Seep ID 1045, but about 1.5 miles south.

A view of the dry creek bed located southwest of County Rd. 31.9 where the methane anomaly was recorded.

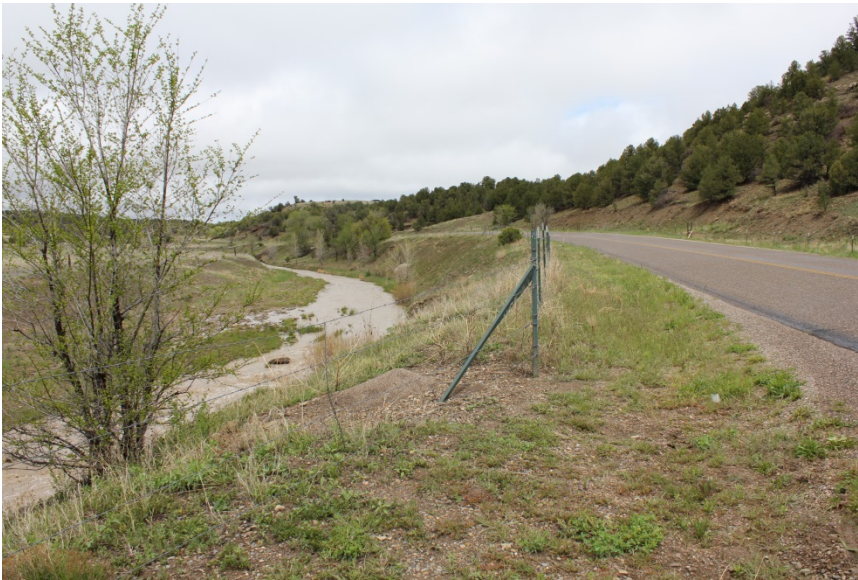
**Description:** An increase in ambient methane levels was detected on the west side of County Rd. 57.7. An active stream is located on the west side of the road. Exposed coal beds are also scattered through the area.

A view of the west side of County Rd. 57.7 where the methane anomaly was recorded.

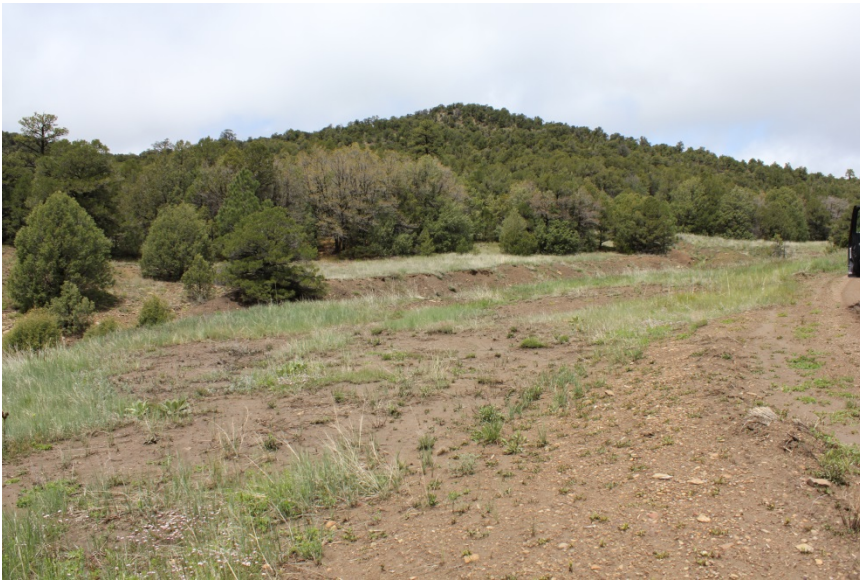
**Description:** An increase in ambient methane levels was detected in a creek bed west of an unnamed leased road. Normally the bed is dry, but at this time it was flowing. A small pond is located about 200ft beyond the creek bed.

Looking west of the unnamed leased road, the creek is in the depression in the center of the picture.

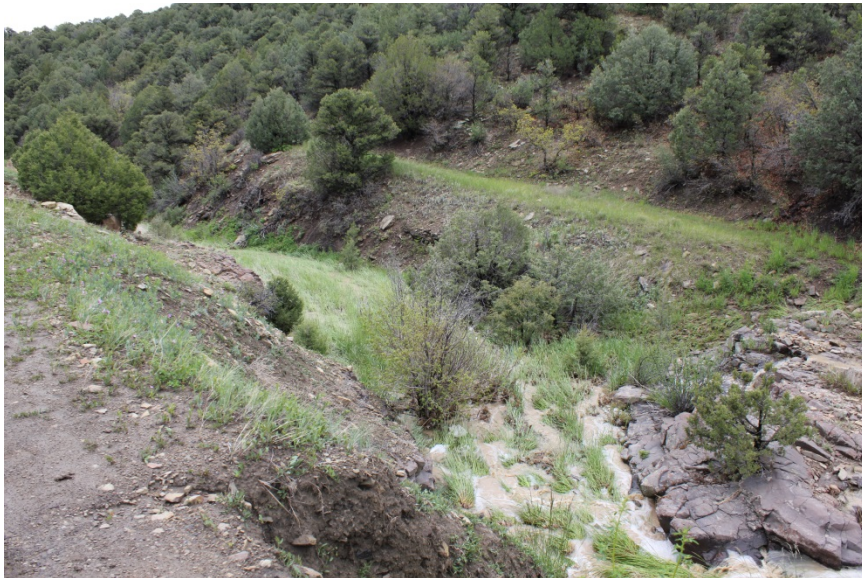
**Description:** An increase in ambient methane levels was detected on the east side of Baldy Canyon Rd. Located on the east side of the road is an active creek and rock formations.

A view looking east of Baldy Canyon Rd which shows the creek and rock formations.

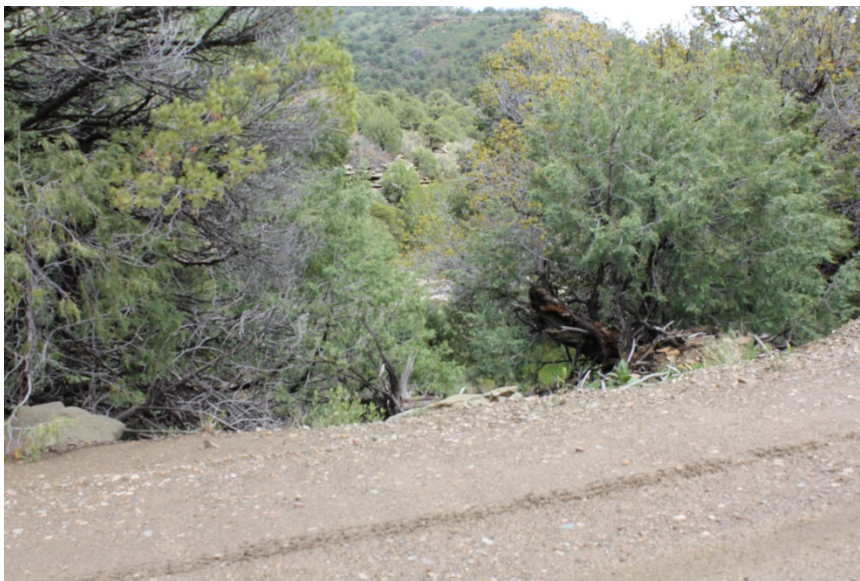
**Description:** An increase in ambient methane levels was detected on the southeast side of an unnamed road. Located on the southeast side is a small ravine where water collects from run off.

Looking southeast, down a ravine where the methane anomaly was recorded.

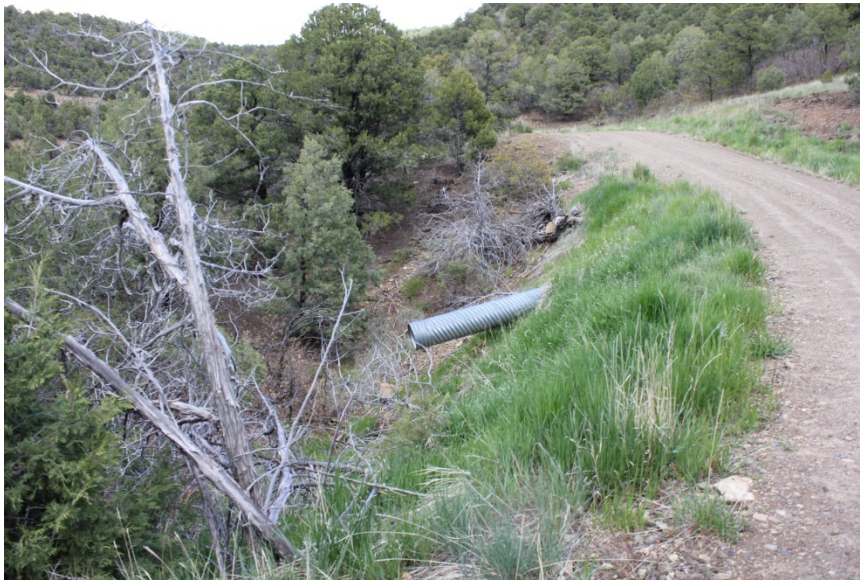
**Description:** An increase in ambient methane levels was detected on the northeast side of an unnamed leased road. On the northeast side of the road is a water run off ditch. At the time of the survey, the ditch was dry.

Looking east on the unnamed leased road. The methane anomaly was detected on the left side of this picture.

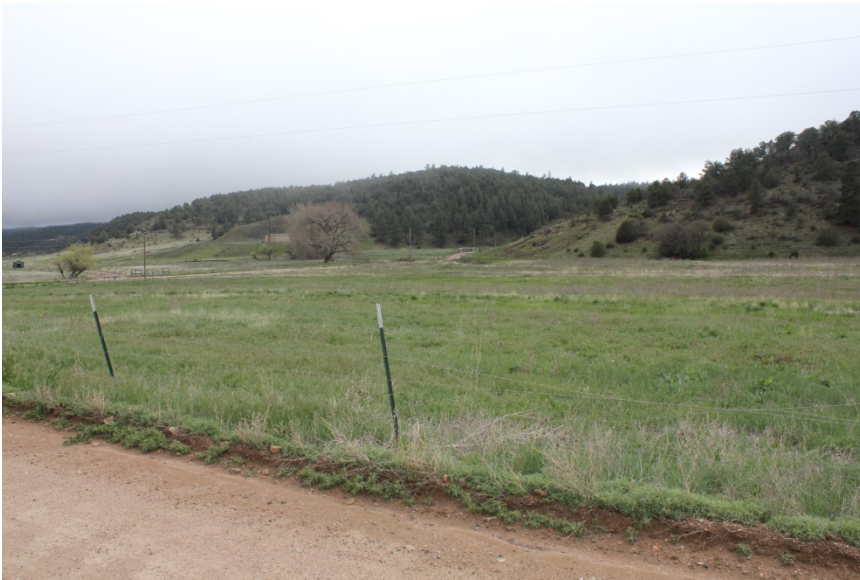
**Description:** An increase in ambient methane levels was detected on the southwest side of County Rd. 51.0. No suspect features are located in the immediate area. This seep is at the same location as a previous identified seep from the 2007 survey.

Looking southwest on County Rd. 51.0 where a methane anomaly was detected.

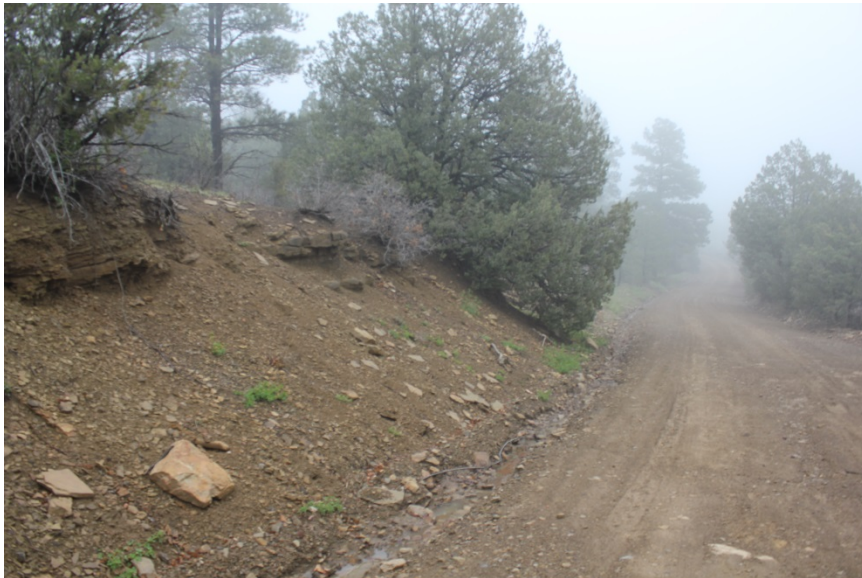
**Description:** An increase in ambient methane levels was detected on the northeast side of County Rd. 40.2. On the northeast side of the picture is a small hill and rock formations.

Looking northeast on County Rd. 40.2 at a hill where a methane anomaly was detected.

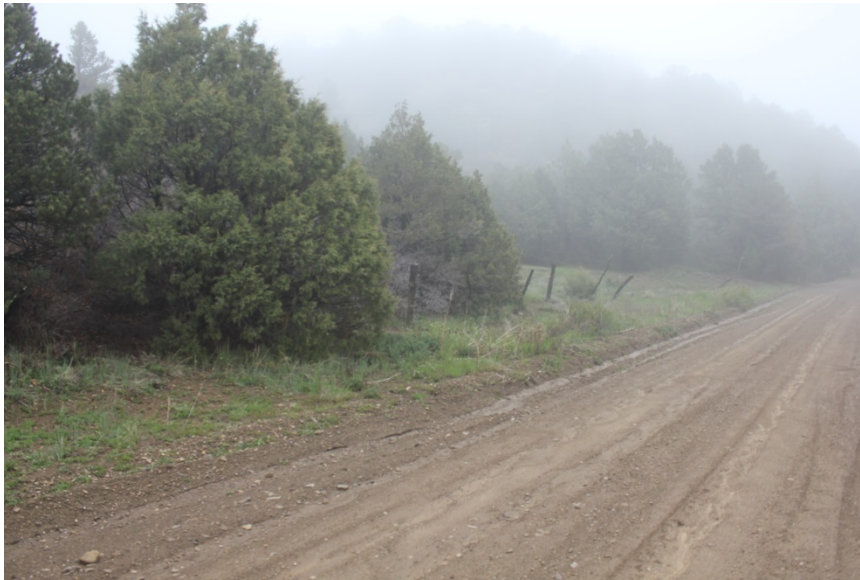
**Description:** An increase in ambient methane levels was detected on the northeast side of County Rd. 40.2. This potential seep was only ¼ mile east of Seep ID: 1060 on the same road. No suspect features are located in the immediate area.

Looking northeast on County Rd. 40.2 where a methane anomaly was detected.

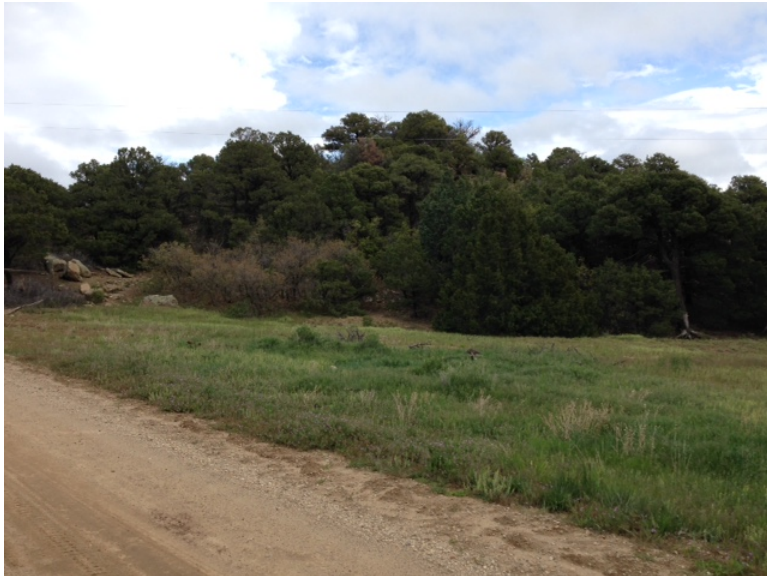
**Description:** An increase in ambient methane levels was detected on the east side of Co. Rd. 358. A hill is located on the southeast side of the road but covered in vegetation. No other suspect features are located in the immediate area. This seep is at the same location as a previous identified seep from the 2007 survey.

Looking southeast on Co. Rd. 358 where a methane anomaly was detected.

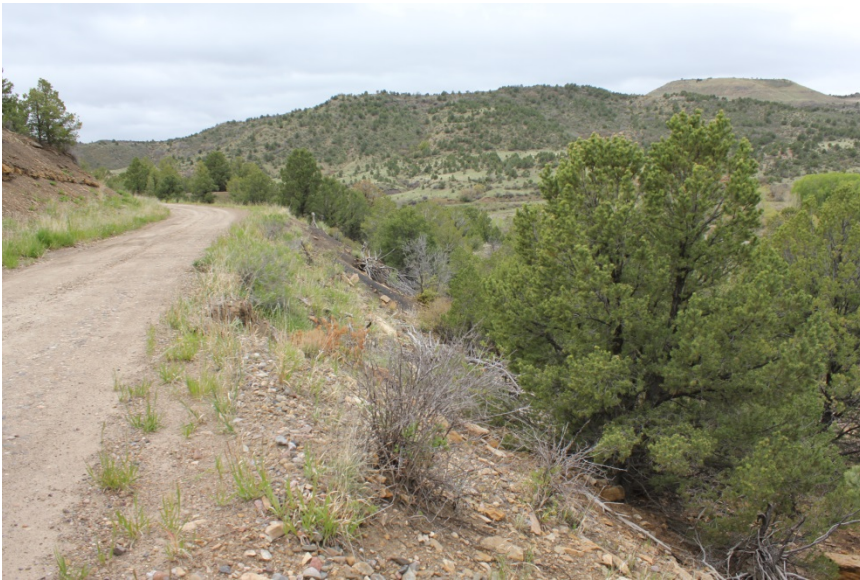
**Description:** An increase in ambient methane levels was detected on the west side of an unnamed leased road. On the west side of the road is a downward slope of a hill which bottoms out into a ravine.

Looking south on the unnamed leased road. The methane anomaly was detected on the right side of the picture.

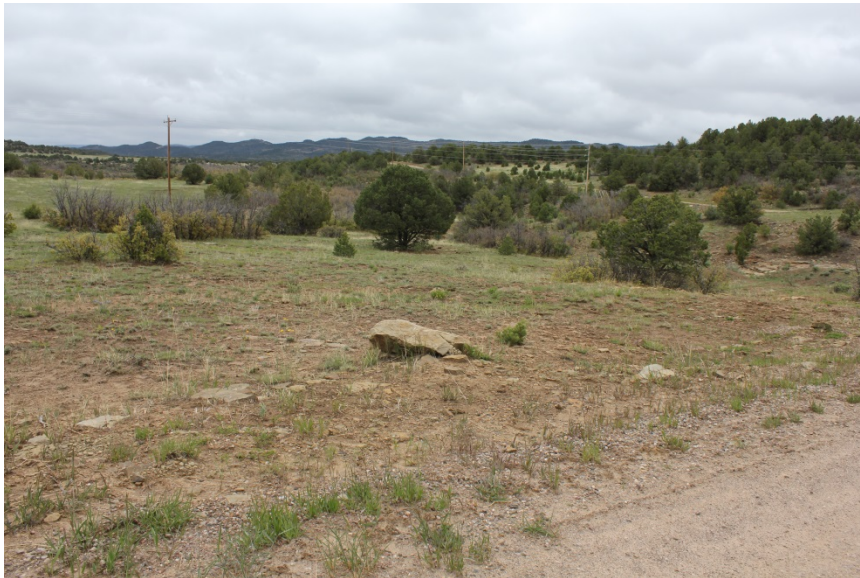
Looking east on the unnamed leased road where a methane anomaly was detected.

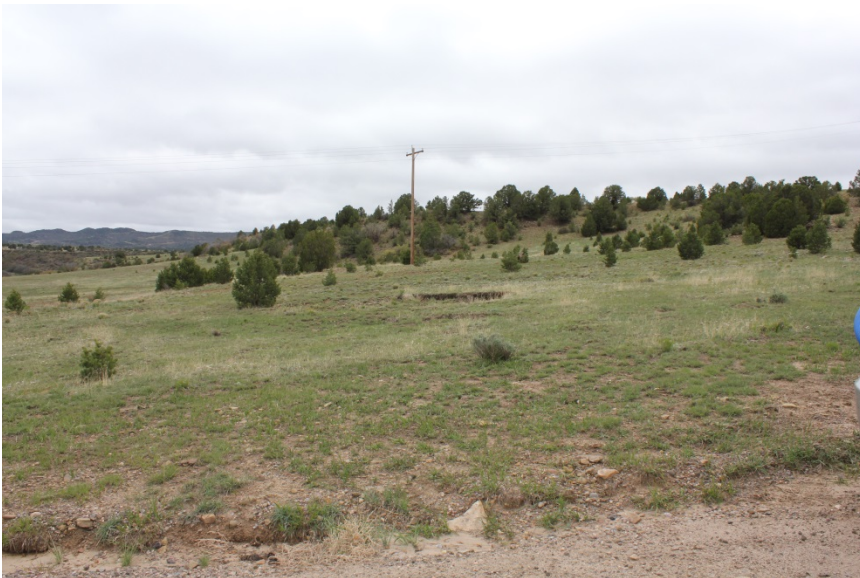
Looking southeast on the unnamed leased road where a methane anomaly was detected.

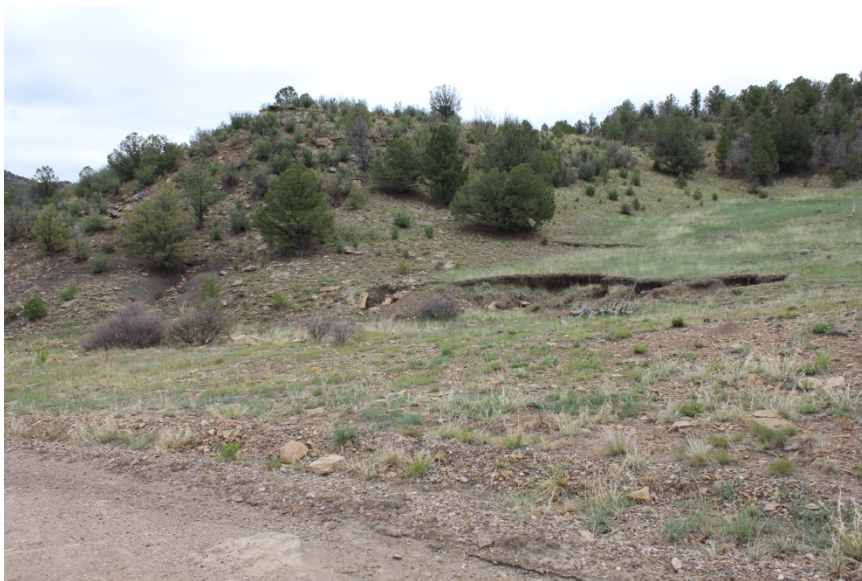
**Description:** An increase in ambient methane levels was detected on the east side of an unnamed leased road. A small fissure with exposed coal seams is located south of the road.

Looking east on the unnamed leased road where a methane anomaly was detected.

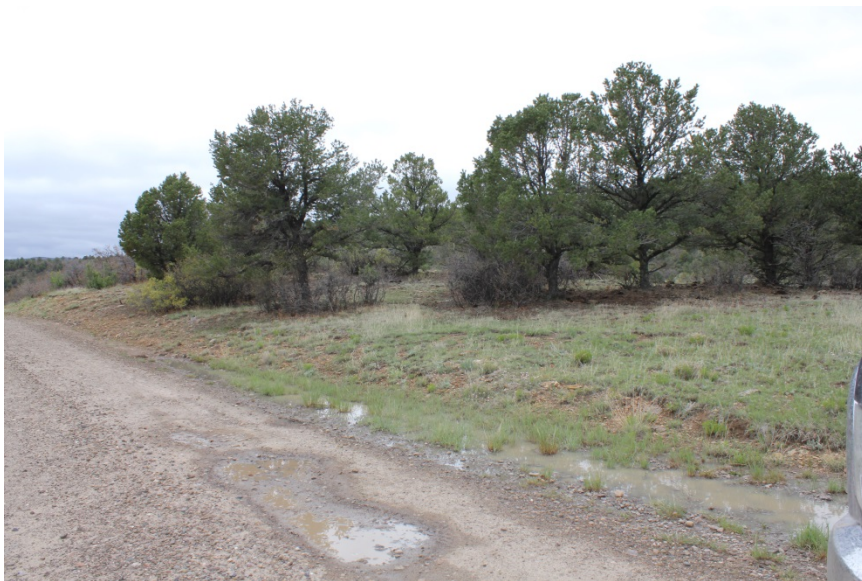
Looking south on the unnamed leased road where a methane anomaly was detected.

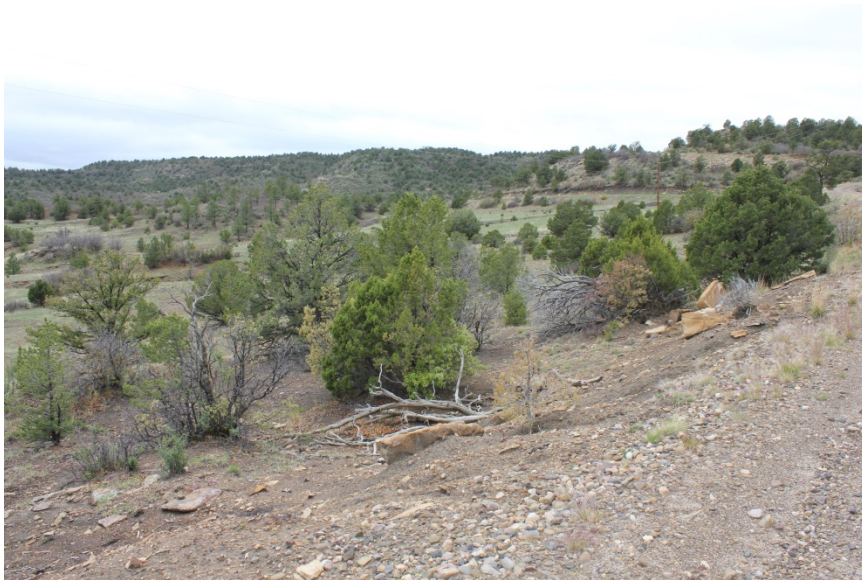
Looking south on the unnamed leased road where a methane anomaly was detected.

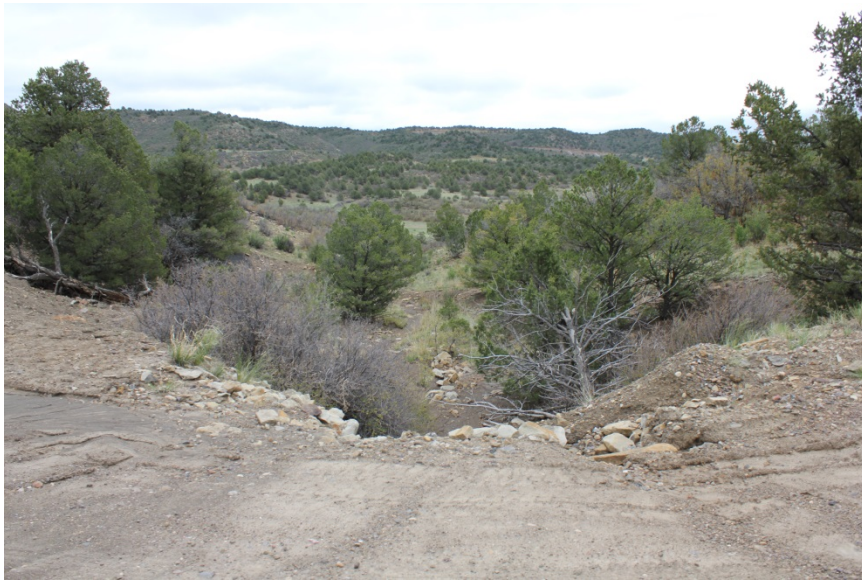
Looking east on the unnamed leased road where a methane anomaly was detected.

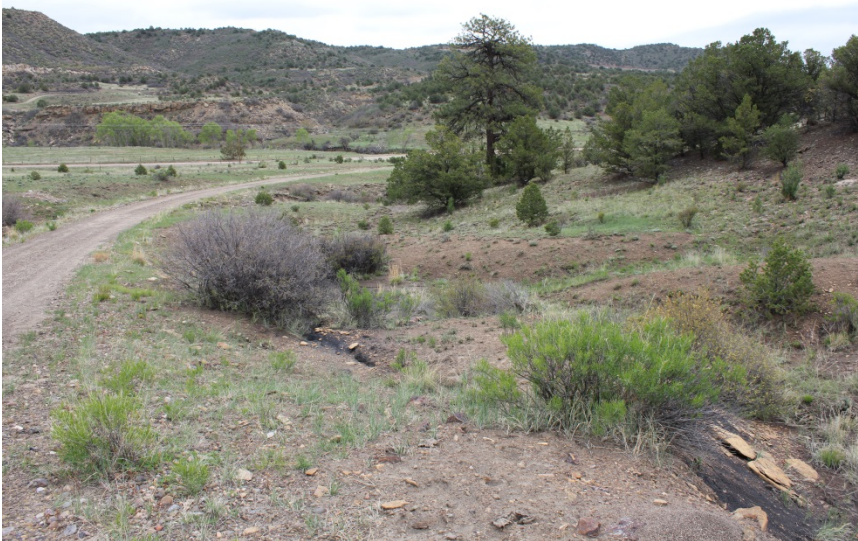
Looking east on the unnamed leased road where a methane anomaly was detected. Notice the coal seams in the right corner.

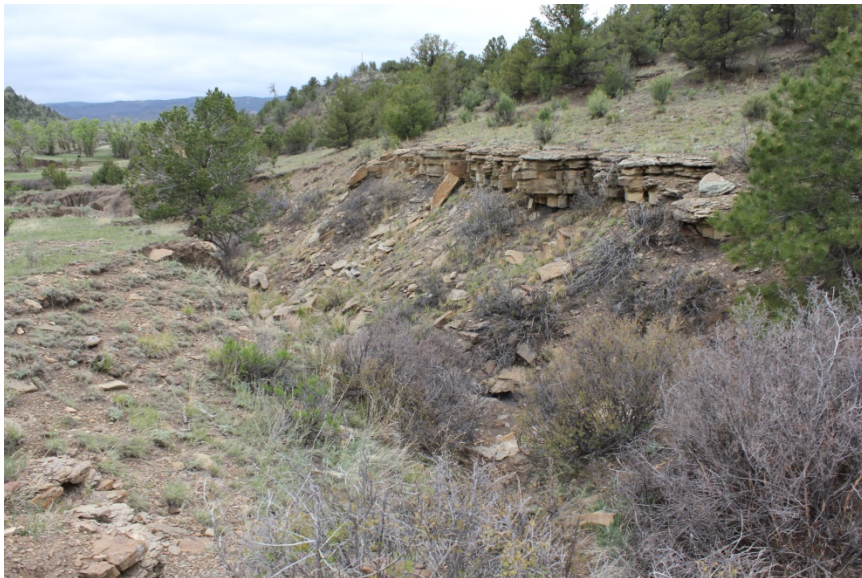
Looking south on the unnamed leased road where a methane anomaly was detected.

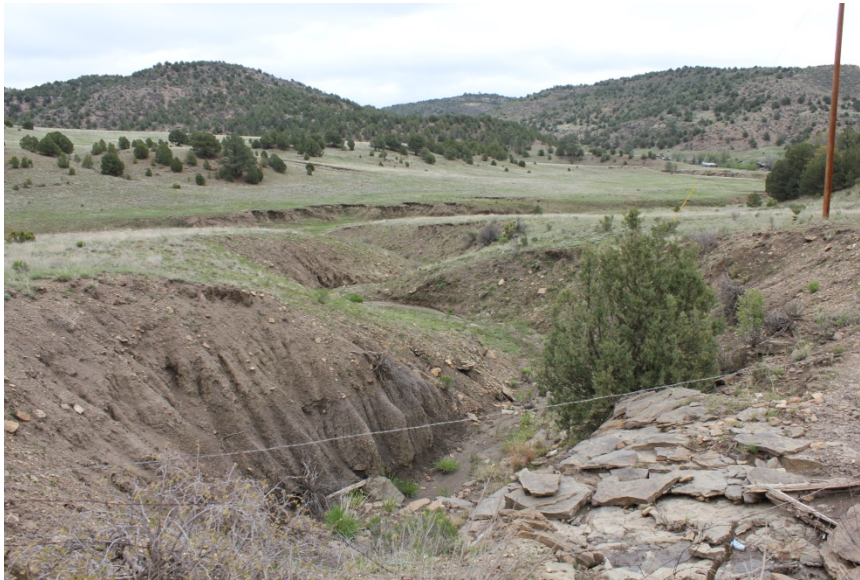
Looking east on County Rd. 41.7 over a dry creek bed where a methane anomaly was detected.

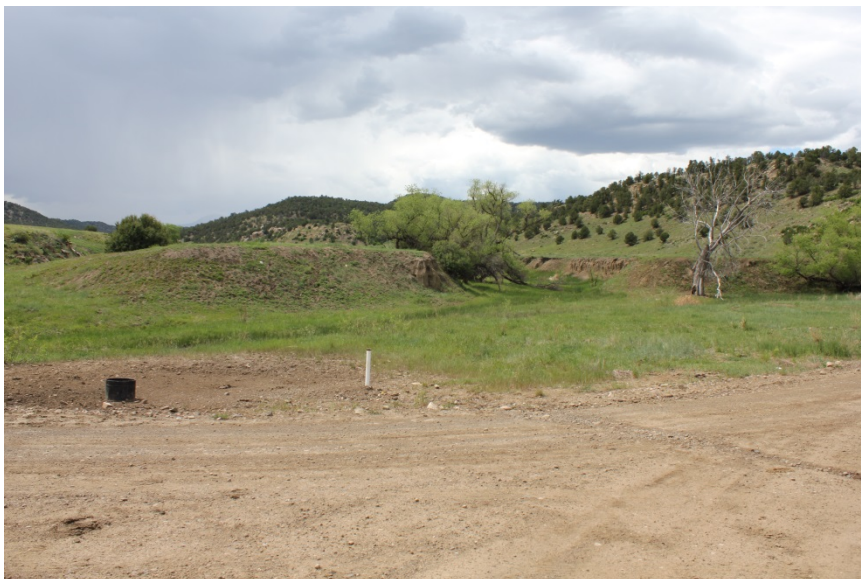
Looking west of the leased road, notice the creek in the background as well as the vertical pipe coming from the ground.

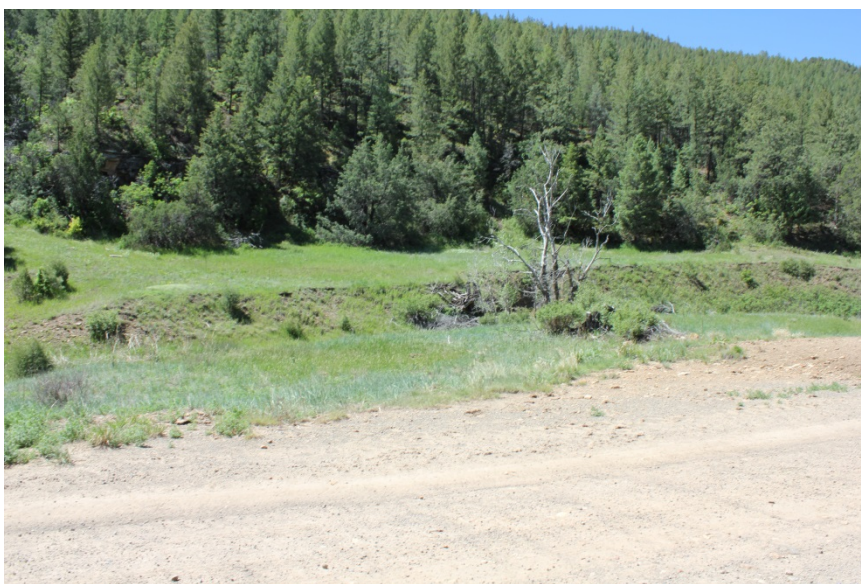
Looking east of the unnamed leased road where abnormal methane levels were detected.
