# Ground Survey of Las Animas County for Methane Anomalies

June 30, 2015

Prepared by:

Prepared for:

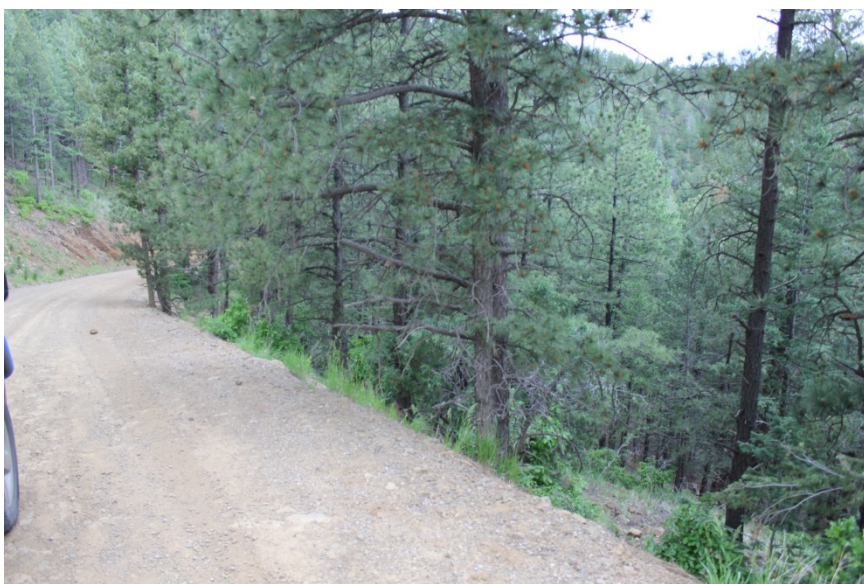
Looking west of the unnamed leased road where the methane anomaly was detected.

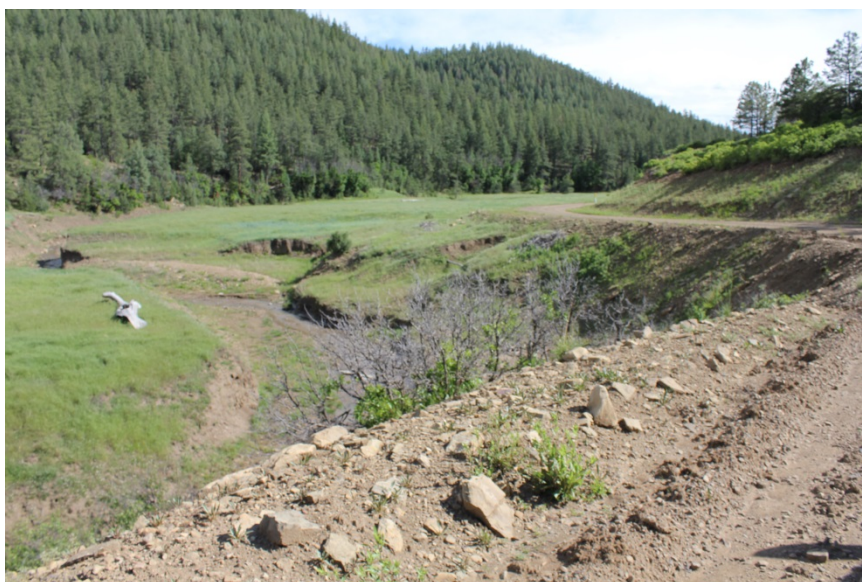
**Description:** An increase in ambient methane levels was detected coming from the south side of Hill Ranch Rd. Located south of the road is a small creek with wide banks. On the other side of the road is a buried transmission pipeline. However, the pipeline is buried 6-8ft and no dead grass is observed.

Looking south at a creek on Hill Ranch Rd where methane was detected.

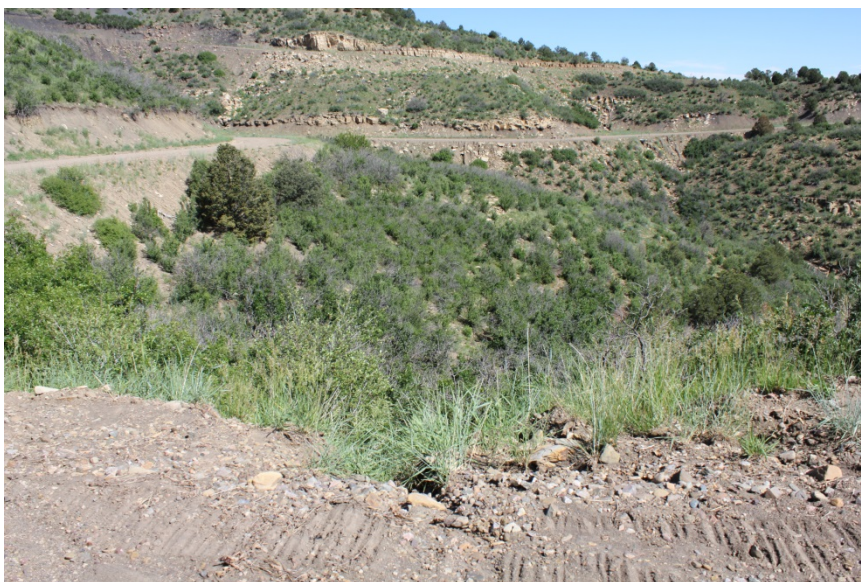
Looking north on the unnamed leased road where methane was discovered.

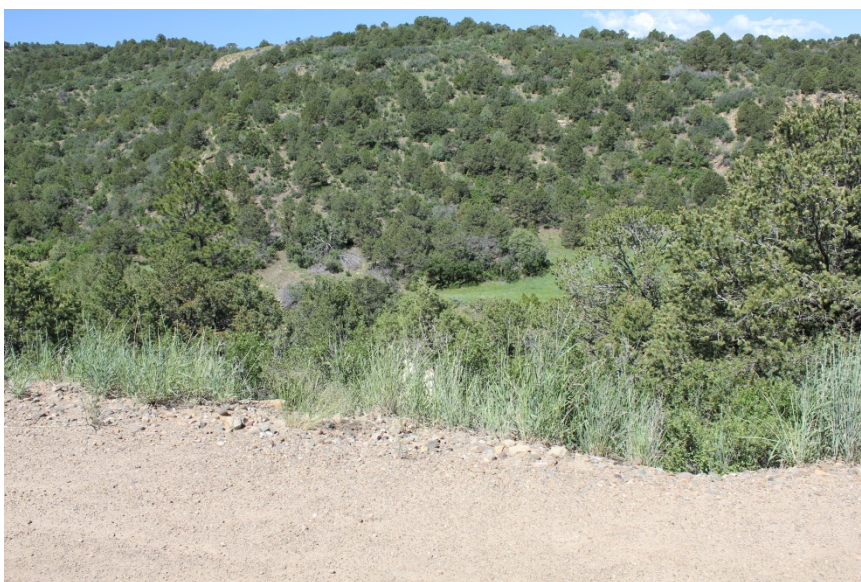
Looking west on the unnamed leased road where methane was discovered.

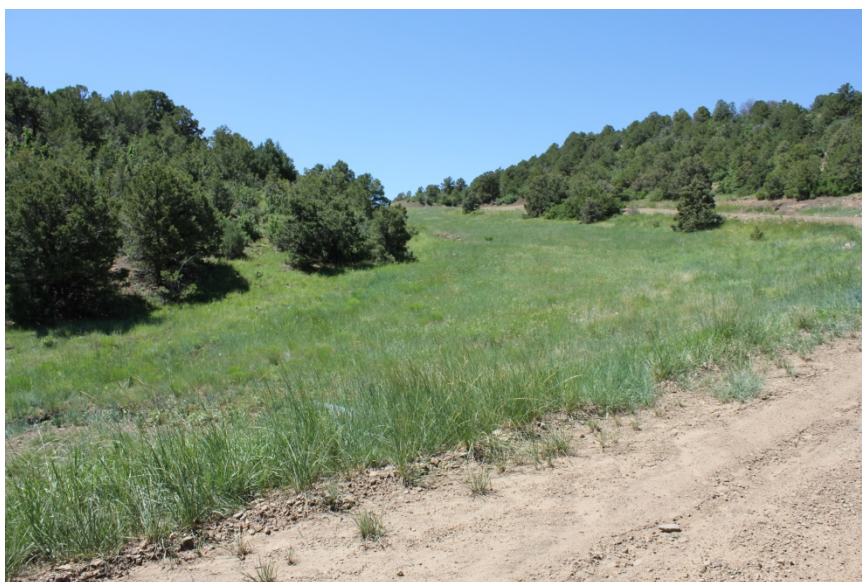
Looking southeast on the unnamed leased road where methane was discovered. The dry creek bed is hidden by vegetation.

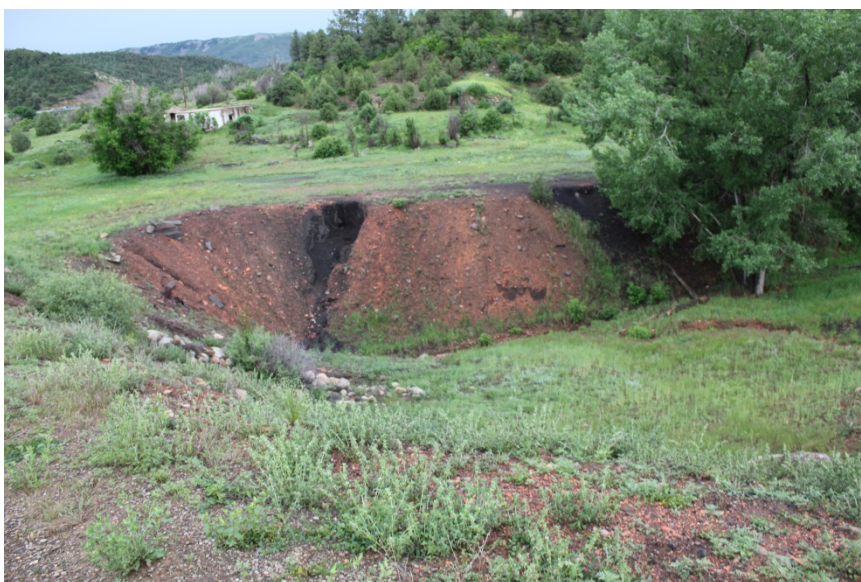
**Description:** An increase in ambient methane levels was detected coming from the south side of Fisher Peak Pkwy. To the south is a culvert with standing water at the bottom. Exposed coal seams are also visible. This potential seep is located ¼ miles from a previous seep found in the 2007 survey.

Looking south on Fisher Peak Pkwy. at the culvert with exposed coal seam.

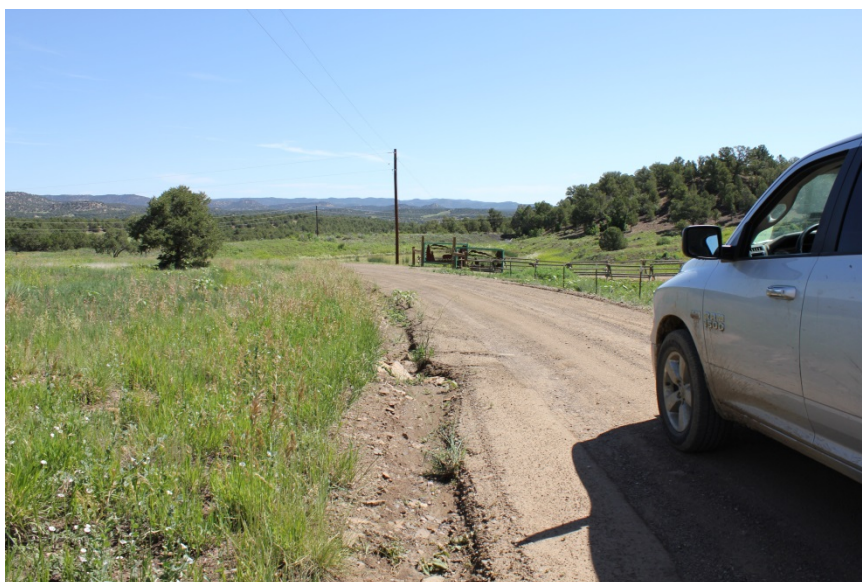
Looking northeast on the unnamed leased road where methane was discovered.

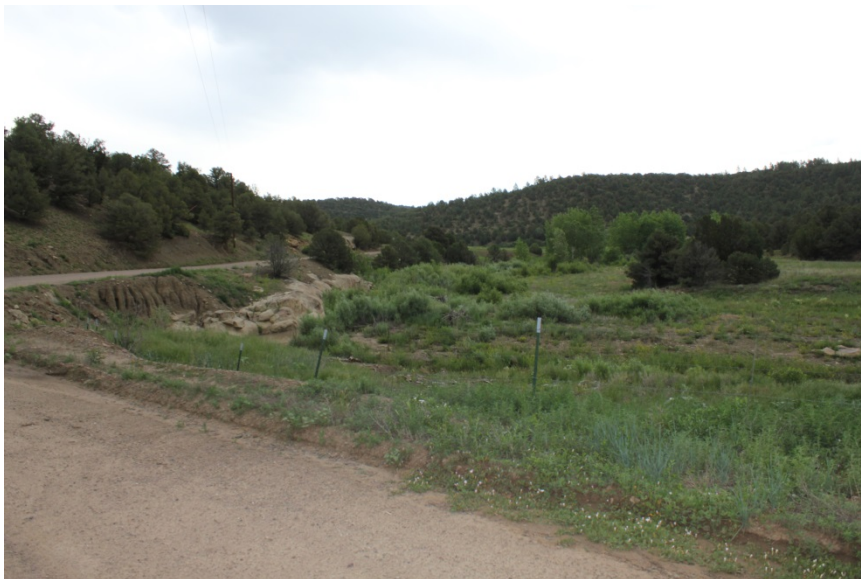
Looking northeast on Co. Rd. 53.1 where a methane anomaly was detected.

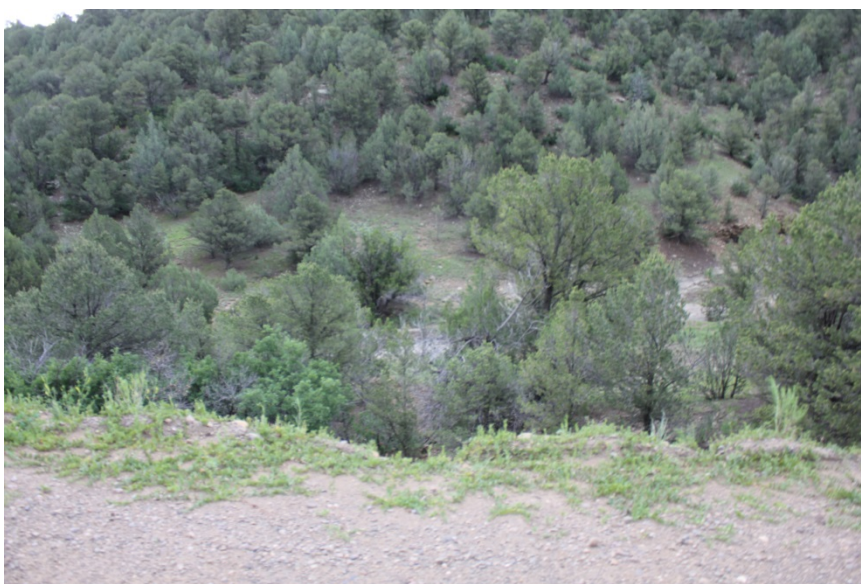
Looking east on Co. Rd. 18.3 where the methane anomaly was detected.

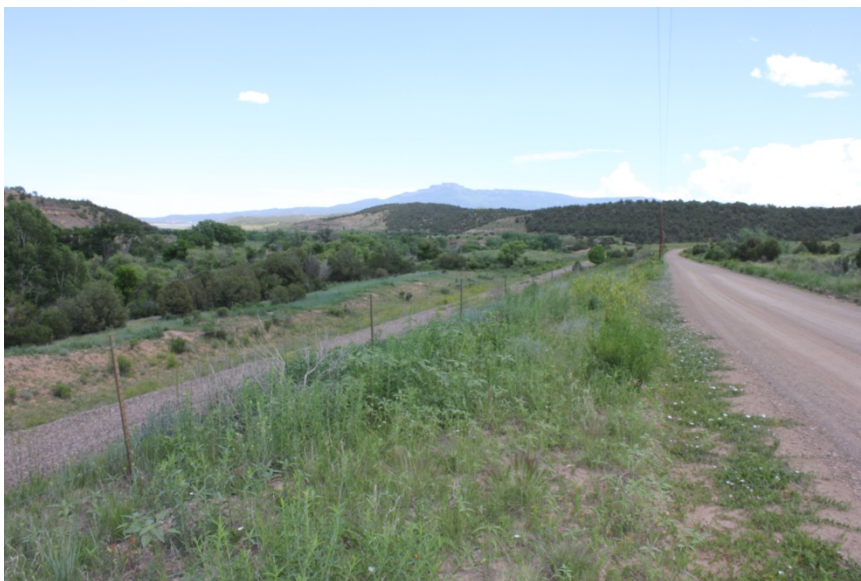
Looking east on Co. Rd. 18.3 where the methane anomaly was detected. The Purgatoire River is beyond the trees on the left hand side of the picture.

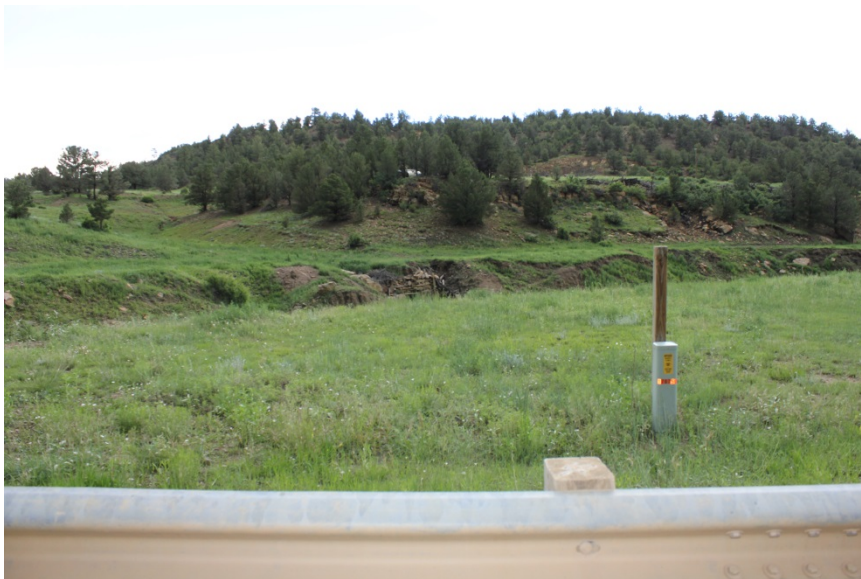
Looking northeast on Co. Rd. 41.7 where the methane anomaly was detected.
