Colorado Oil and Gas Conservation Commission

Monitor Wells Summary Report May 2014

4M Project Monitoring Program Archuleta and La Plata Counties Colorado

May 22, 2014

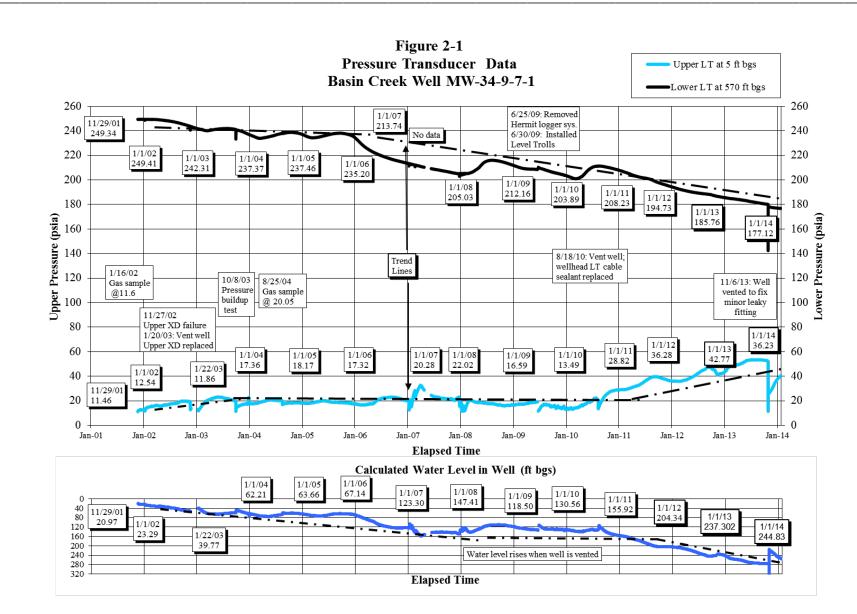
Figure 2-1 Pressure Transducer Data Basin Creek Well MW-34-7-1

Figure 2-1 charts the upper and lower pressure transducer data and the calculated water level in the well. Table 2-1 and Figure 2-1 show a net increase of 24.77 psi in wellhead pressure for the entire 12-year period of record from November 29, 2001 (11.46 psia) to January 1, 2014 (36.23 psia). Figure 2-1 generally shows a pattern of minor seasonal fluctuations within an overall stable trend in wellhead pressure prior to wellhead cable gland seal replacement on August 18, 2010, followed by a rise in wellhead pressure to a recorded high of 53.42 psia on September 11, 2013. A very minor leak persisted so on November 6, 2013 the well was vented to allow a safe condition to repair leaking threads at the

wellhead. Recovery of the wellhead pressure is now still slowly occurring following this wellhead venting.

In contrast to the wellhead pressure patterns, Table 2-1 and Figure 2-1 show a net decline of 223.85 feet in the calculated well water level and a corresponding net decline in downhole pressure of 72.22 psi for the period of record. Figure 2-1 also shows a pattern of slight seasonal fluctuations within the overall declining trend in the water level and corresponding downhole pressure for the period of record.

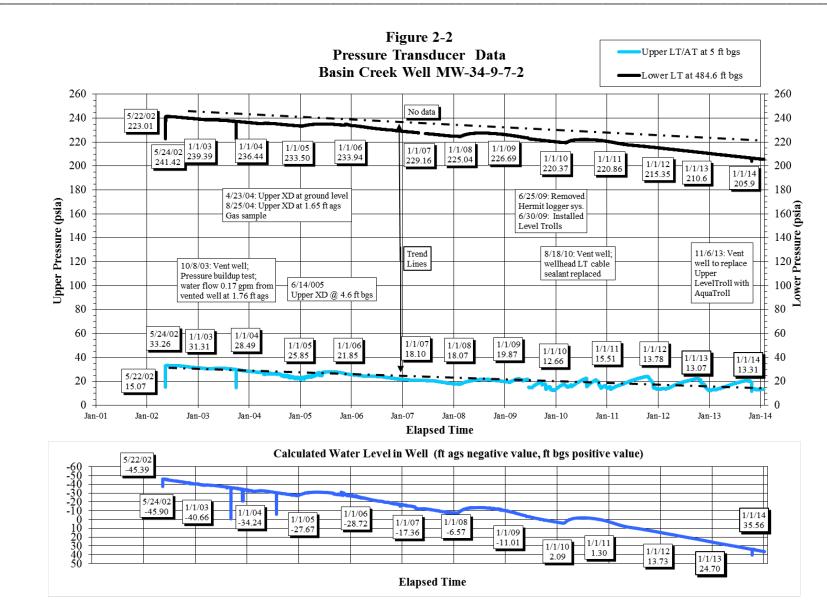
Figure 2-2 Pressure Transducer Data Basin Creek Well MW-34-9-7-2

A small amount of gas was released and artesian flow (~0.2 gpm) from the well consistently occurred each time the well was vented for maintenance during the period of record between 2002 and 2010. The pressure regime documented was relatively high pressure but low volume based on the head pressure versus artesian flow. Artesian flow from the well did not occur when the wellhead was vented on August 18, 2010 to replace the Level Troll wellhead cable Conax gland sealants. The final recorded upper transducer pressure in 2011 of 13.7 PSI was very near atmospheric pressure indicating the well was essentially in hydrostatic balance. The pressure fluctuations since early 2009 suggest that ambient surface temperatures may be affecting the gas pressure as measured by the upper transducer. In order to attempt to distinguish water pressure versus gas pressure being recorded by the upper transducer, the Level Troll was replaced by an Aqua Troll, which records specific conductance (SC) in addition to pressure and temperature. The concept was that if water was present at the Aqua Troll, it would record an SC value greater than zero. If a value of zero was recorded for SC, then a pressure greater than atmospheric pressure would be gas pressure only. The Aqua Troll was installed on November 6, 2013, but it appears by this time the static water level in this well had dropped from the near-surface balance of 2009-2011. Unless the water level decline trend reverses, the pilot test utilizing the Aqua Troll to determine the presence of water will not be successful. Data will be collected and interpreted in the first half of 2014 to assess if the Aqua Troll would be better suited at another location with a near-surface static water level.

Substantial water level decline has been documented in this well, going from artesian flowing with a calculated shut-in head of approximately 46 feet above ground surface just after construction to approximately 36 feet below ground surface on January 1, 2014. This calculated water level has been verified by a manual open-well water level measurement on November 6, 2013 of 40.20 ft bgs compared to a water level calculation using the lower Level Troll data within fifteen minutes on the same date of 40.46 feet below ground surface.

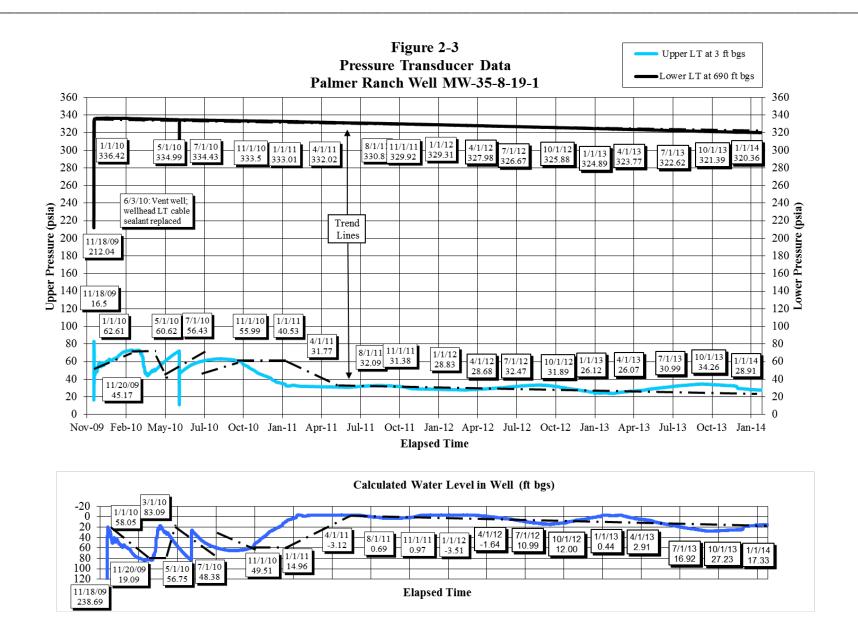
Figure 2-3 Pressure Transducer Data Palmer Ranch Well MW-35-8-19-1

Figure 2-3 shows an immediate water level rise in response to the drop in well pressure when the well was vented for maintenance on June 3, 2010, followed by a gradual, partial return of the wellhead pressure and water level to trends exhibited prior to June 3, 2010. By August 1, 2010, the wellhead pressure and water level reached about 64 percent of trends exhibited prior to June 3, 2010, then plateaued through late October, 2010. Figure 2-3 also shows a trend of water level rise in response to a steady drop in wellhead pressure between late October, 2010 and early February, 2011. The drop in wellhead pressure after October 2010 is likely due to an incomplete shut-in condition. A minor leak was detected at the wellhead during the 2011-2013 site inspections but not corrected because tightening the leaky pipe fitting would likely have caused more damage and further compromised the seal. Preparations will be made to attempt to seal the minor leak during the 2014 site visit if conditions warrant and allow a repair.

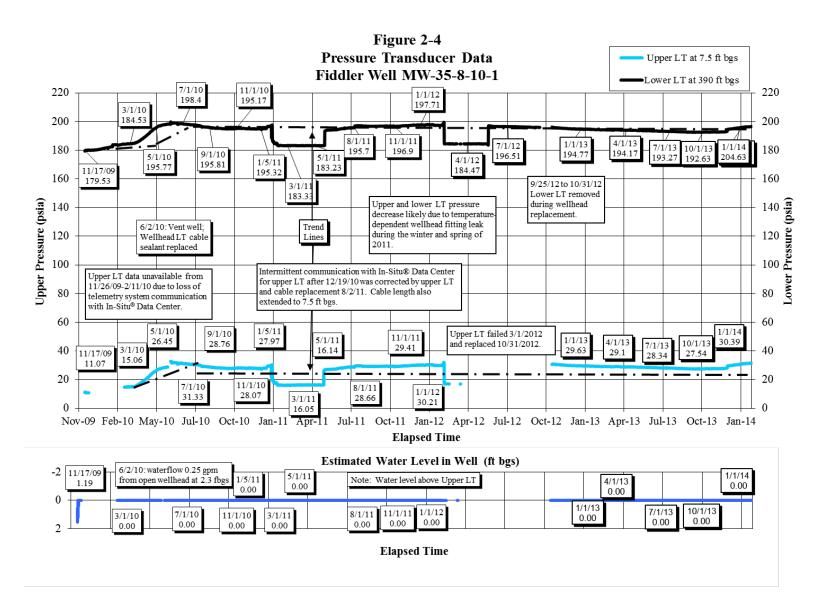
Figure 2-4 Pressure Transducer Data Fiddler MW-35-8-10-1

As noted on Figure 2-4 the lower Level Troll was removed during wellhead maintenance on September 25, 2012 and reinstalled on October 31, 2012. A net water level change was not calculated because the upper transducer is below the water level in the well. Figure 2-4 documents a natural flow rate from the well at a rate of 0.25 gallons per minute (gpm) when the well was vented for maintenance on June 2, 2010. At the time of the well inspection on October 31, 2012, the flow rate was measured at 0.14 gpm. For charting purposes, the water level in the shut-in well is estimated to be at or near ground surface above the upper pressure transducer (set at 7.5 ft bgs).

Also noted on Figure 2-4, telemetry system communication with the In-Situ[®] Data Center for the upper transducer was lost from November 26, 2009 through February 11, 2010 due to cable connection problem, and was intermittent from December 19, 2010 to January 1, 2011. The upper transducer and

cable were replaced during the 2011 well inspection and the cable length was extended from 3 ft bgs to 7.5 ft bgs. Additionally, a wellhead fitting leak during the winter and spring of 2011 through the summer of 2012 caused a pressure decrease observed on both the upper and lower transducers. Related to the freeze-thaw cycles the upper transducer failed again March 1, 2012. Inspection of the wellhead on June 6, 2012 revealed the minor water leak at an estimated flow rate of 0.1 to 0.2 gpm. The tubing head threading was cleaned in an attempt to achieve a pressure tight seal at the mandrel head, but both the rubber seals and threading had deteriorated significantly. Documentation was conducted for a later wellhead replacement. Souder Miller Associates supervised installation of the new wellhead on September 25, 2012, which required removal of all instrumentation from the well. Rather than reset the instrumentation at that time, it was planned to remain out of service until the well inspection conducted by COGCC, Norwest and In-Situ, Inc. on October 31, 2012. During that well inspection the upper transducer and cable was reset, however the new set depth was approximately 15 feet deeper than the previous set depth, so the proper offset has been incorporated into the lower transducer data in Figure 2-4.

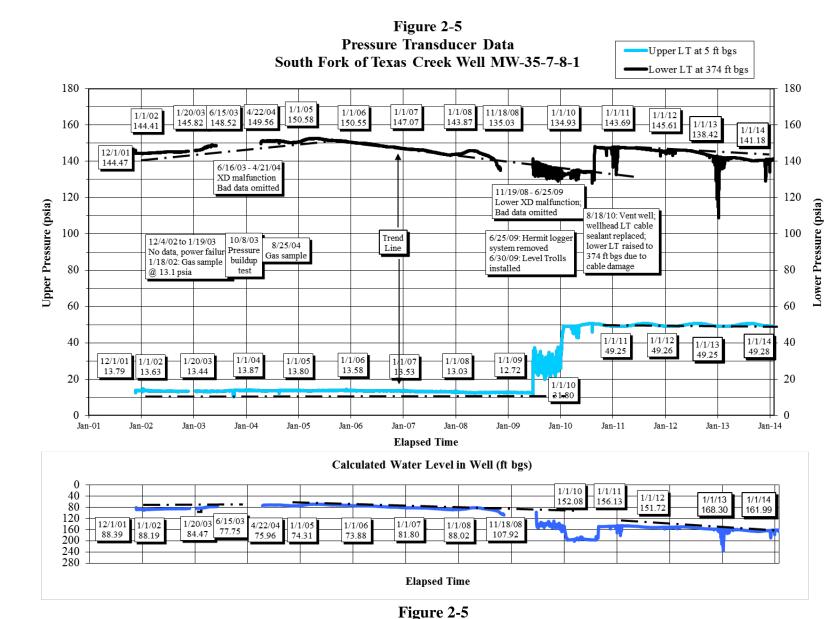
Pressure Transducer Data South Fork of Texas Creek Well MW-35-7-8-1

Figure 2-5 shows a relatively stable wellhead pressure (12 to 13.5 psia) prior to installation of the Level Troll instrument on June 30, 2009. After the transducer change-out, there was a build-up in wellhead pressure from 11.52 psia on June 30, 2009 to 33.76 psia on July 3, 2009 followed by frequent fluctuations in wellhead pressure ranging between 19 psia and 38 psia through January 18, 2010. Between January 19, 2010 and January 30, 2010, the wellhead pressure rose from 38 psia to 49 psia and then has remained fairly stable through January 1, 2014. The relatively stable wellhead pressure curve prior to June 30, 2009. Likewise, the lower Level Troll has recorded frequent downhole pressure fluctuations (between 129 and 142 psia) not previously observed in well pressure data prior to June 30, 2009. The higher well pressure regime since August 2010 may indicate complete well shut-in was not achieved until after the Level Troll cable wellhead seals were replaced on August 18, 2010. Some higher magnitude pressure fluctuations in the lower transducer began occurring in December of

2012 and were continuing through the current period of record. These fluctuations will be monitored further in early 2014 and evaluated to determine if the lower transducer is malfunctioning and it is a candidate for replacement during the 2014 site visit.

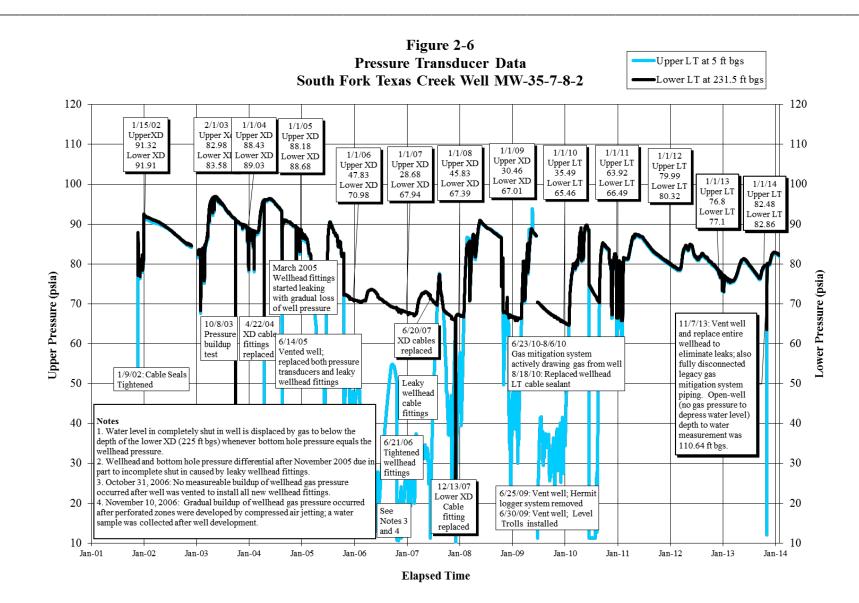
Figure 2-6 Pressure Transducer Data South Fork Texas Creek Well MW-35-7-8-2

Figure 2-6 charts the pressure data for well MW 35-7-8-2, which exhibits an entirely different pressure regime than the deeper monitoring well MW 35-7-8-1. Figure 2-6 shows nearly equal wellhead and downhole pressures for the period of record when the well is completely shut in. For example, wellhead and downhole pressures recorded on January 1, 2014 were 82.48 psia and 82.86 psia respectively under shut-in conditions. Based on the period of record to date, incomplete well shut-in is indicated whenever the well pressure drops below about 70 psia.

Figure 2-6 shows a fairly rapid increase in well pressure after the well was shut in on August 18, 2010. The peak build-up pressure of about 85 psia on September 28, 2010 was followed by an erratic decline in well pressure. The inspection of the well in 2013 documented a minor fitting leak at that time; this was a consistent leak on a pipe fitting that has been attempted to be tightened in the past years, but required significant replacement of numerous wellhead fittings. The colder air temperatures occurring with early winter of 2012 and again in 2013 appeared to cause some erratic pressure fluctuations documented with the upper and lower transducers in Figure 2-6. This seemed to indicate that the leak was becoming more significant. On November 7, 2013 during a site specific follow-up trip that documented continued leakage on September 30, 2013. The well gas pressure was allowed to safely bleed down, with continuous gas detector monitoring. Both upper and lower Level Trolls were removed from the well and the wellhead was completely removed down to the 2-inch line pipe that is the well

casing extending up from the cement pad. The threads were reconditioned with a hand-operated 2-inch pipe die. The wellhead was reconstructed using all new carbon steel pipe fittings, with the exception of the Conax compression fittings secured around each Level Troll Rugged Cable, as they had not been documented as leaking. Several manual water level measurements were taken while the wellhead was open. Initially, the water level was recovering fairly quickly as the gas pressure had been vented. After approximately 2.5 hours open during the new wellhead installation, the water level was relatively static and measured 110.64 ft bgs. This is the static water level when no gas pressure is allowed to depress the water column in the well. As can be seen in Figure 2-6, the upper and lower Level Troll pressure readings diverge at this time indicating that for the short period following well shut-in the lower Level Troll was actually submerged in water. The lower Level Troll pressure reading was approximately 63.6 psia, which calculates to 111.06 ft bgs. This gives good confidence in the calculated versus measured water level in this well, given error in the assumption of barometric pressure which is not currently recorded at this location. To prevent damage to the existing lower Level Troll cable, the Conax compression fitting was not adjusted to offset the new wellhead's increased height above ground surface of 0.25 feet, so the new set depth is 231.25 ft bgs.

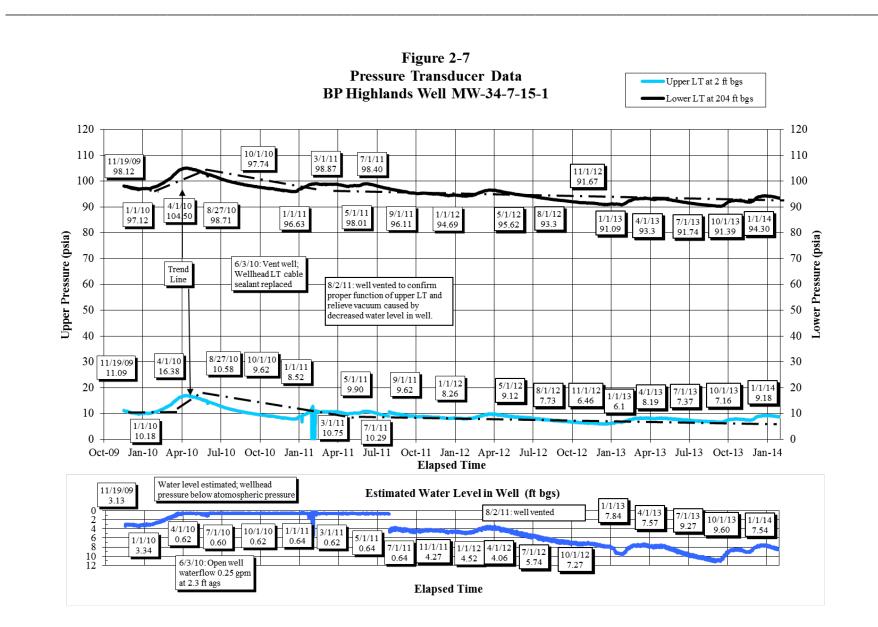
Figure 2-7 Pressure Transducer Data BP Highlands Well MW-34-7-15-1

Monitoring data for MW 34-7-15-1 are plotted in Figure 2-7. As summarized in Table 2-5 for the 4-year period of record, the net change in downhole pressures is a decrease of 3.82 psi. The wellhead pressure curve and the downhole pressure curve follow the same trend with an initial rise in pressure through April 1, 2010 then a steady decline through late December 2010. The net change in the calculated water level in the well is a decrease of 4.41 feet. As noted on Figure 2-7, water flowed from the well at a rate of 0.25 gallons per minute (gpm) when the well was vented for maintenance on June 3, 2010. For charting purposes, the water level in the shut-in well at that time was estimated to be slightly above ground surface with the upper transducer under water at 2 ft bgs.

The wellhead pressure started dropping below atmospheric pressure around August 12, 2010. This condition suggested either a potential problem with the upper transducer or a well pressure vacuum effect created in a completely shut-in well under declining water level conditions. A well instrumentation inspection and barometric pressure check conducted during each subsequent site visit through 2013 has confirmed the proper function of the upper transducer. Venting the well allowed for physical confirmation that the well was under vacuum pressure conditions.

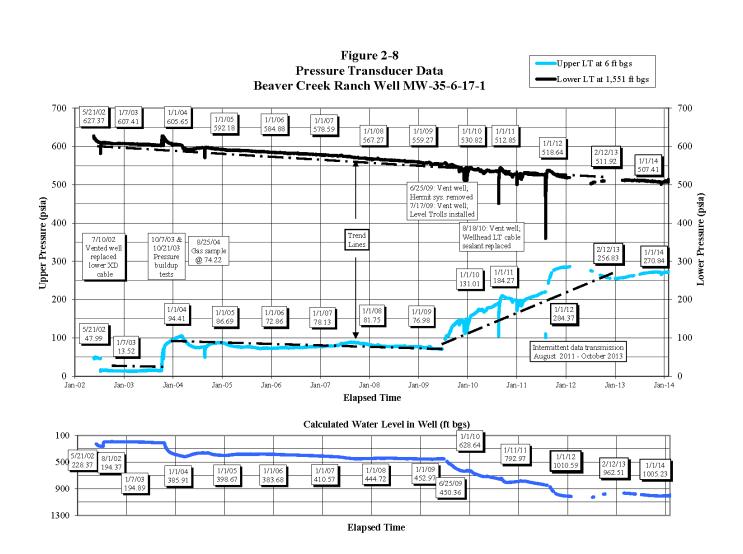
Figure 2-8 Pressure Transducer Data Beaver Creek Ranch Well MW-35-6-17-1

Table 2-6 and Figure 2-8 show a net increase of 255.40 psi in wellhead pressure, a net decline of 102.14 psi in downhole pressure and a corresponding net decline of 810.86 feet in the water level in the well for the entire approximate 11.5-year period of record. Figure 2-8 also shows a steady decline in bottomhole pressure curve for the period of record, while the wellhead pressure curve shows two notable increases in the well pressure regime. Both increases in wellhead pressure suggest stimulation of gas flow into the well with corresponding declines in the water level occurred in response to venting the well in July 2003, June and July 2009 and August 2011. However, the most substantial cause for gas pressure increase during the period of record was the replacement of monitoring equipment and minimization of fittings leakage in July 2009. A significant leak was again repaired during the 2011 well inspection. These fittings and also an upper and lower transducer communication problem causing

intermittent data collection since the second half of 2011 will be investigated and repaired as necessary if this site is accessible in 2014.

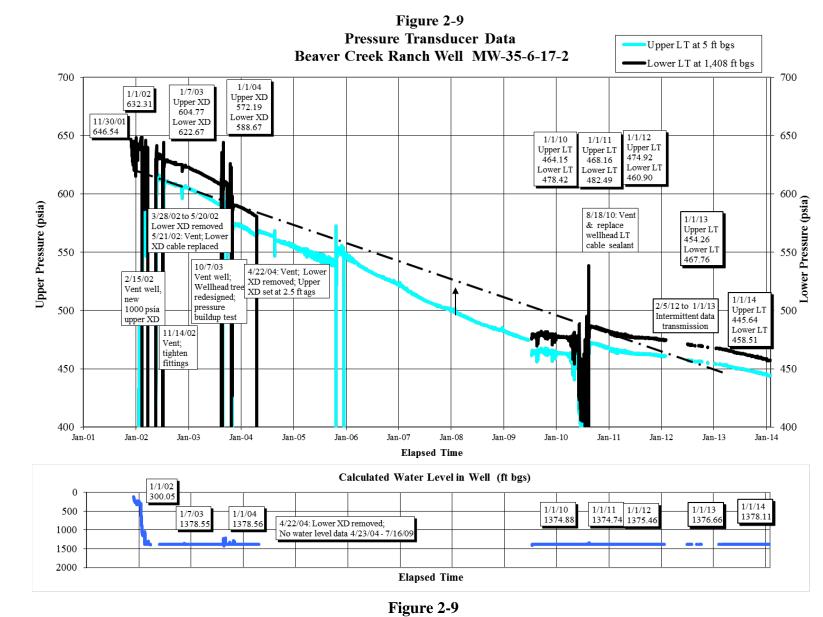
Pressure Transducer Data Beaver Creek Ranch Well MW-35-6-17-2

Figure 2-9 shows the well pressure in a declining trend for the entire period record. There is a notable shift in the well pressure curve following the installation of Level Troll instruments on July 17, 2009, followed by erratic well pressure spikes associated with incomplete shut-in through August 17, 2010. After the well was vented August 18, 2010 to replace the Level Troll cable fitting sealants, there was a steady build-up of well pressure through early September 2010 followed by a return to a declining trend through December 2013. This may be a result of an incomplete shut-in condition as a small leak was found at a two pipe fittings on the wellhead during the 2011 inspection. The fittings were not tightened at that time due to concern of further damage to the fittings causing an increase in leak-off.

As shown on Figure 2-9, no water level data is available for the 6-year period of record when there was only one well pressure transducer. Well pressure data available after installation of wellhead and downhole Level Trolls on July 19, 2009 shows very little change in the water level.

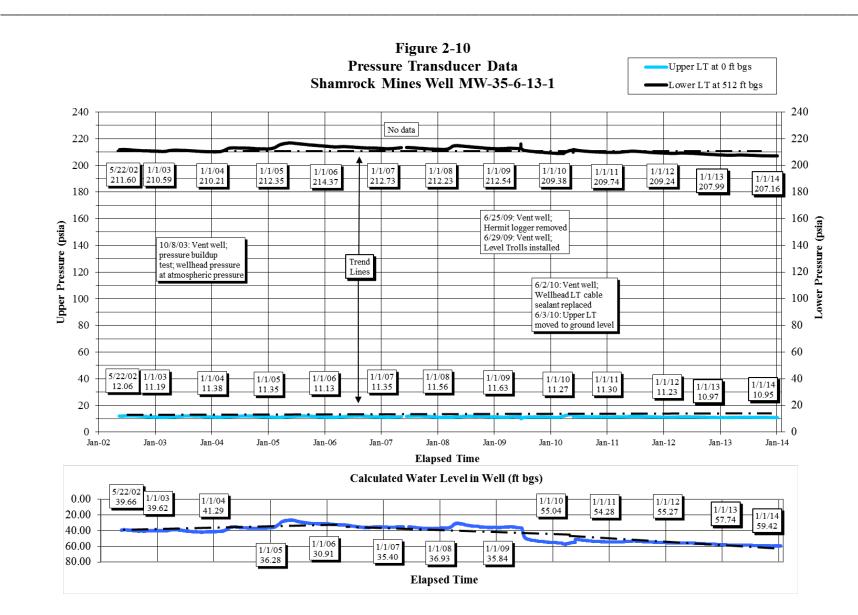
Figure 2-10 Pressure Transducer Data Shamrock Mines Well MW-35-6-13-1

Figures 2-10 shows the wellhead pressure regime continues to be at atmospheric pressure and fluctuates within a range of 2 psi (between 10 psia and 12 psia). During the months of April and May 2010, the wellhead pressure steadily increased to around 13.4 psia. Wellhead pressure returned to the historic atmospheric pressure trend after the Level Troll wellhead cable sealants were replaced on June 2, 2010.

Figure 2-10 also shows the downhole pressure and calculated water level in the well continued to exhibit an overall declining well pressure trend for the period of record since April 2005. With wellhead pressure equal to atmospheric pressure, fluctuation of downhole pressure is attributable to the fluctuation of the water level in the well.

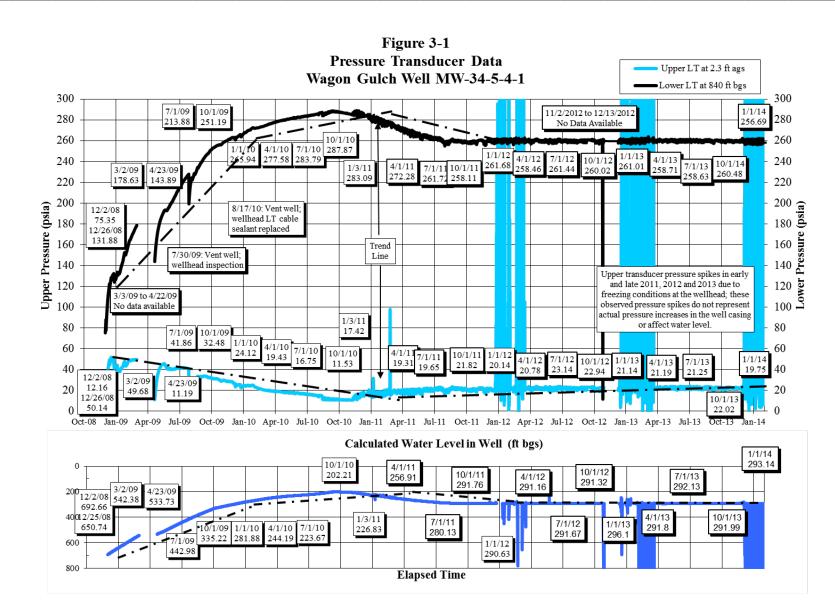
Figure 3-1 Pressure Transducer Data Wagon Gulch Well MW-34-5-4-1

continued in 2010 until the trend reversed in mid-September 2010. This may be related to the transducer cable sealant being changed on August 17, 2010 and possibly eliminating a partial shut-in condition. No leaks were detected during the site inspections in 2012. Between October 1, 2010 and December 31, 2010, Figure 3-1 shows the water level decreased about 21.2 feet while the downhole pressure decreased about 2.7 psia.

During the winters of 2011-2012, 2012-2013 and 2013-2014 pressure spikes in the upper transducer occurred due to the pressure transducer freezing within its deployment location in the wellhead 2.3 feet above ground surface. These are not actual increases in gas pressure within the well casing, but rather caused when the air volume next to the transducer inlet is trapped and then compressed by expanding frozen water condensate. When the 2011 well inspection was conducted at MW 34-5-4-1 the well was vented to ensure that the transducer would return to atmospheric pressure; this test successfully showed that the transducer continued to function properly and was not damaged. Equipment has not been available to lower the transducer to prevent it from freezing again. The transducer appears to have recovered after surface temperatures warmed each spring. The transducer has been inspected for damage in each subsequent site visit since this problem began in 2011 and continues to function properly when not subjected to a hard freeze. The transducer will be lowered below the freeze line during the 2014 site inspection if equipment is available and conditions allow.

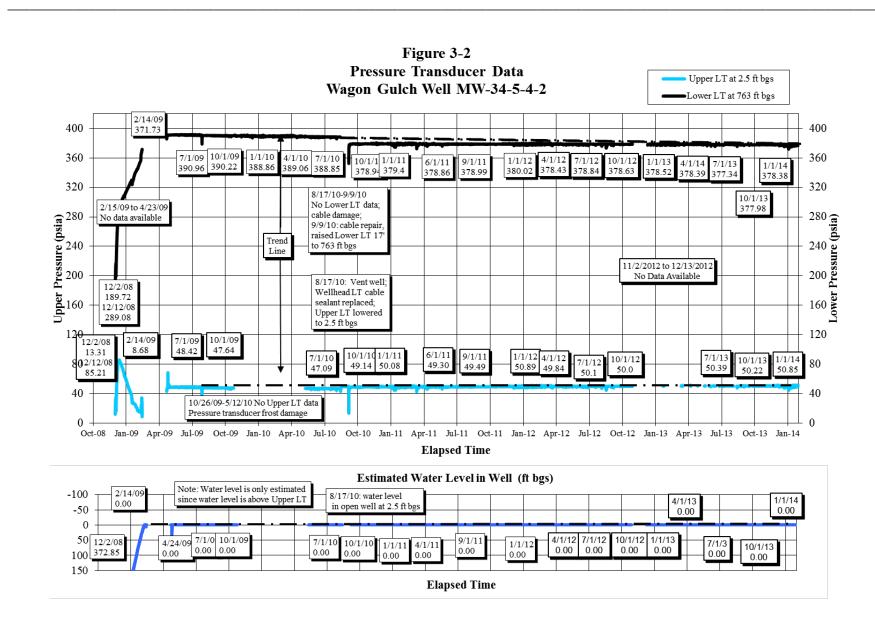
Figure 3-2 Pressure Transducer Data Wagon Gulch Well MW-34-5-4-2

Figure 3-2 shows a relatively constant wellhead pressure of about 47 to 48 psia between April 24, 2009 and October 25, 2009. An erratic pressure spiking pattern between October 26, 2009 and May 12, 2010 suggested wellhead Level Troll pressure sensor freeze damage, so the data were omitted from Figure 3-2. Between May 13, 2010 and August 16, 2010 the wellhead pressure remained fairly constant at around 47 psia.

Freeze damage to the upper Level Troll pressure transducer sensor was confirmed after the well was vented on August 17, 2010. As noted on Figure 3-2, the water level inside the open wellhead was at a height of about 2.5 feet above ground level. The new upper Level Troll was changed from an external mount to an internal depth setting of 2.5 ft bgs on August 17, 2010 to protect the transducer sensor from freezing conditions. After well shut-in on August 17, 2010, Figure 3-2 shows a relatively rapid return of wellhead pressure to an average constant pressure of about 50 psia.

The lower Level Troll cable was damaged during replacement of Level Troll wellhead cable sealants on August 17, 2010. Cable repair performed on September 9, 2010 included raising the Level Troll 17 feet from 780 ft bgs to 763 ft bgs. As a result of this change, Figure 3-2 shows a shift in the downhole pressure curve to a corrected constant downhole pressure regime of 378 to 379 psia.

As noted above, the water level was inside the open wellhead at a height of about 2.5 feet above ground level on August 17, 2010. The wellhead pressure build-up after shut-in may reflect water and/or gas pressure build-up. For charting purposes, the water level in the shut-in well is estimated to be at or near ground surface above the upper Level Troll (set at 2.5 ft bgs). However, there is a possibility that the observed build-up in wellhead pressure is from gas pressure, which could result in a downward displacement of the water in the well to some level below the upper Level Troll. The current monitoring scheme for observing shut-in well pressure does not include the capability of determining the source(s) of wellhead pressure build-up in response to complete well shut-in. As an alternative, the upper transducer will be evaluated for the possibility of replacement with a pressure sensor that also records fluid conductivity, thereby detecting if the sensor is in fluid or air/gas. Based on the preliminary results of the test of the Aqua Troll at Basin Creek MW 34-9-7-2, this instrument may be a candidate for exchange with the upper Level Troll at Wagon Gulch MW 34-5-4-2 in 2014.

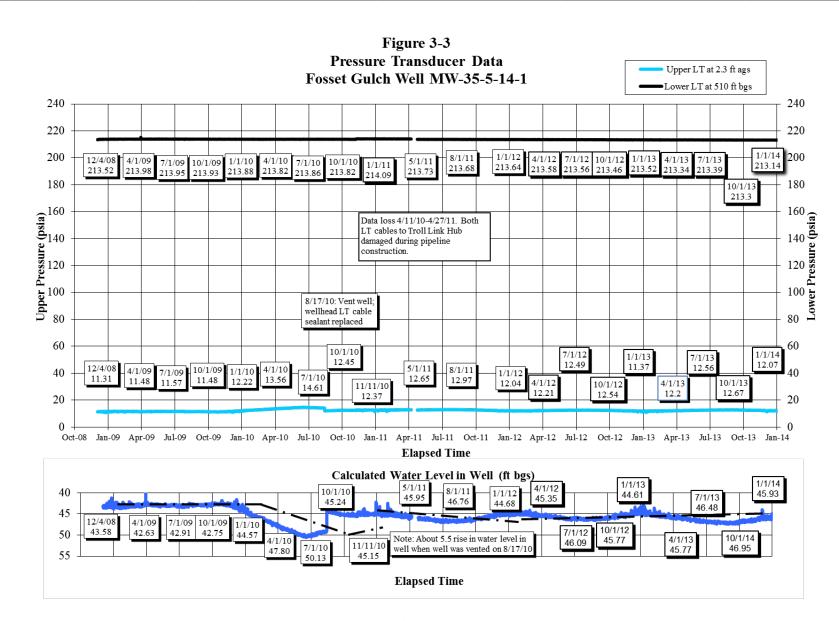
Figure 3-3 Pressure Transducer Data Fosset Gulch Well MW-35-5-14-1

Figure 3-3 charts the upper and lower pressure transducer data and the calculated water level in the well. Table 3-2 and Figure 3-3 show the wellhead pressure at atmospheric pressure prior to 2010 followed by a gradual increase in pressure through August 16, 2010 to 14.19 psia. Following the August 17, 2010 well maintenance event including venting, the wellhead pressure has remained relatively constant within a normal atmospheric pressure range through January 1, 2014. Figure 3-3 shows a stable downhole pressure trend (213.5-213.1 psia) for the entire period of record. Figure 3-3 also shows a stable water level averaging 43.0 ft bgs until November 2009, followed by a gradually declining water level trend through July 1, 2010 (50.13 ft bgs). The water level increased to 49.28 ft bgs until the well was vented on August 17, 2010. The water level immediately rose to 44.36 ft bgs when the well was vented on August 17, 2010, but has since followed apparent gentle seasonal fluctuation through January 1, 2014. Altogether, the upper and lower transducer pressures and thus the calculated water level have remained relatively constant since the venting event in August 2010.

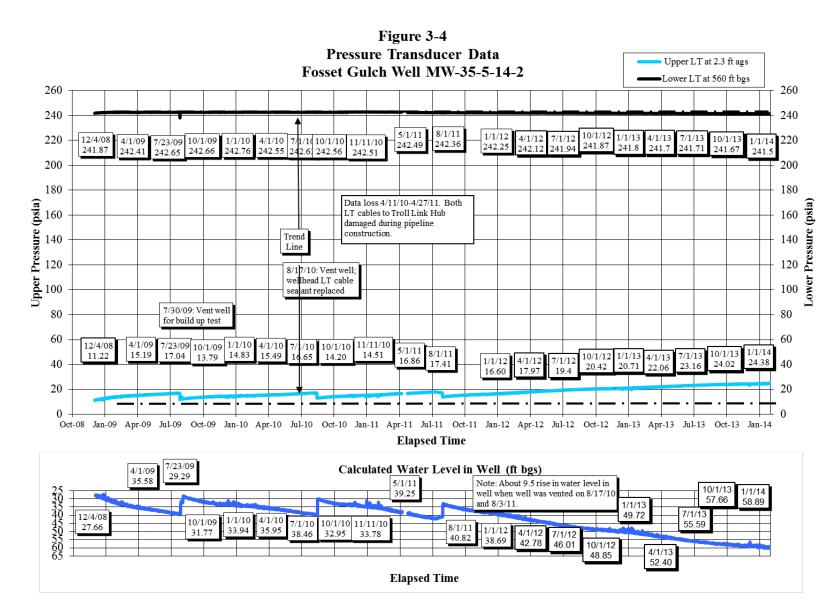
Figure 3-4 Pressure Transducer Data Fosset Gulch Well MW-35-5-14-2

Figure 3-4 plots the upper and lower pressure transducer data and the calculated water level in the well. Although the well was shut in for monitoring on December 4, 2008, wellhead pressure did not stabilize at about 17 psia until July 2009. Table 3-2 and Figure 3-4 show a net increase of about 13.03 psi in wellhead pressure for the period of record between December 4, 2008 (11.35 psia) and January 1, 2014 (24.38 psia). Figure 3-4 shows a stable downhole well pressure trend for the entire period of record, with fluctuations ranging between a minimum pressure of 241 psia to a maximum pressure of 242.8 psia. The downhole pressure was 241.5 psia on January 1, 2014.

Table 3-2 indicates a net water level drop of about 26.60 feet in the well as of January 1, 2014. However, Figure 3-4 shows that the wellhead pressure and water level on January 1, 2014 has continued at the same trend of increasing pressure and decreasing calculated water level without the annual venting of the wellhead. Although there is an immediate drop in wellhead pressure and corresponding rise in the water level each time the well is vented to the atmosphere, Figure 3-4 also shows the build-up in wellhead pressure takes approximately 12 months to return to the pressure exhibited prior to each venting event so unless required for servicing the instrumentation, the well will not be vented in attempt to determine the static wellhead pressure.

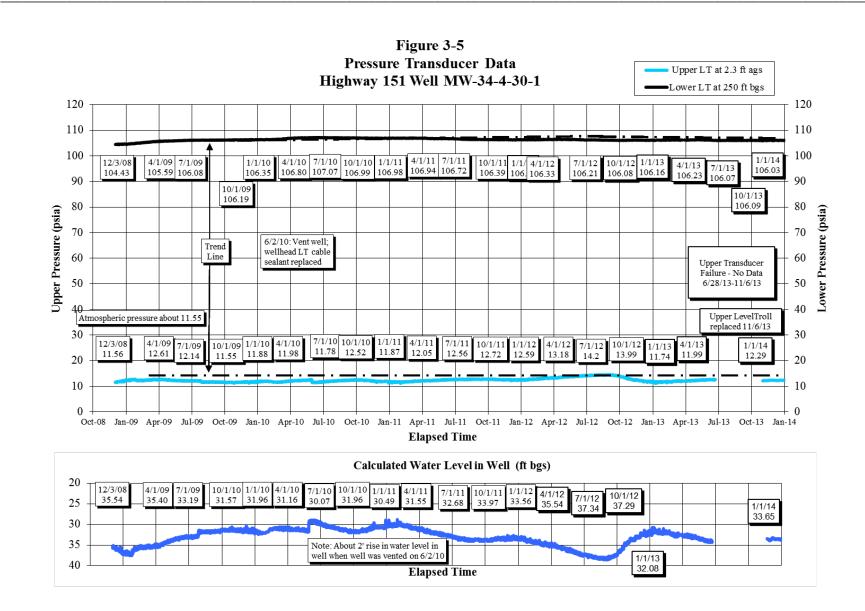
Figure 3-5 Pressure Transducer Data Highway 151 Well MW-34-4-30-1

Figure 3-5 charts the upper and lower pressure transducer data and the calculated water level in the well. Table 3-3 and Figure 3-5 show a relatively stable well pressure regime with a stable wellhead pressure trend at atmospheric pressure, a stable downhole pressure trend of about 106-107 psia, and a stable water level trend of 32-37 ft bgs since August 2009. Spike fluctuations in both wellhead pressure and the calculated water level shown on Figure 3-3 correspond to the immediate loss of pressure when the well is vented (e.g., June 2, 2010), followed by a gradual return to the well pressure regime exhibited prior to venting the well.

In June 2013 the upper Level Troll began reporting pressure in the range of negative 25 psia. During the September 30, 2013 site visit diagnostics were conducted and it was determined that the transducer had malfunctioned and needed to be replaced. The Level Troll was replaced on a follow-up site visit on November 6, 2013. When the upper Level Troll was replaced and function tested it was found that the Troll NetHub port that this Level Troll was connected to had become inoperable. Data could still be measured and logged on the Level Troll, but could not be transmitted via the Troll Link 201 telemetry system. After troubleshooting the Troll NetHub circuit board on November 8, 2013 found it needed to be replaced, a new board was ordered from In-Situ, Inc. The new circuit board was successfully replaced on November, 26, 2013 and the entire Highway 151 station is again fully operable.

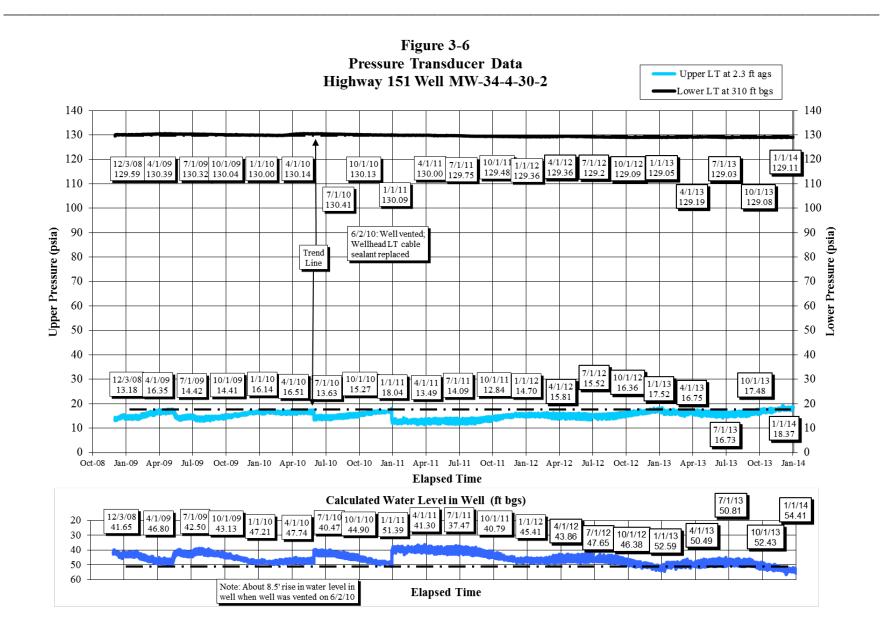
Figure 3-6 Pressure Transducer Data Highway 151 Well MW-34-4-30-2

Figure 3-6 charts the upper and lower pressure transducer data and the calculated water level in the well. Table 3-3 and Figure 3-6 shows a stable downhole pressure trend with 0.5 psi change from 129.59 psia on December 3, 2008 to 129.11 psia on January 1, 2014. In addition, there was a net wellhead pressure increase of 5.19 psi with a corresponding net water level decline of 12.76 feet for the entire period of record from December 3, 2008 (13.18 psia) to January 1, 2014 (18.37 psia).

Similar to the Well 34-4-30-1 pressure regime for the period record, spike fluctuations in both wellhead pressure and the calculated water level correspond to the immediate loss of pressure when the well is vented (e.g., June 2, 2010), followed by a gradual return to the well pressure regime exhibited prior to venting the well. This includes an event on 1/1/11 in which there was a sudden loss of wellhead pressure to approximately atmospheric pressure. No COGCC field activities occurred on this date, but the pressure response is similar to the venting that was intentionally conducted on June 2, 2010.

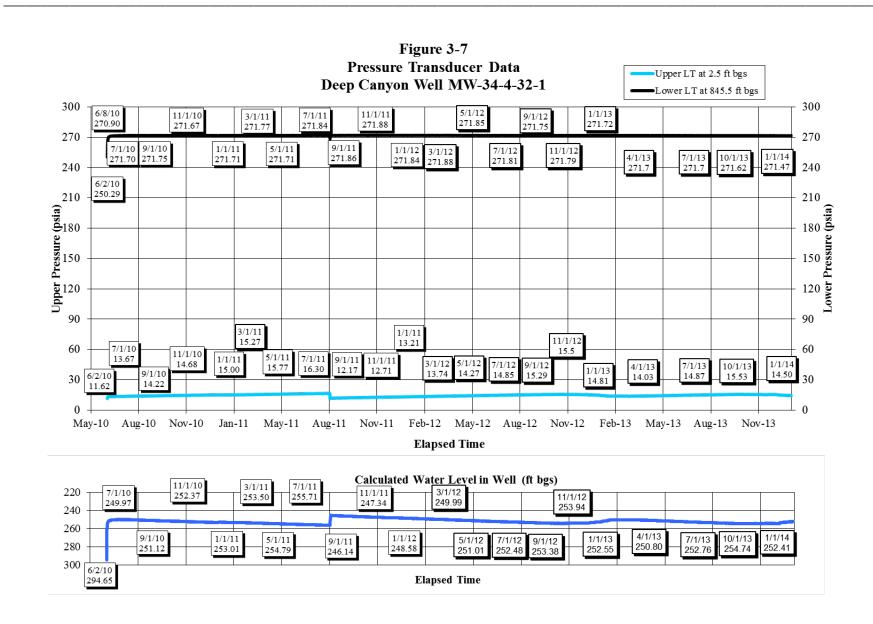
Figure 3-7 Pressure Transducer Data Deep Canyon Well MW-34-4-32-1 3-15

Figure 3-7 charts the upper and lower pressure transducer data and the calculated water level in the well. Table 3-4 and Figure 3-7 show the well pressure initially stabilized on June 8, 2010, six days after the well was shut in for monitoring on June 2, 2010. Prior to shut-in on June 2, 2010, Figure 3-7 shows the wellhead pressure at 11.62 psia (atmospheric pressure), downhole pressure at 250.29 psia, and water level in the well at about 294 ft bgs. By June 8, 2010, wellhead pressure had increased 1.8 psi to 13.41 psia, bottom-hole pressure had increased 20.4 psi to 270.7 psia, and the water level in the well had risen about 43 ft to 252.21 ft bgs. Table 3-4 and Figure 3-7 also show a relatively stable well pressure regime for the 3.5 year period of record through January 1, 2014 with only a slight increase in well pressure and a corresponding net water level decrease of 1.2 feet in the well.
