November 10, 2005

RE: Bryce 1-X Inspection Summary
Bondad, Colorado

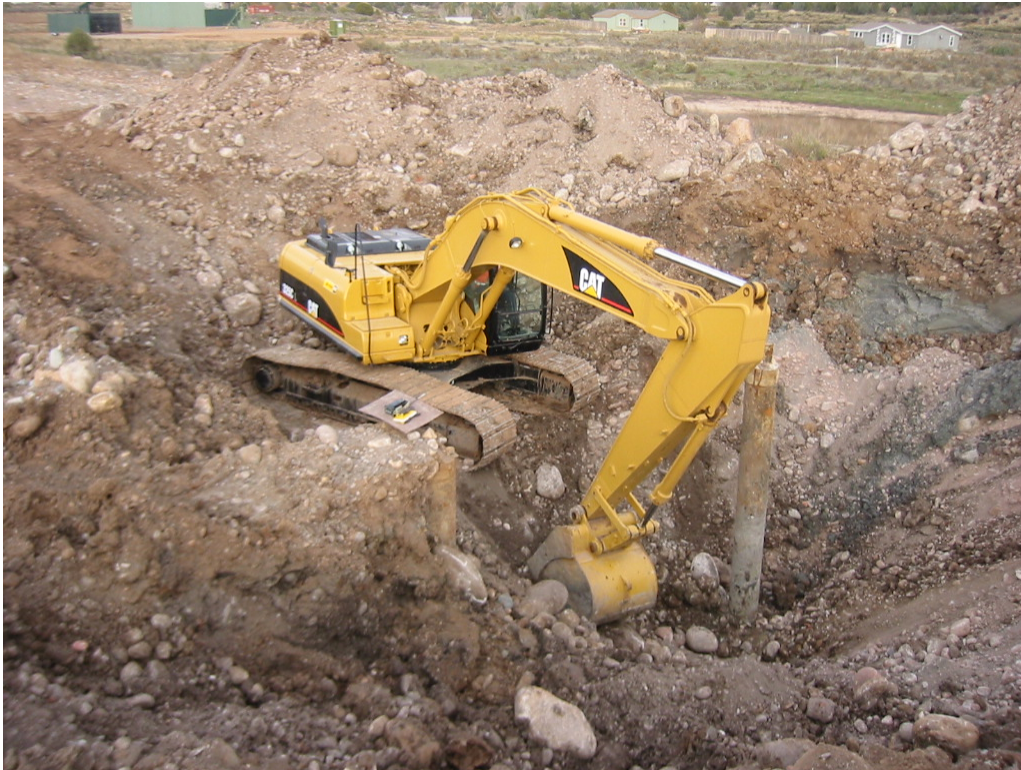
The excavation depth was approximately 20 feet below ground surface (bgs) upon completion. The horizontal dimensions of the excavation measured approximately 40 feet long by 30 feet wide. In addition to the rectangular shaped excavation, LTE constructed a ramp along the north wall of the excavation approximately 50 feet long to allow safe access the bottom of the excavation. All excavation walls were benched and sloped to allow for safe entry into the excavation.

Photograph 1: Excavation of Bryce 1-X, view northeast.

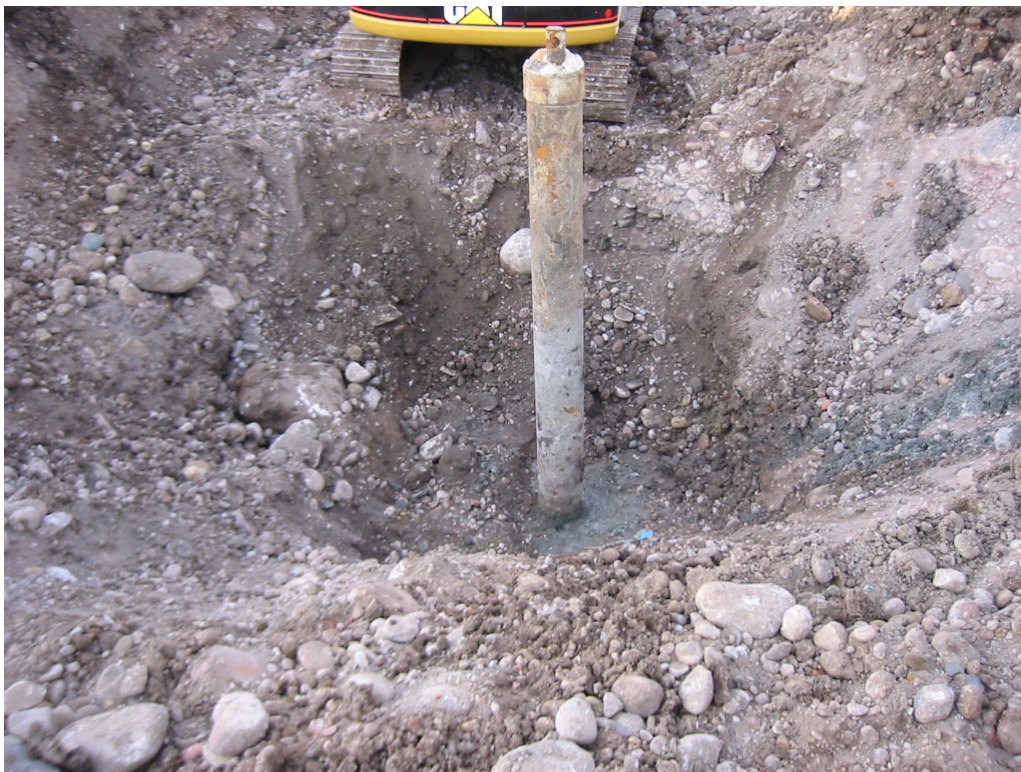
Photograph 2: Bryce 1-X excavation complete, note gray sandstone surface at bottom of conductor pipe, view north.

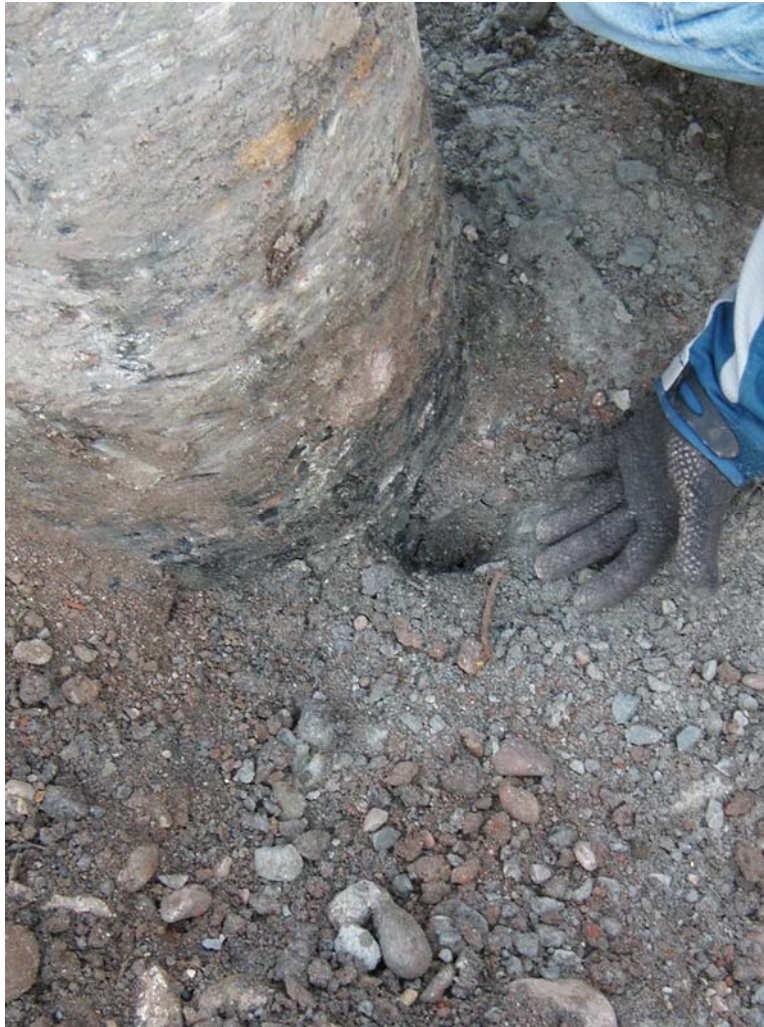
of the bedrock surface, a small fracture in the sandstone was noted radiating outward from the conductor pipe. Gas with noticeable pressure was observed seeping from the fracture.

Based on our observations of the sandstone bedrock adjacent to the Bryce 1-X conductor pipe, it is clear that methane gas is trapped beneath the sandstone layer. Gas trapped beneath the sandstone layer is migrating upward through fractures and in one observed instance under noticeable pressure.

Photograph 3: Fracture in sandstone with seeping gas.

LTE recommends the installation of a network of passive or active vapor extraction wells to vent the gas trapped beneath the sandstone layer. If, in fact, the Bryce 1-X is the primary conduit, venting the trapped gas should help to limit the horizontal extent of surface gas seeps; provide an added level of safety to nearby structures (particularly the fire station); and expedite the remediation of the gas seep.

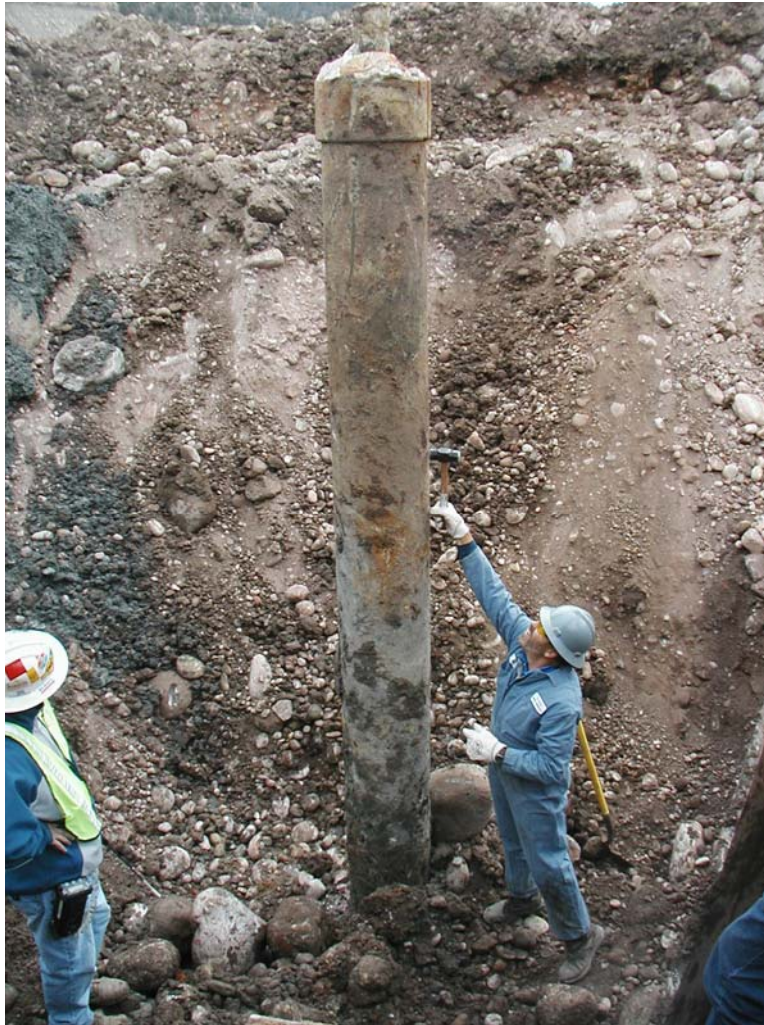
Immediately following the completion of the excavation activities, Mr. Bill Clark of A-Plus Well Service (A-Plus) used a mallet to tap on the exterior of the conductor pipe at depth. A hollow portion of the conductor pipe appeared to be present approximately eight to ten feet below the top-of-casing (TOC).

Photograph 4: Inspection of conductor pipe with mallet, view southeast.

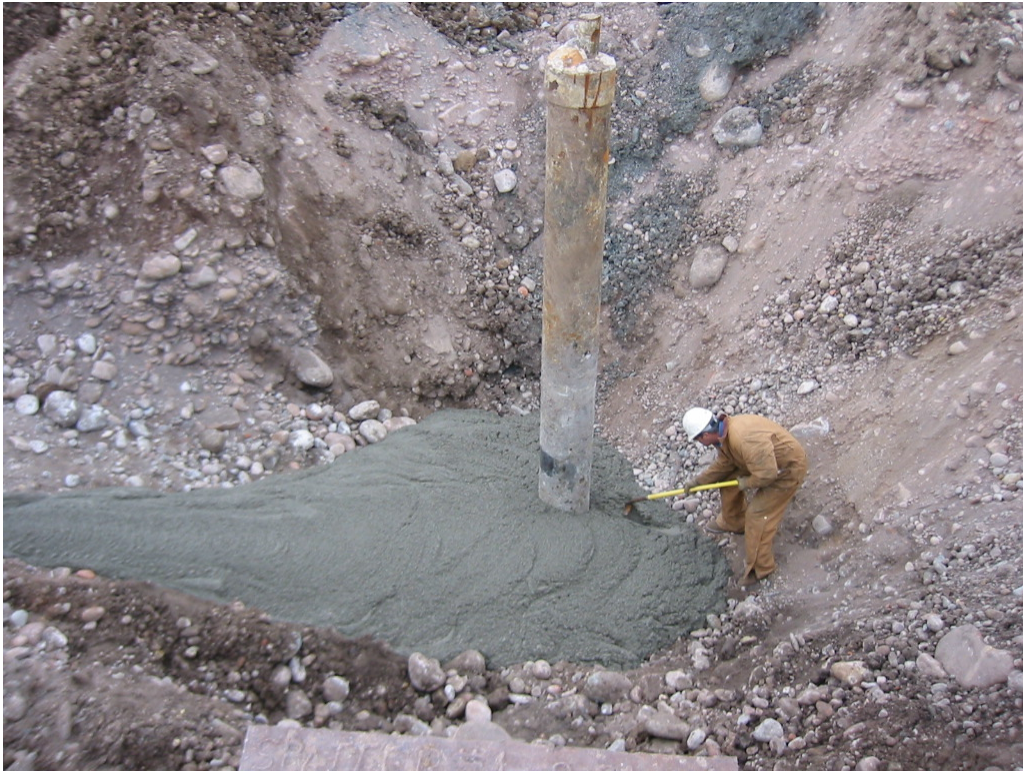
In an effort to reduce the gas seepage in close proximity to the conductor pipe and allow for welding activities to continue on the conductor pipe, 10 cubic yards of concrete was placed in the base of the excavation. In addition to the concrete, LTE placed flame resistant welding blankets around the perimeter of the concrete to further increase the radius of the surface seal and divert seeping gas around the welding area.

Photograph 5: Placement of concrete barrier, view east.

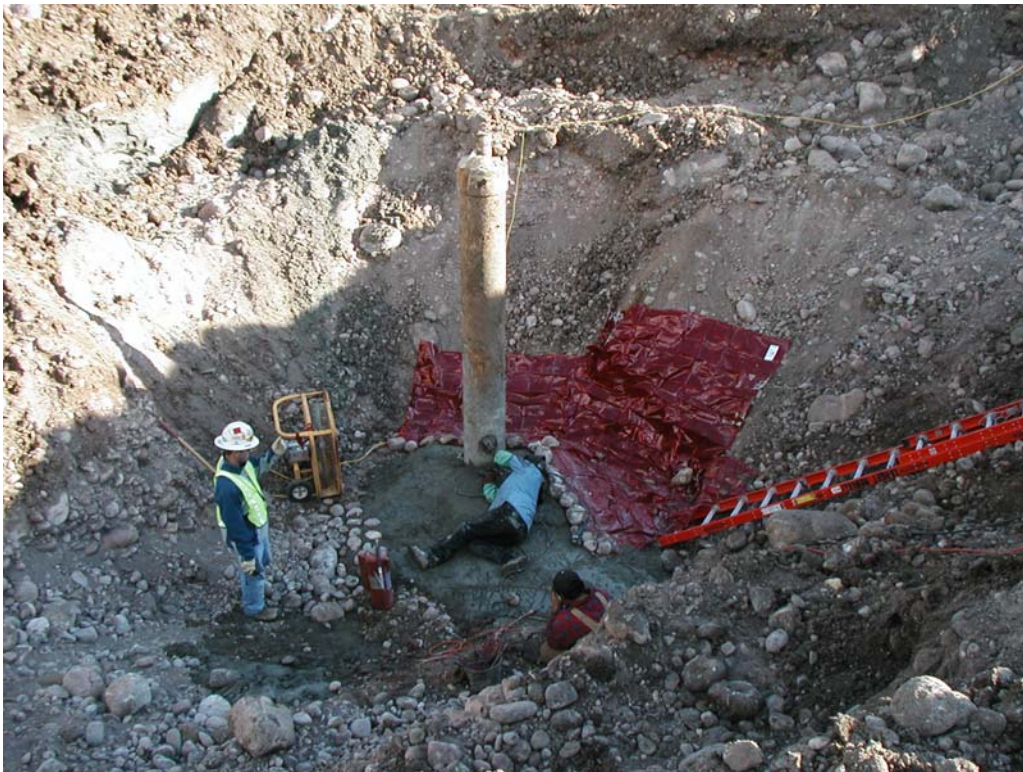
Welding activities resumed after the concrete was allowed to cure for approximately four hours. The hot-tap was performed successfully without additional flare up. Following completion of the tap, Mr. Clark inspected the interior of the conductor pipe and determined that no inner casing was present.

Photograph 6: Hot-tap with welding blanket barriers, view southeast.

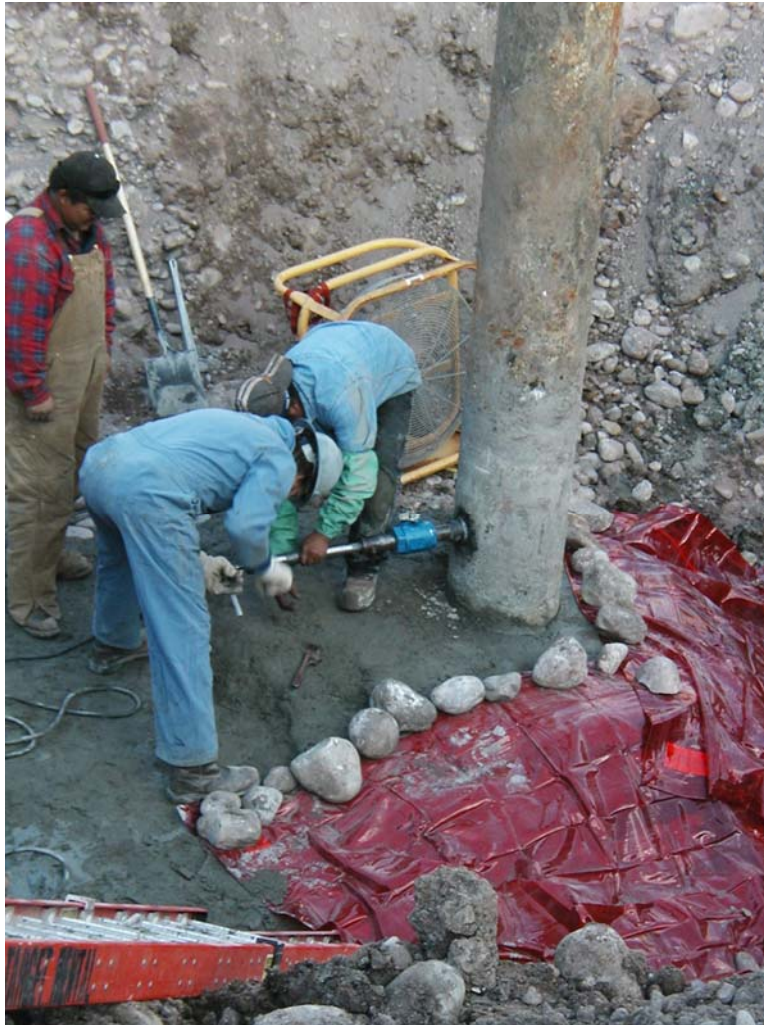
Photograph 7: Hot-tap with welding blanket barriers, view southeast.

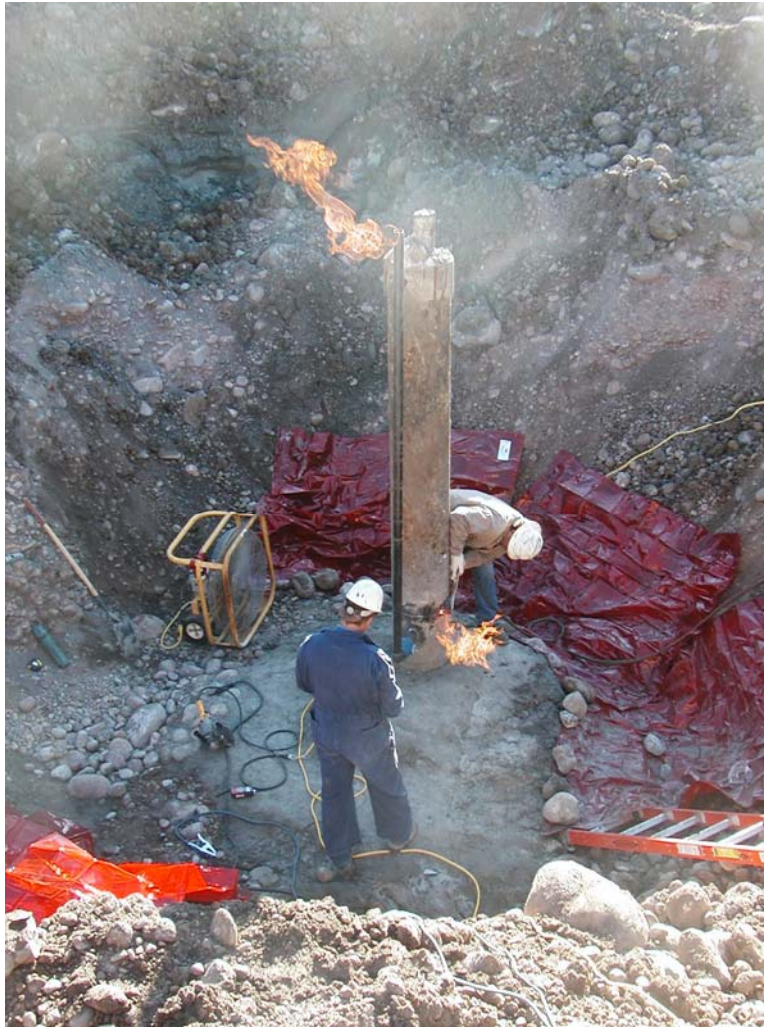
To prepare the conductor pipe for re-entrance using a drilling rig, the existing conductor pipe with surface plug had to be removed and replaced with open steel pipe to the ground surface. On November 4, 2005, LTE and A-Plus returned to the site to cut the existing conductor pipe off at depth and replace it with open conductor pipe. A-Plus personnel used an acetylene torch to cut the existing conductor pipe approximately 10 feet below the TOC.

Photograph 8: Cut off of existing conductor pipe, view southeast.

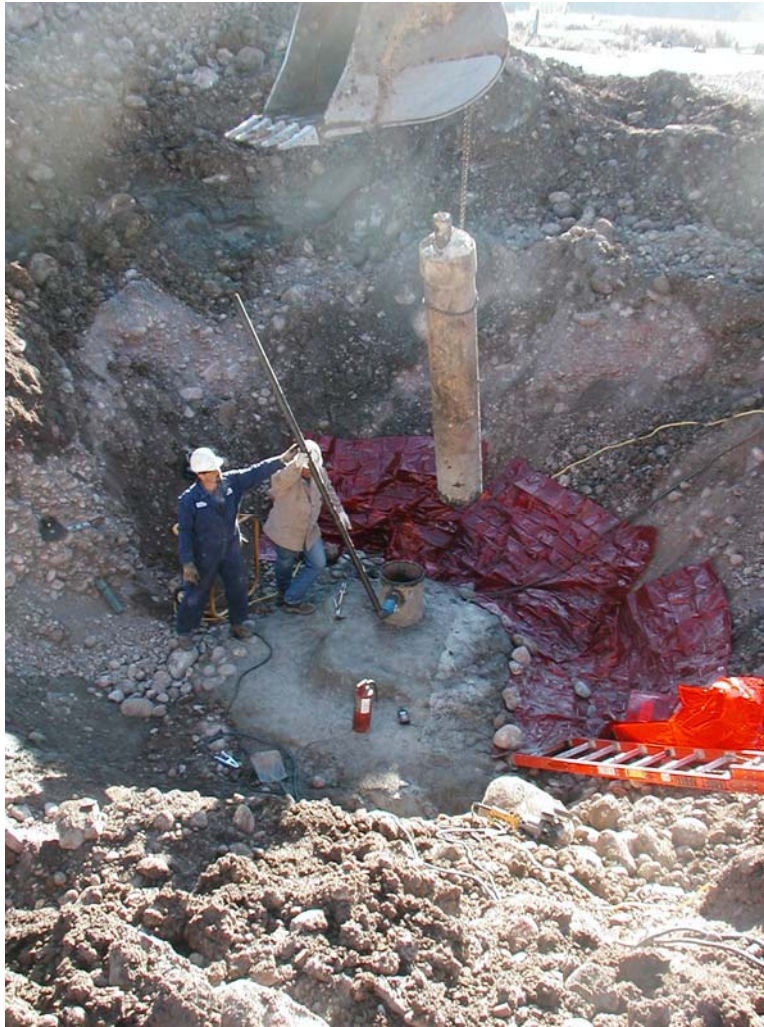
Photograph 9: Removal of existing conductor pipe, view southeast.

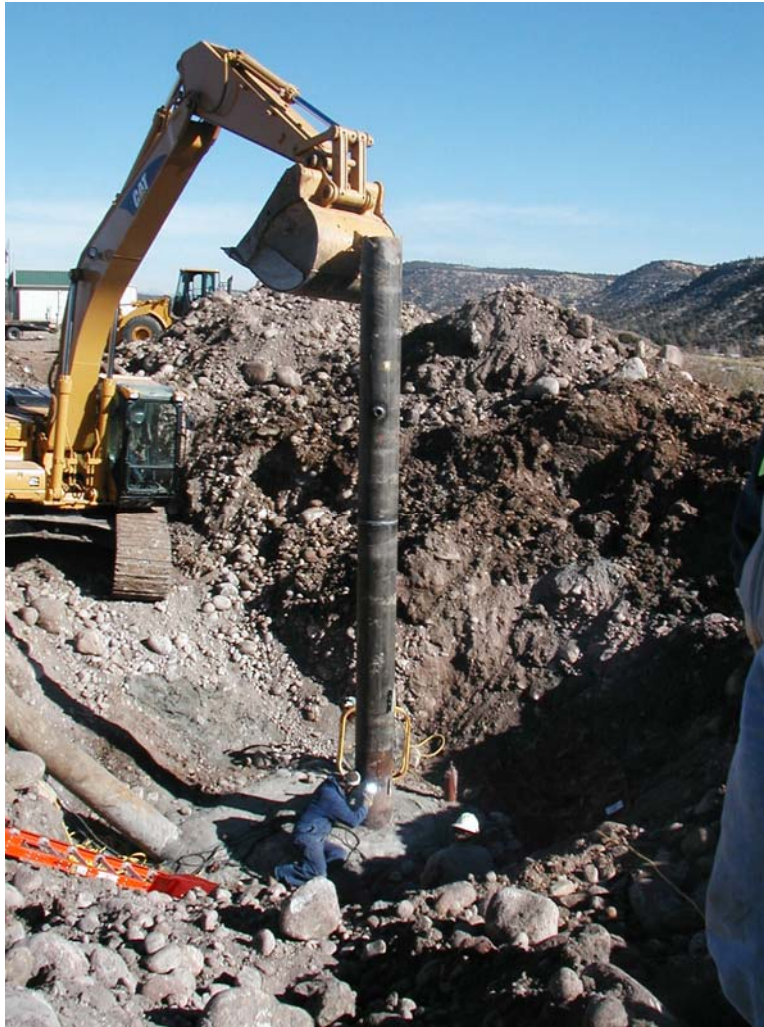
A refurbished section of 16-inch steel pipe was lowered into the excavation and welded to the existing conductor pipe. Once completed, all equipment was removed from the excavation and the excavation was backfilled.

Photograph 10: Replacement of conductor pipe, view northeast.

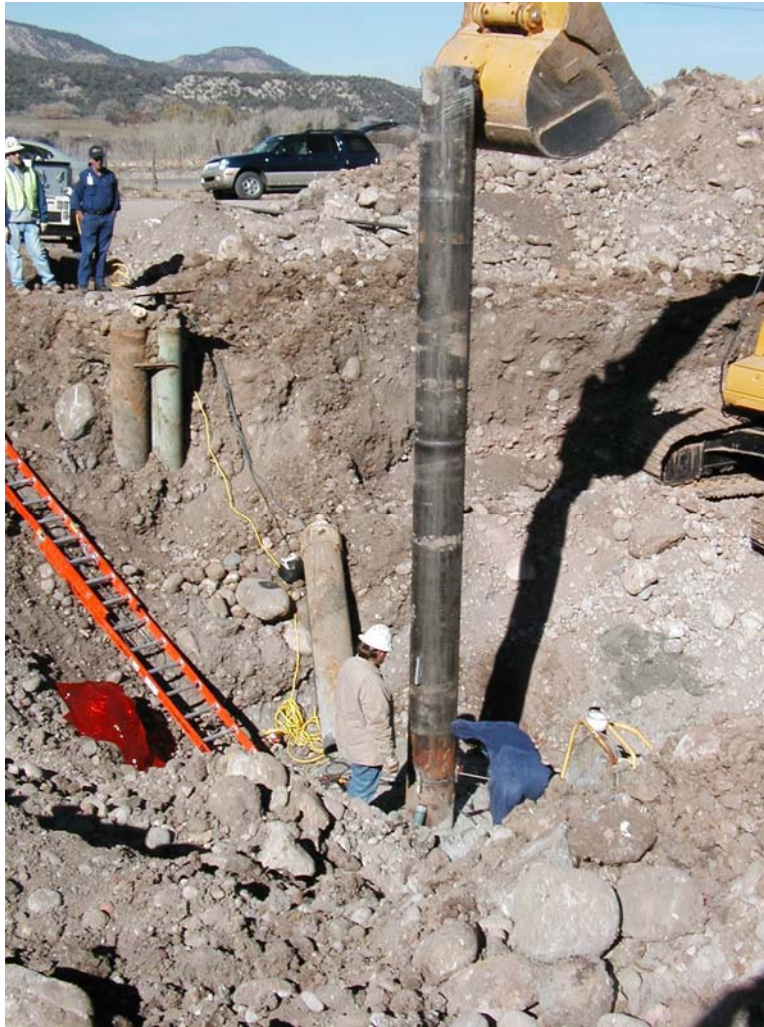
Photograph 11: Replacement of conductor pipe, view northwest.

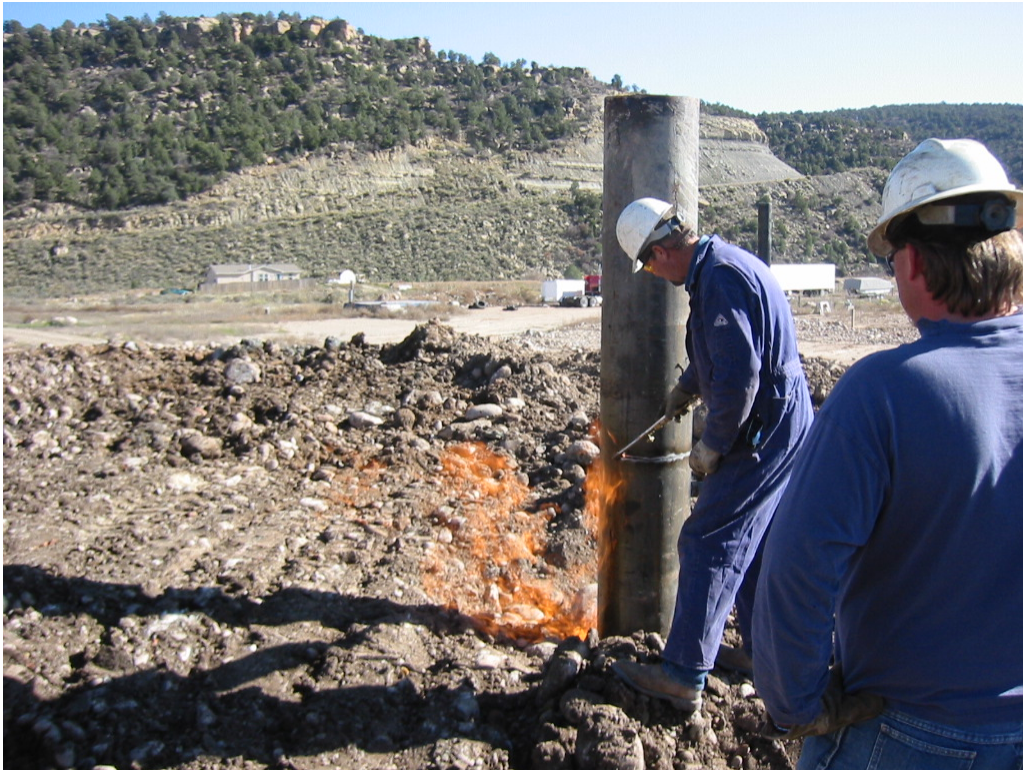
Upon completion of backfill activities, A-Plus personnel cut the conductor pipe at the ground surface leaving approximately four feet of steel pipe sticking up from the ground. A steel plate was attached to the TOC and locked with a pad lock. A ball valve assembly was attached to the exterior of the 16-inch conductor pipe at the ground surface and a four-foot long section of two-inch diameter steel pipe was erected and used to vent gas from the conductor pipe. The vent was left open before leaving the site and a sign warning of the presence of flammable gas was placed in front of the well head.

Photograph 12: Cutoff of conductor pipe at ground surface, view southeast.

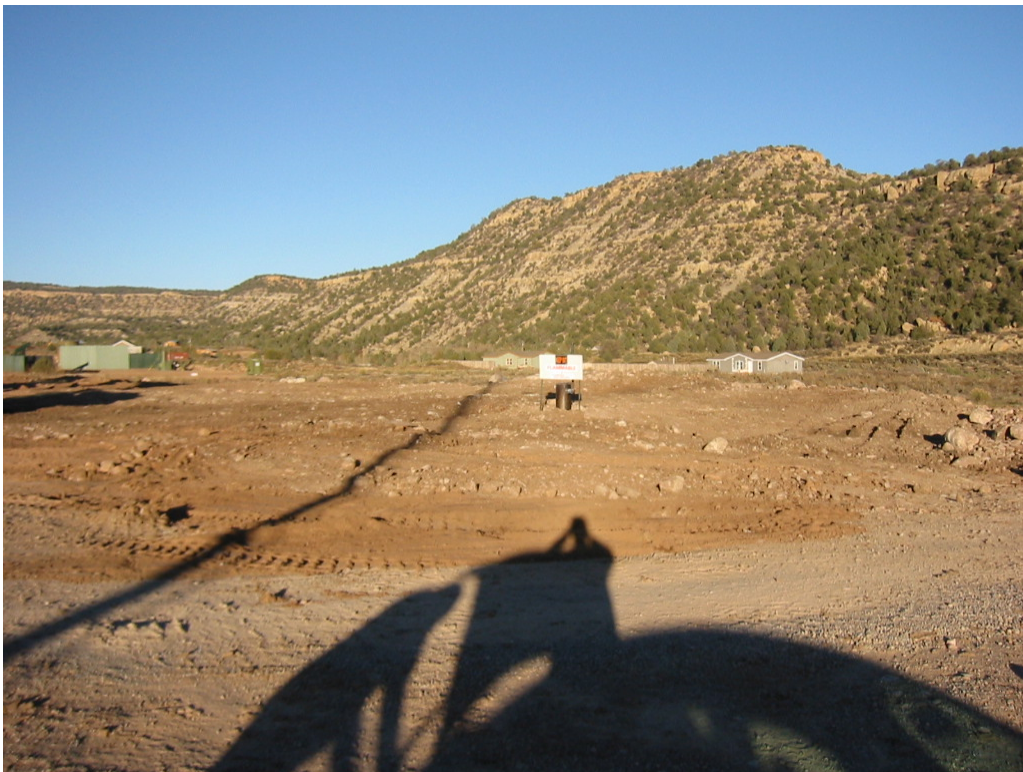
Photograph 13: Backfill of excavation area, view northeast.

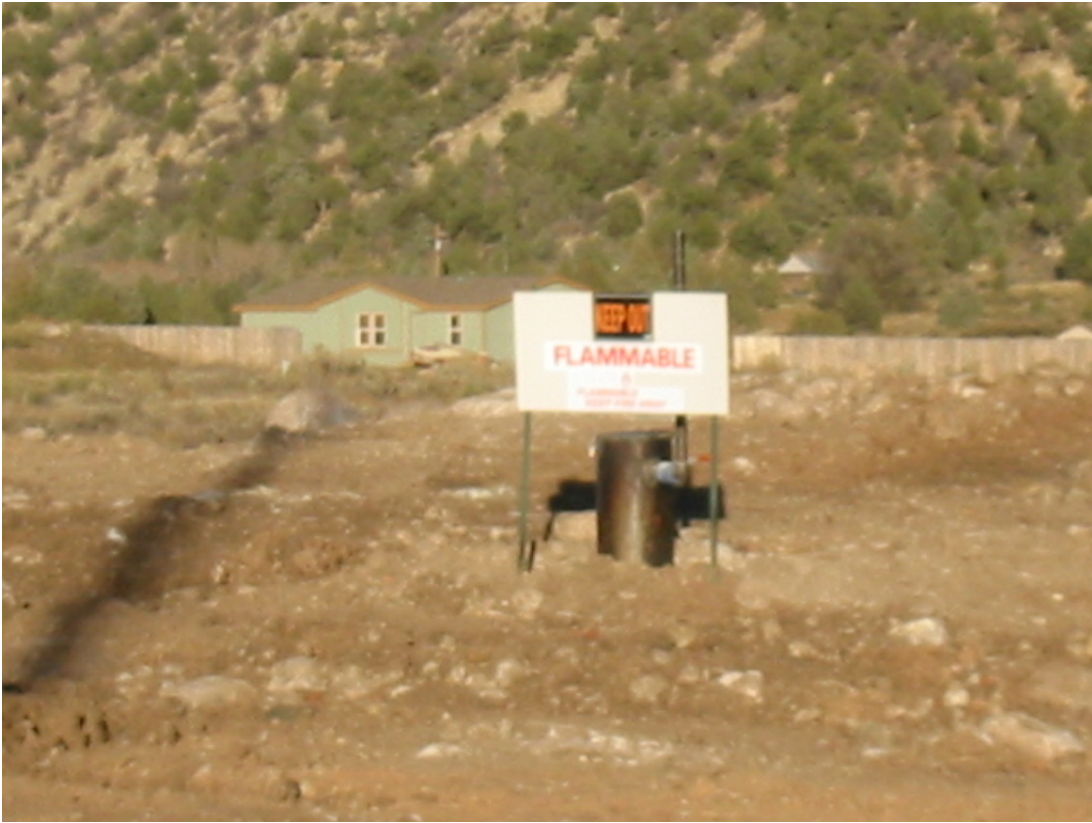
Photograph 14: Well head completion, view northeast.

LTE recommends that a chain-link fence be erected around the Bryce 1-X to reduce the potential for vandalism to the well head and provided an added level of safety to the public from the flammable vapors. LTE recommends a minimum of 15 feet of space between the well head and the fence. The chain link fence should also be equipped with barbed-wire and a pad-lock.
