Colorado Oil and Gas Conservation Commission

**Monitor Wells Summary Report
2018**

**4M Project Monitoring Program
Archuleta and La Plata Counties
Colorado**

June 14, 2019

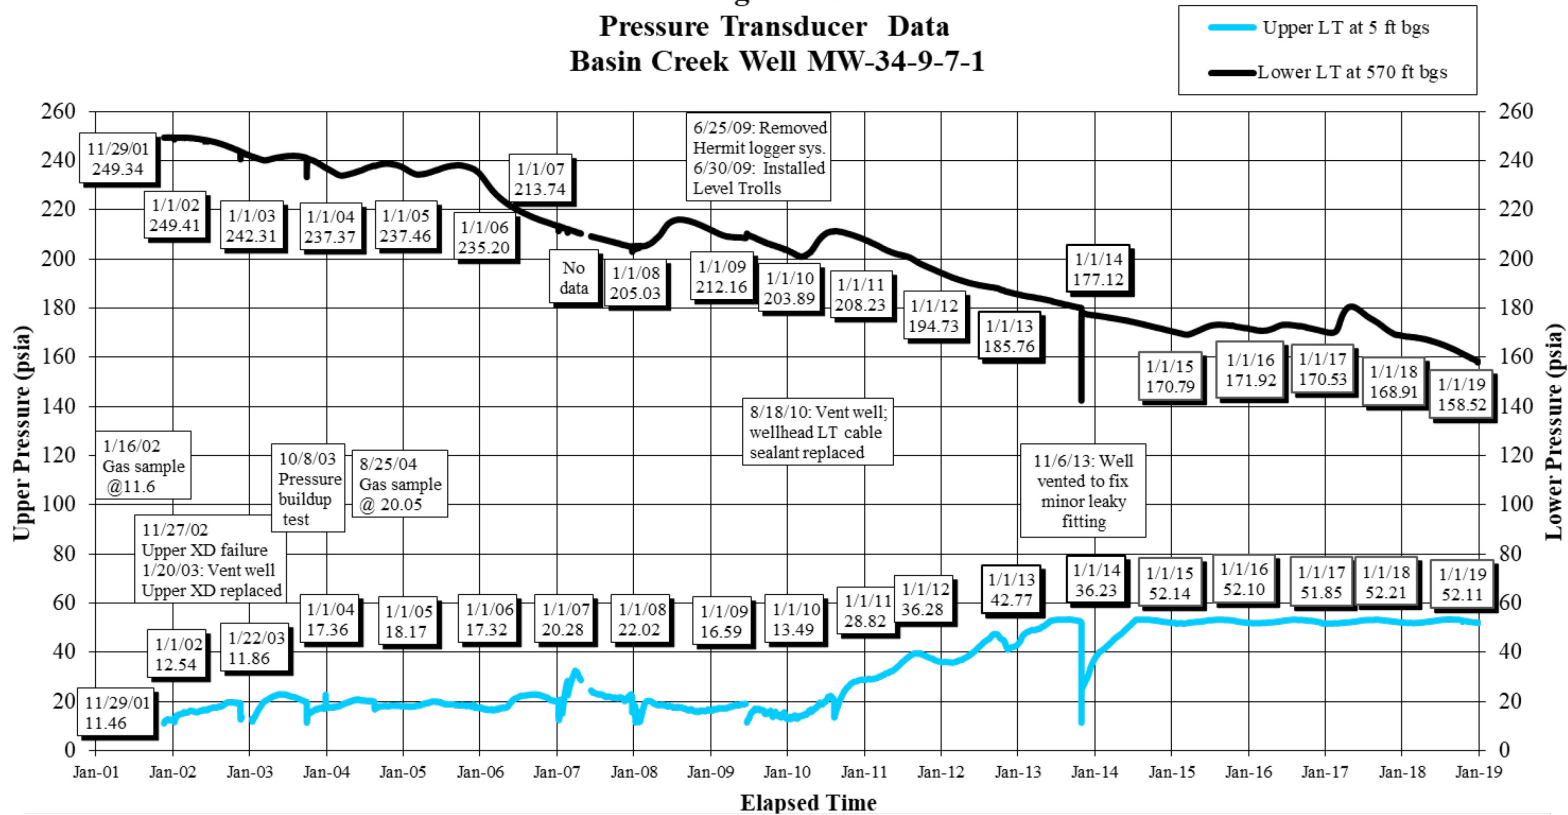
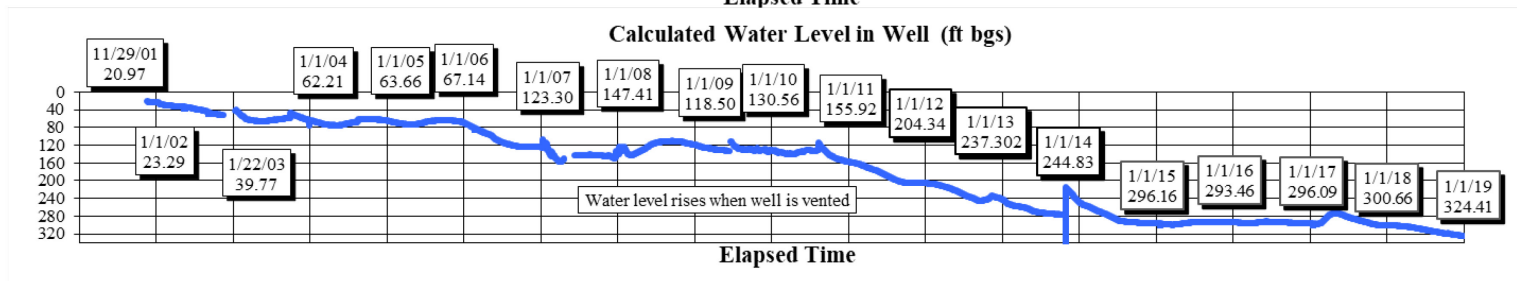
**Figure 2-1
Pressure Transducer Data Basin Creek Well MW-34-9-7-1**

Figure 2-1 charts the upper and lower pressure transducer data and the calculated water level in the well. Table 2-1 and Figure 2-1 show a net increase of 40.65 psi in wellhead pressure for the entire 17-year period of record from November 29, 2001 (11.46 psia) to January 1, 2019 (52.11 psia). Figure 2-1 generally shows a pattern of minor seasonal fluctuations within an overall stable trend in wellhead pressure prior to wellhead cable gland seal replacement on August 18, 2010, followed by a rise in wellhead pressure to a recorded high of 53.42 psia on September 11, 2013. A very minor leak persisted so on November 6, 2013 the well was vented to allow a safe condition to repair leaking threads at the wellhead. Recovery of

In contrast to the wellhead pressure patterns, Table 2-1 and Figure 2-1 show a substantial net decline of 303.44 feet in the calculated well water level and a corresponding net decline in downhole pressure of 90.82 psi for the period of record. Figure 2-1 also shows a pattern of slight seasonal fluctuations within the overall declining trend in the water level and corresponding downhole pressure for the period of record.

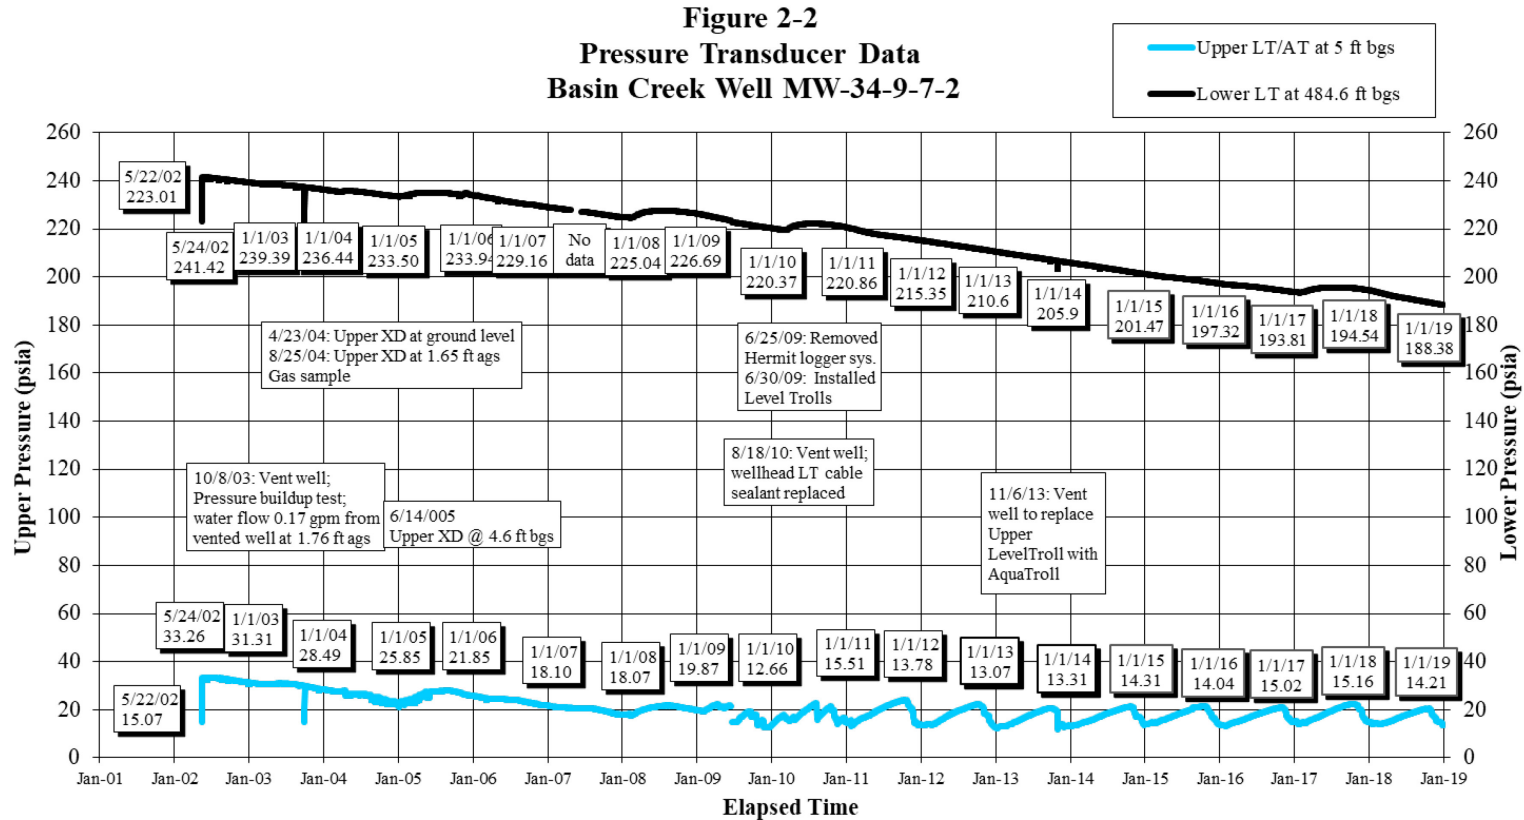
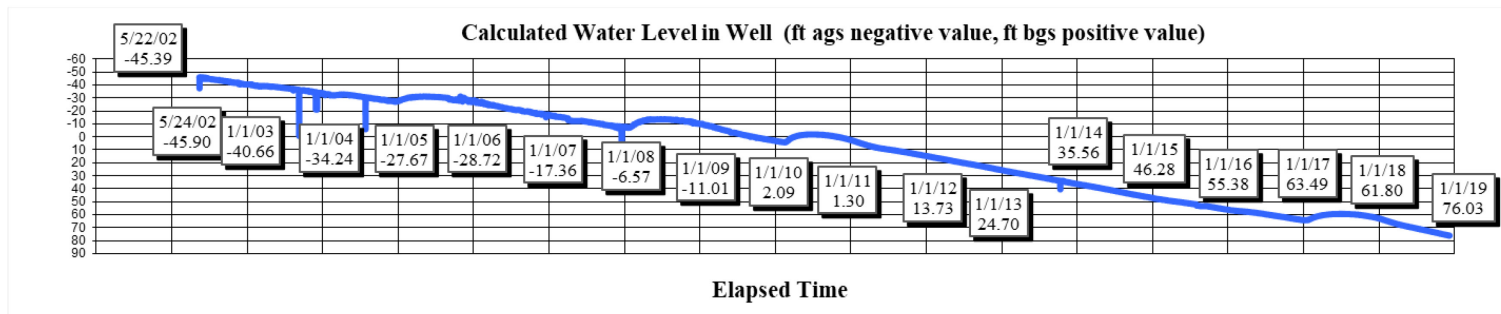
**Figure 2-2
Pressure Transducer Data Basin Creek Well MW-34-9-7-2**

A small amount of gas was released and artesian flow (~0.2 gpm) from the well consistently occurred each time the well was vented for maintenance during the period of record between 2002 and 2010. The pressure regime documented was relatively high pressure but low volume based on the head pressure versus artesian flow. Artesian flow from the well did not occur when the wellhead was vented on August 18, 2010 to replace the Level Troll wellhead cable Conax gland sealants. The final recorded upper transducer pressure in 2011 of 13.7 PSI was very near atmospheric pressure indicating the well was essentially in hydrostatic balance. The pressure fluctuations since early 2009 suggest that ambient surface temperatures may be affecting the gas pressure as measured by the upper transducer. In order to attempt to distinguish water pressure versus gas pressure being recorded by the upper transducer, the Level Troll was replaced by an Aqua Troll, which records specific conductance (SC) in addition to pressure and temperature. The concept was that if water was present at the Aqua Troll, it would record an SC value greater than zero. If a value of zero was recorded for SC, then a pressure greater than atmospheric pressure would be gas pressure only. The Aqua Troll was installed on November 6, 2013, but it appears by this time the static water level in this well had dropped from the near-surface balance of 2009-2011. 2017 brought a change in trend of the downhole pressure; it increased slightly throughout the first half of 2017, plateaued and then continued to decrease in the linear trend followed since mid-2011. This was a similar trend as observed in 2010. 2018 demonstrated a return to approximately the same rate of bottom hole pressure and calculated water level decline.

Substantial water level decline has been documented in this well, going from artesian flowing with a calculated shut-in head of approximately 53 feet above ground surface just after construction to 76.03 feet below ground surface on January 1, 2019. This calculated water level data set has been verified by a manual open-well water level measurement on November 6, 2013 of 40.20 ft bgs used as a calibration point for water level calculation using the lower Level Troll data within fifteen minutes on the same date of 40.46 feet below ground surface.

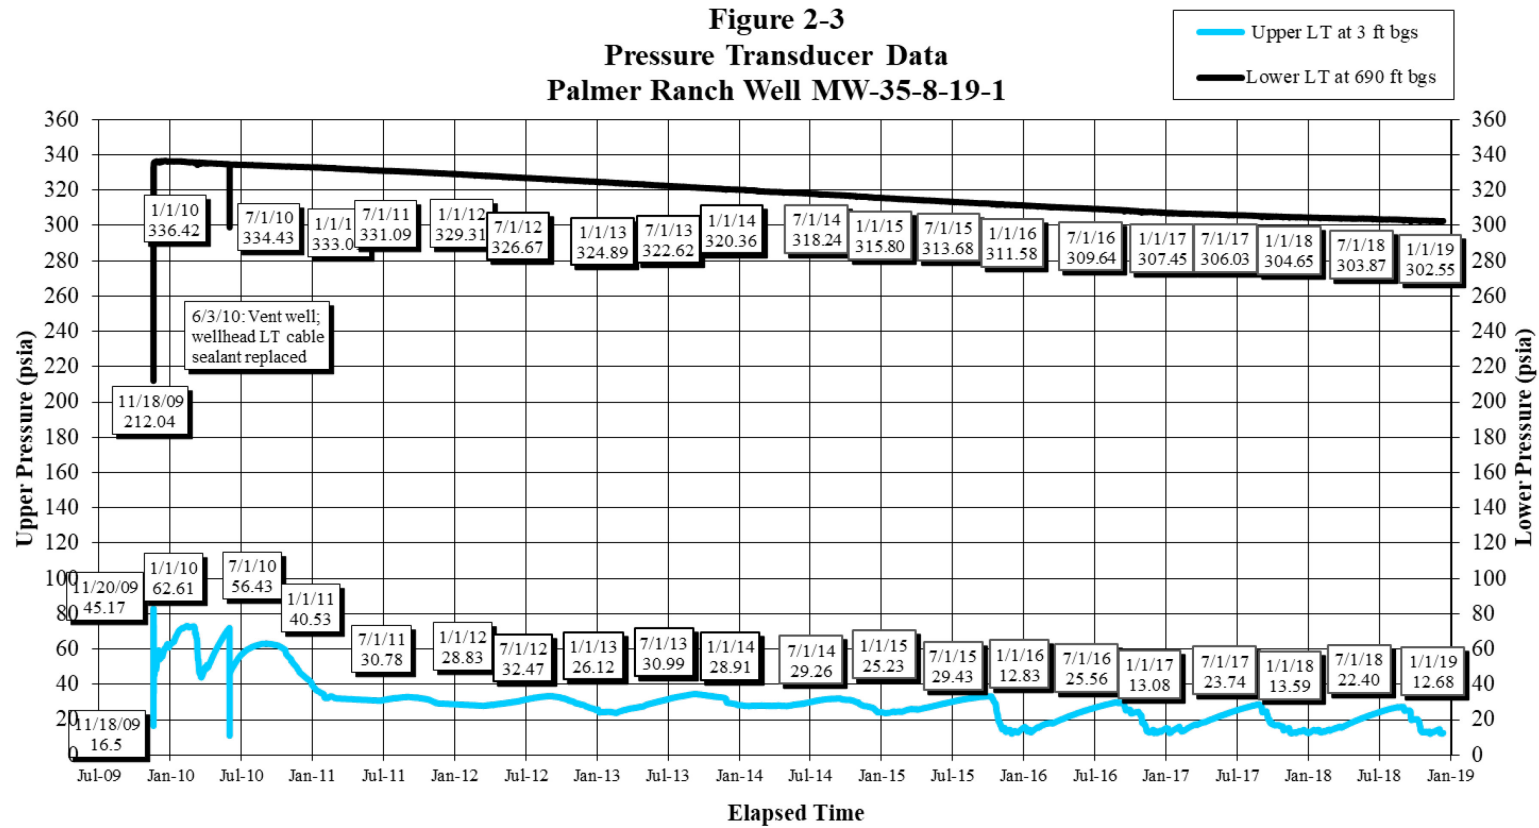
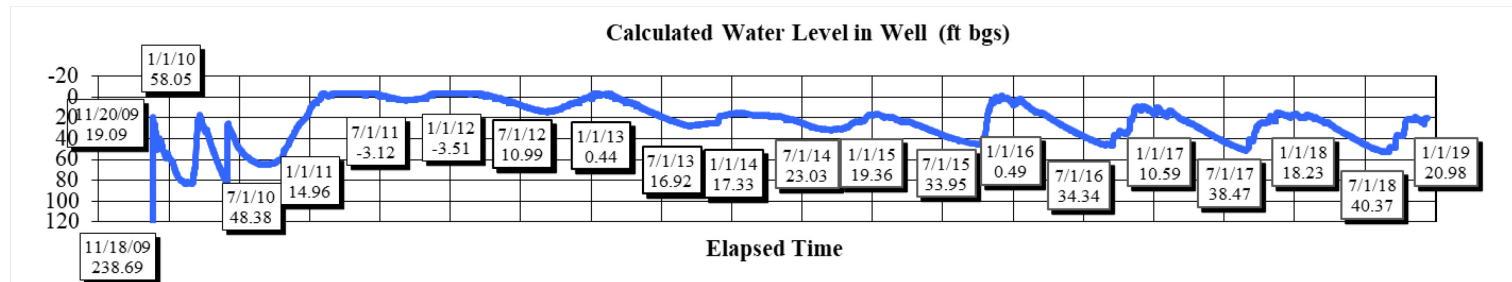
**Figure 2-3
Pressure Transducer Data Palmer Ranch Well MW-35-8-19-1**

In late October 2015, wellhead pressure apparently began dropping slowly from approximately 33 psi to approximately 12 psi in mid-December 2015. Wellhead pressure then was fairly stable through the winter and then slowly built up from late winter through late summer. The pressure trend appears to be similar

but stronger seasonal trend that has been occurring since 2011. The trend repeated in 2018 and suggests the well has been demonstrating an increased response to seasonal groundwater level changes, increased local groundwater production effects or coal seam reservoir pressure fluctuations.

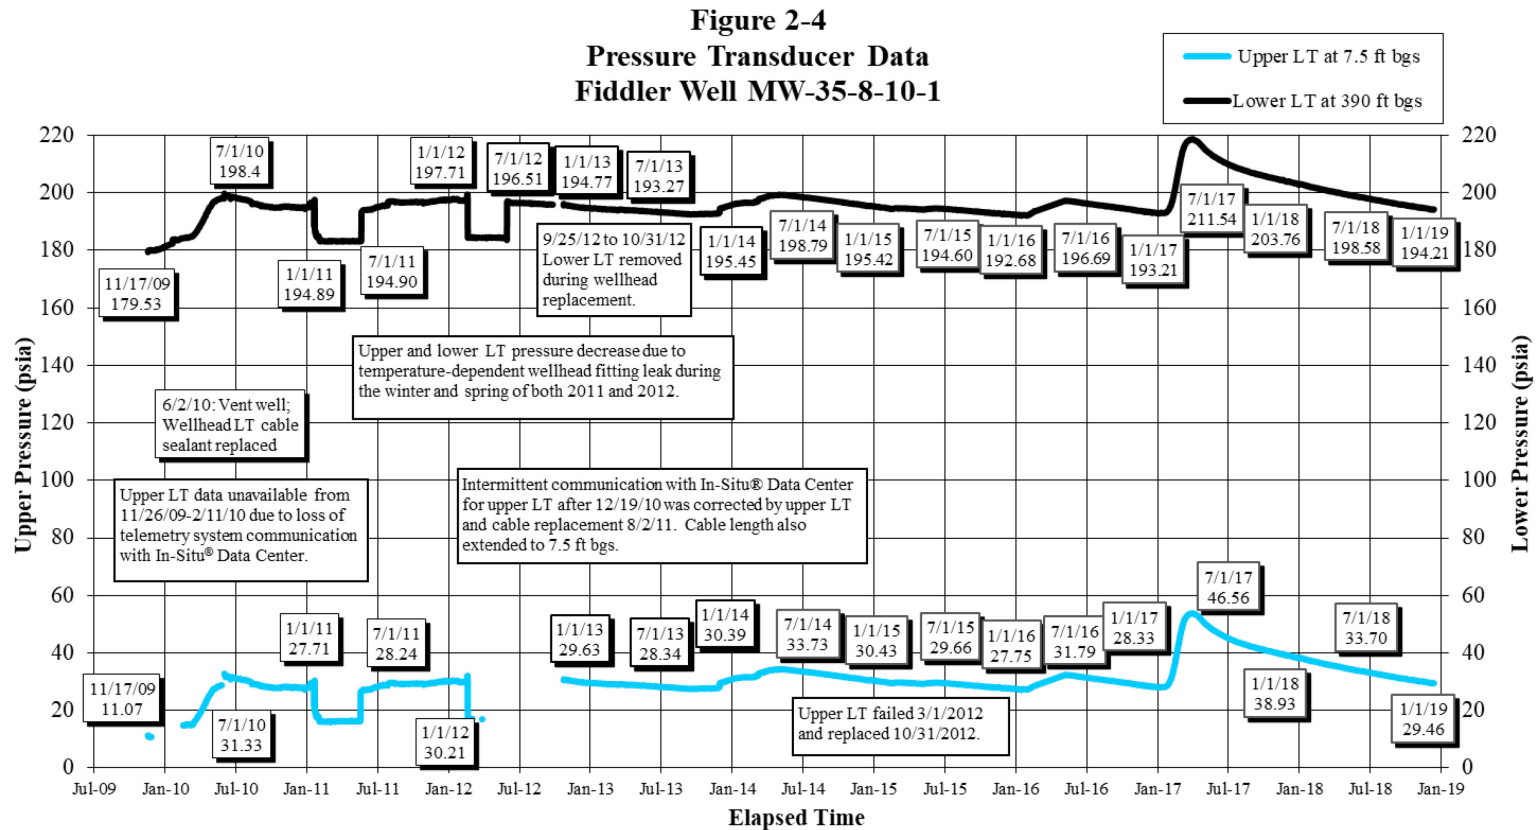
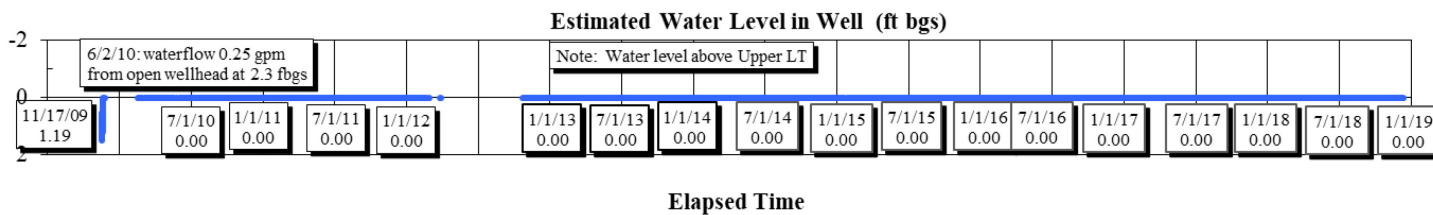
**Figure 2-4
Pressure Transducer Data Fiddler MW-35-8-10-1**

Monitoring data for MW 35-8-10-1 are plotted in Figure 2-4. The net change in wellhead pressure is 29.46 psi and the net change in downhole pressure is 9.91 psi for the 9-year period of record. As Figure 2-4 shows, both the wellhead pressure and downhole pressure steadily increased from installation on November 17, 2009 to early June, 2010. This well has seen moderate fluctuation in the pressure regime, however instrumentation problems and wellhead leakage occurred until 2013. These issues are discussed below.

As noted on Figure 2-4 the lower Level Troll was removed during wellhead maintenance on September 25, 2012 and reinstalled on October 31, 2012. A net water level change was not calculated because the upper transducer is below the water level in the well. Figure 2-4 documents a natural flow rate from the well at a rate of 0.25 gallons per minute (gpm) when the well was vented for maintenance on June 2, 2010. At the time of the well inspection on October 31, 2012, the flow rate was measured at 0.14 gpm. For charting purposes, the water level in the shut-in well is estimated to be at or near ground surface above the upper pressure transducer (set at 7.5 ft bgs).

Also noted on Figure 2-4, telemetry system communication with the In-Situ[®] Data Center for the upper transducer was lost from November 26, 2009 through February 11, 2010 due to cable connection problem and was intermittent from December 19, 2010 to January 1, 2011. The upper transducer and cable were replaced during the 2011 well inspection and the cable length was extended from 3 ft bgs to 7.5 ft bgs. Additionally, a wellhead fitting leak during the winter and spring of 2011 through the summer of 2012 caused a pressure decrease observed on both the upper and lower transducers. Related to the freeze-thaw cycles the upper transducer failed again March 1, 2012. Inspection of the wellhead on June 6, 2012

revealed the minor water leak at an estimated flow rate of 0.1 to 0.2 gpm. Evidence of the wellhead freezing and then popping the wellhead seal is observed by the minor pressure spiking on both transducers in January 2011 and February 2012. The tubing head threading was cleaned in an attempt to achieve a pressure tight seal at the mandrel head, but both the rubber seals and threading had deteriorated significantly. Documentation was conducted for a later wellhead replacement. Souder Miller Associates supervised installation of the new wellhead on September 25, 2012, which required removal of all instrumentation from the well. Rather than reset the instrumentation at that time, it was planned to remain out of service until the well inspection conducted by COGCC, Norwest and In-Situ, Inc. on October 31, 2012. During that well inspection the upper transducer was replaced with a new 100 psia Level Troll. Also, as planned, the lower transducer and cable was reset, however the new set depth was approximately 15 feet deeper than the previous set depth, so the proper offset has been incorporated into the lower transducer data in Figure 2-4.

Since mid-2014, the Fiddler monitoring well showed a fairly steady decline in bottom-hole and wellhead pressure of approximately 6 psi through January 1, 2016. However, bottom hole and wellhead pressure measurements show a steady increase of approximately 5 psi from late February 2016 through May 2016. This could have been a response related to temporary shut-in of one or more nearby coal bed methane production wells. A similar pressure decline trend as the 2014-2015 resumed in June 2016.

2017 demonstrates a substantial pressure build-up measured on both the upper and lower transducers. It appears to represent a change to the local production regime; a decrease or shut-in of coal seam reservoir production by a nearby operator allows pressure build-up at Fiddler through 2017 quarter 1. This build-up is followed by a fall-off trend through the remainder of 2017 and all of 2018, which could represent local production well(s) coming back online.

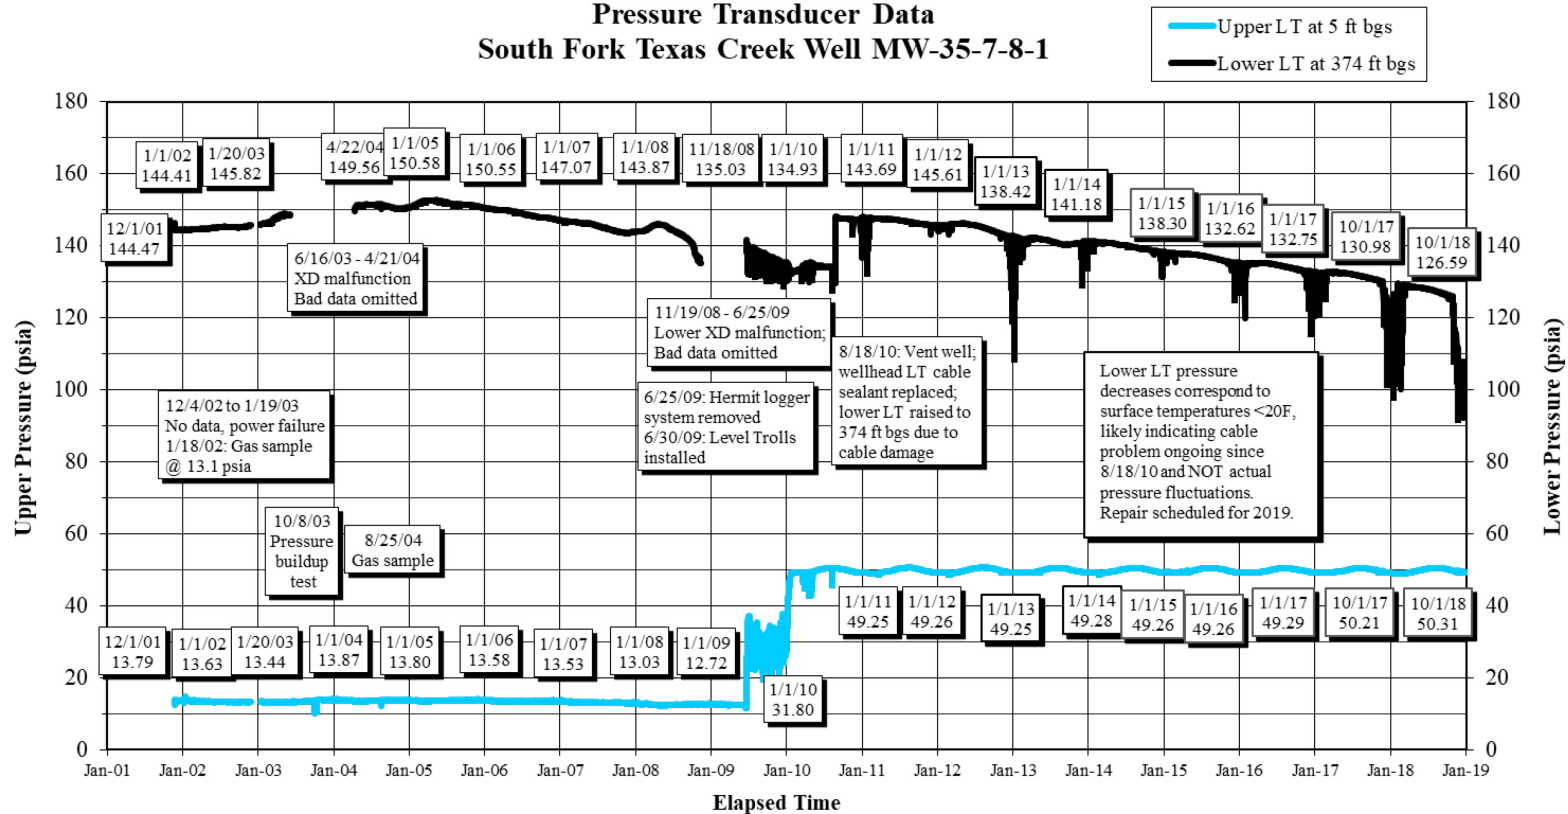
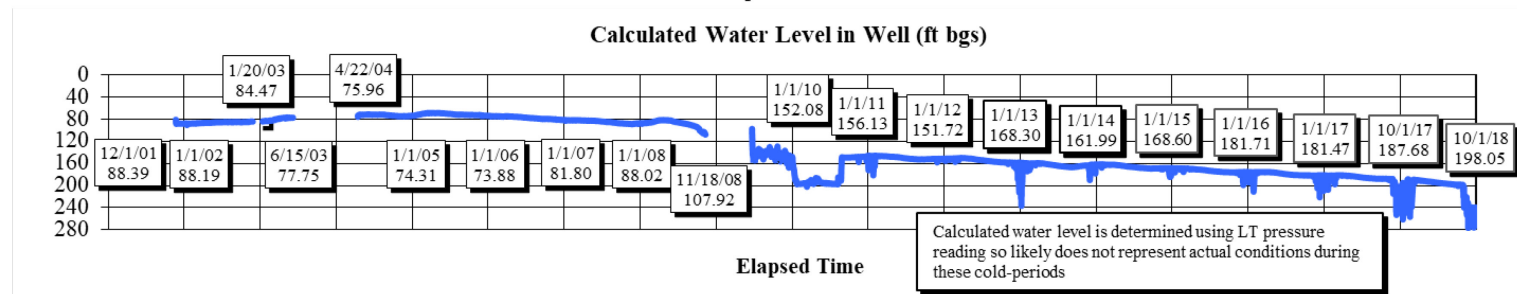
**Figure 2-5
Pressure Transducer Data South Fork Texas Creek Well MW-35-7-8-1**

Monitoring data for MW 35-7-8-1 are plotted in Figure 2-5. As summarized in Table 2-4, the net change in wellhead and downhole pressures is 36.52 psi and -17.88 psi respectively for the 18-year period of record. Note that while the annual monitoring period is the calendar year, due to a damaged downhole Level Troll cable, the lower pressure data point used in Table 2-4 is from October 1, 2018. The net change in the calculated water level in the well for this period is -109.66 feet.

pressure regime since August 2010 may indicate complete well shut-in was not achieved until after the Level Troll cable wellhead seals were replaced on August 18, 2010. Some higher magnitude pressure fluctuations in the lower transducer began occurring in December of 2012 and were continuing through the current period of record during winter (cold) periods. These fluctuations continued in 2018 and have been evaluated to determine that the lower transducer or its cable is malfunctioning and will be replaced in 2019.

Specifically, all site instrumentation enclosure desiccants will be replaced. Additionally, the lower LevelTroll and cable will be replaced at South Fork Texas Creek well #1 (MW 35-7-8-1) to eliminate the cold-weather pressure deviations that have been occurring seasonally for several years. Also, the Highway 151 well #2 (MW 34-4-30-2) will be investigated for a wellhead fitting leak to confirm whether the drop in well head pressure to atmospheric pressure range is due to a change in the pressure regime or an incomplete shut-in condition.

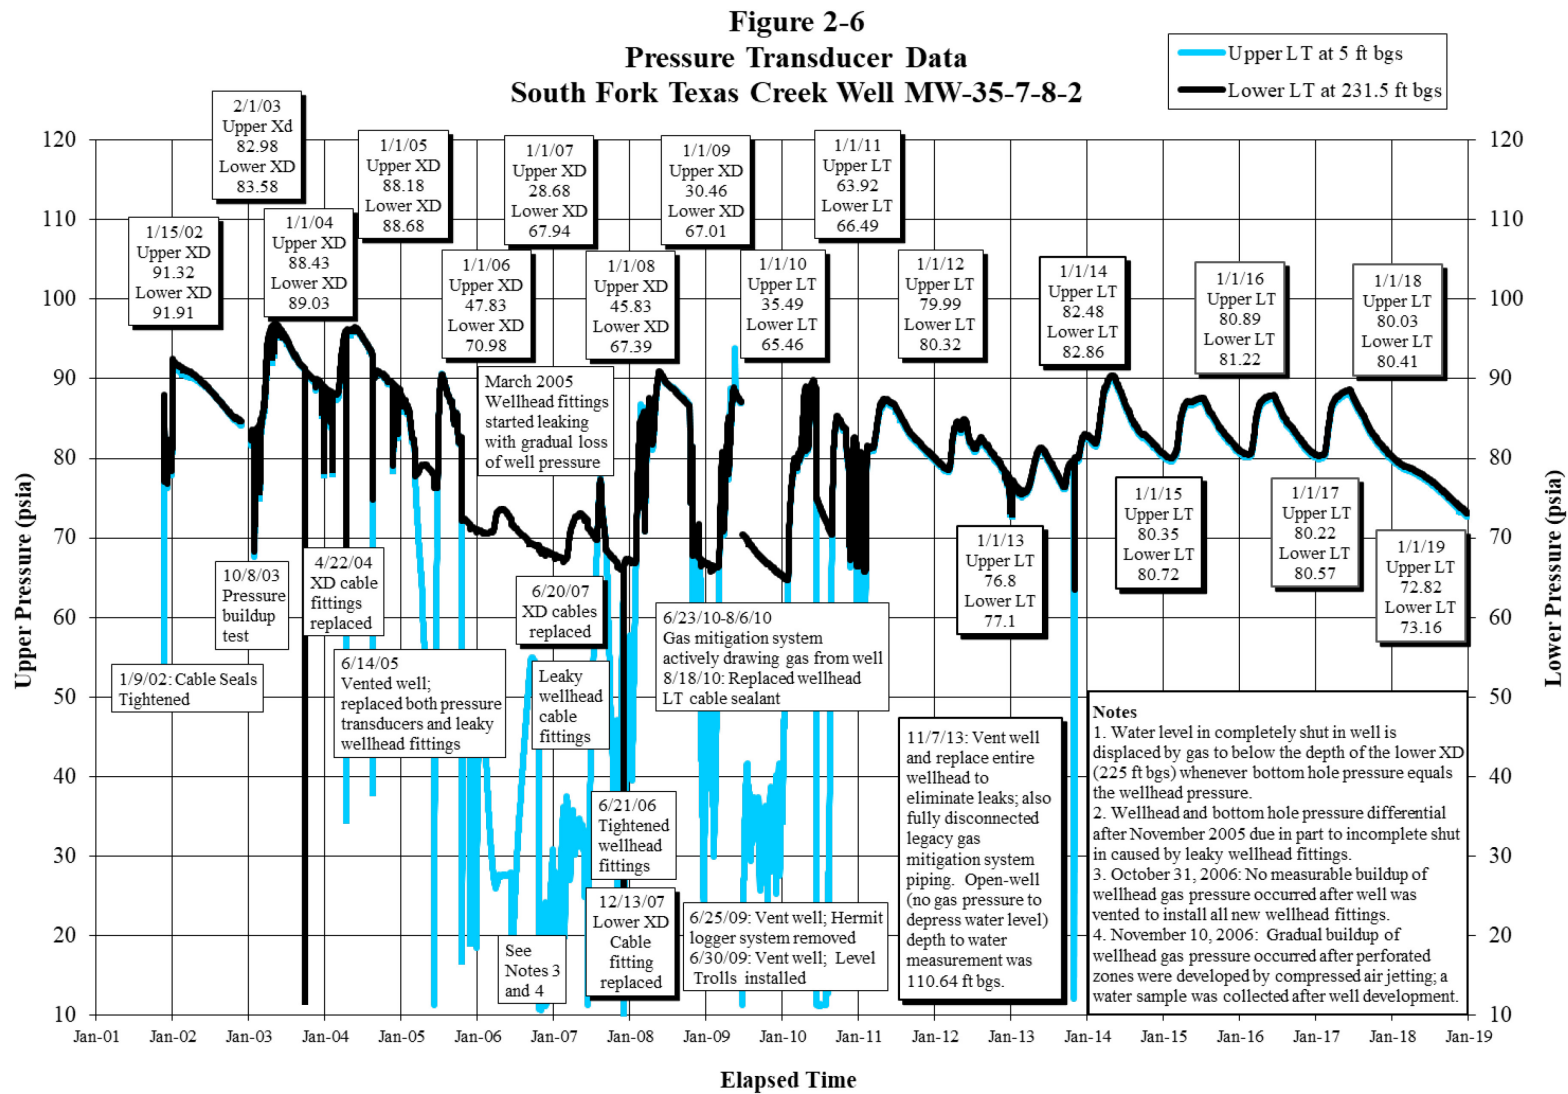
**Figure 2-6
Pressure Transducer Data South Fork Texas Creek Well MW-35-7-8-2**

Figure 2-6 charts the pressure data for well MW 35-7-8-2, which exhibits an entirely different pressure regime than the deeper monitoring well MW 35-7-8-1. Figure 2-6 shows nearly equal wellhead and downhole pressures for the period of record when the well is completely shut in. For example, wellhead and downhole pressures recorded on January 1, 2019 were 72.82 psia and 73.16 psia respectively under shut-in conditions. Based on the period of record to date, incomplete well shut-in is indicated whenever the well pressure drops below about 70 psia.

Figure 2-6 shows a fairly rapid increase in well pressure after the well was shut in on August 18, 2010. The peak build-up pressure of about 85 psia on September 28, 2010 was followed by an erratic decline in well pressure. The inspection of the well in 2013 documented a minor fitting leak at that time; this was a consistent leak on a pipe fitting that has been attempted to be tightened in the past years but required significant replacement of numerous wellhead fittings. The colder air temperatures occurring with early winter of 2012 and again in 2013 appeared to cause some erratic pressure fluctuations documented with the upper and lower transducers in Figure 2-6. This seemed to indicate that the leak was becoming more significant. On November 7, 2013 a site-specific follow-up trip was conducted to repair the leak that had been most recently documented on September 30, 2013. The well gas pressure was allowed to safely bleed down, with continuous gas detector monitoring. Both upper and lower Level Trolls were removed from the well and the wellhead was completely removed down to the 2-inch line pipe that is the well

A fairly consistent well pressure trend was observed for the previous four years, 2014 – 2017, whereby the well pressure builds in the first two quarters of the year and then falls off during the second two quarters. This trend may be documentation of seasonal effects of groundwater recharge and discharge, natural or otherwise. As 2018 was documented with extreme drought conditions, it appears that the monitored interval did not receive recharge and thus the pressure trend continued to decrease during the usual recharge period through 2018.

casing extending up from the cement pad. The threads were reconditioned with a hand-operated 2-inch pipe die. The wellhead was reconstructed using all new carbon steel pipe fittings, with the exception of the Conax compression fittings secured around each Level Troll Rugged Cable, as they had not been documented as leaking. Several manual water level measurements were taken while the wellhead was open. Initially, the water level recovered fairly quickly as the gas pressure was vented. After approximately 2.5 hours open during the new wellhead installation, the water level was relatively stable and measured 110.64 ft bgs. This is the static water level when no gas pressure is allowed to depress the water column in the well. As can be seen in Figure 2-6, the upper and lower Level Troll pressure readings diverge at this time indicating that for the short period following well shut-in the lower Level Troll was actually submerged in water. The lower Level Troll pressure reading was approximately 63.6 psia, which calculates to 111.06 ft bgs. This gives good confidence in the calculated versus measured water level in this well, given error in the assumption of atmospheric pressure which is not currently recorded at this location. To prevent damage to the existing lower Level Troll cable, the Conax compression fitting was not adjusted to offset the new wellhead's increased height above ground surface of 0.25 feet, so the new set depth is 231.25 ft bgs. No leaks have been detected at this wellhead since the replacement.

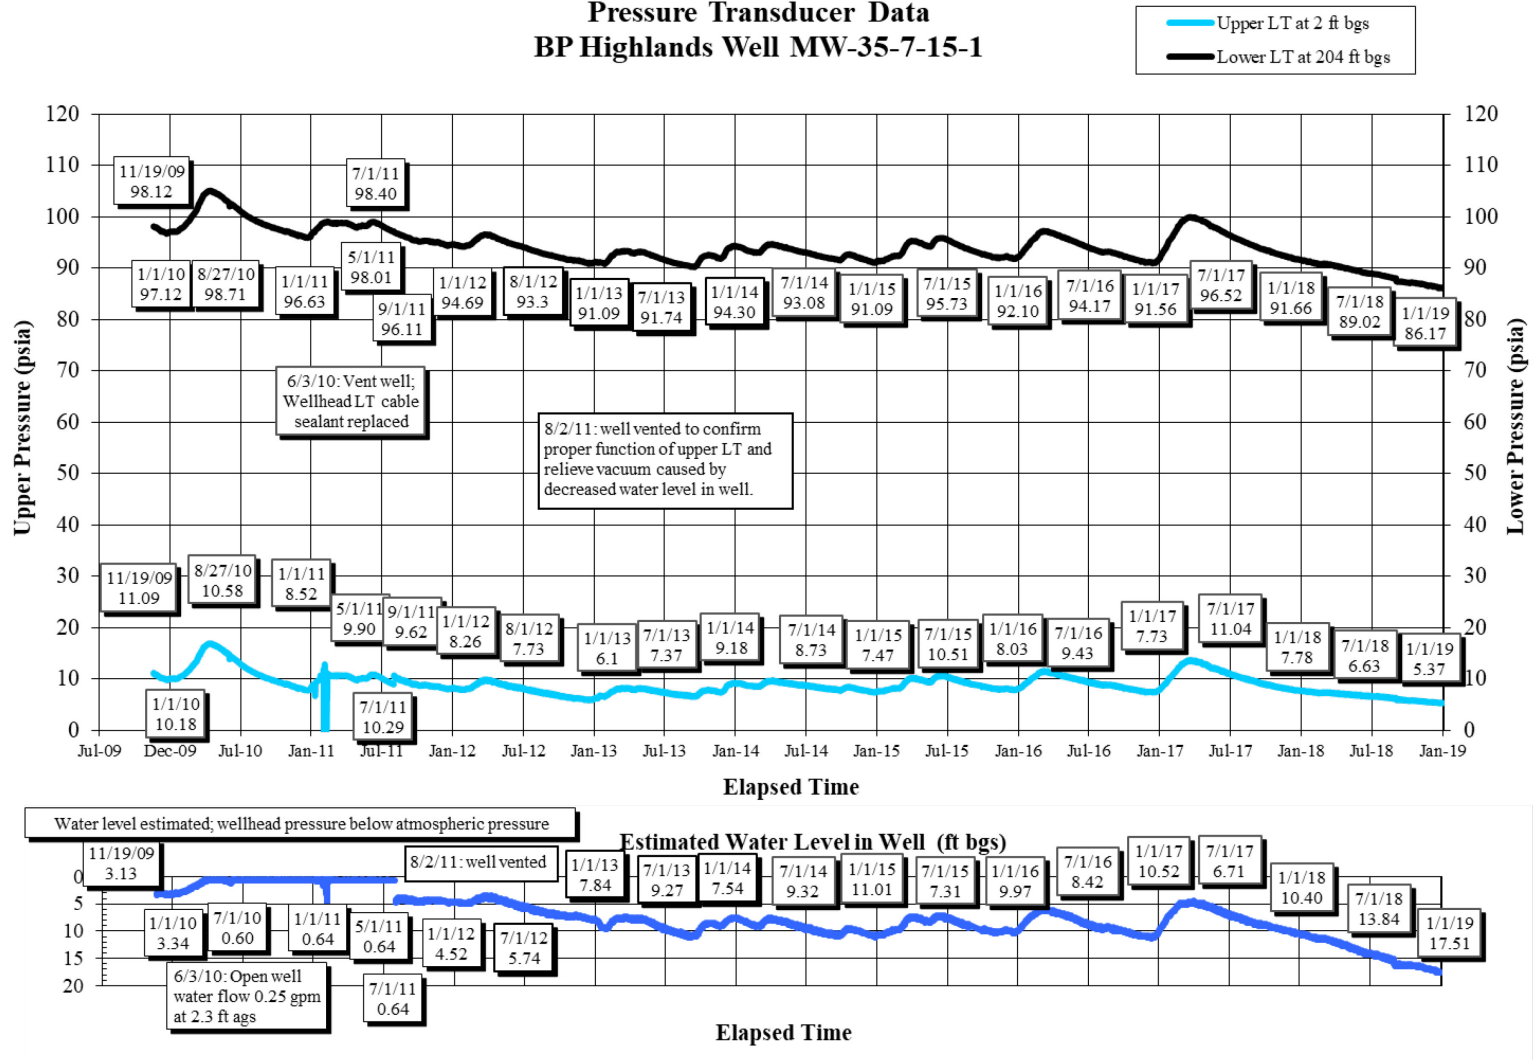
**Figure 2-7
Pressure Transducer Data BP Highlands Well MW-35-7-15-1**

The wellhead pressure started dropping below atmospheric pressure around August 12, 2010. This condition suggested either a potential problem with the upper transducer or a well pressure vacuum effect created in a completely shut-in well under declining water level conditions. A well instrumentation inspection and atmospheric pressure check conducted during each subsequent site visit through 2013 has confirmed the proper function of the upper transducer. Venting the well allowed for physical confirmation that the well was under vacuum pressure conditions which have continued through January 1, 2019.

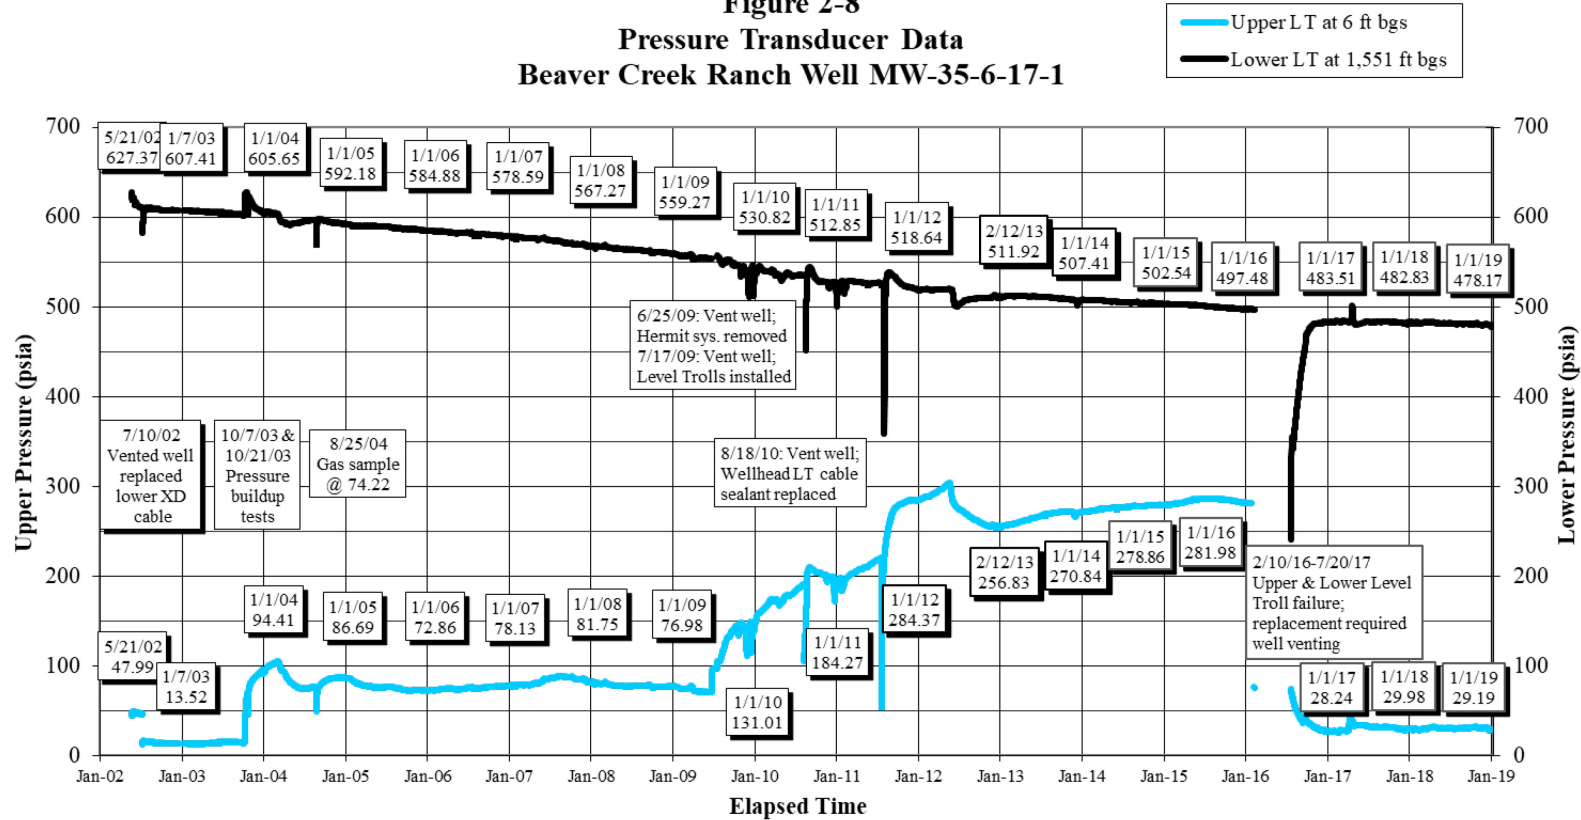
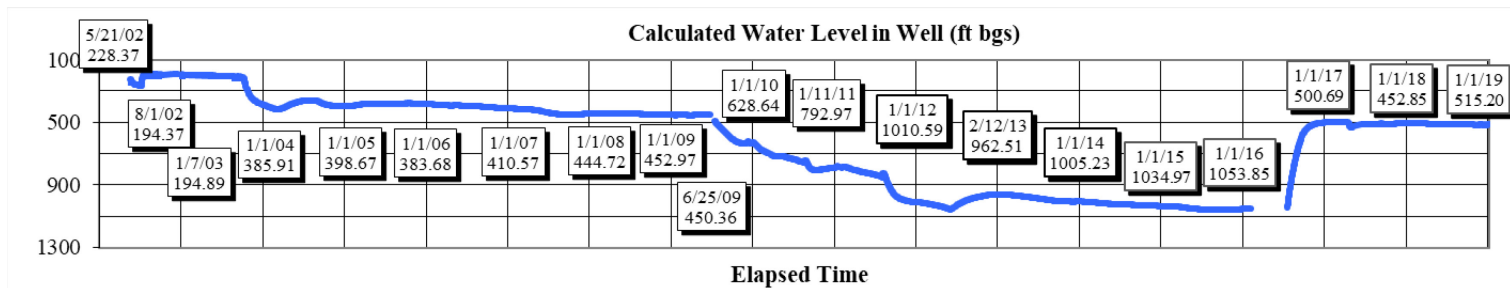
**Figure 2-8
Pressure Transducer Data Beaver Creek Ranch Well MW-35-6-17-1**

demonstrates that following this bleed-off the wellhead pressure has remained depressed at approximately 30 psi and relatively stable. This is likely because the water head pressure of approximately 500 feet (215 PSI) is effectively preventing significant gas build-up at the wellhead.

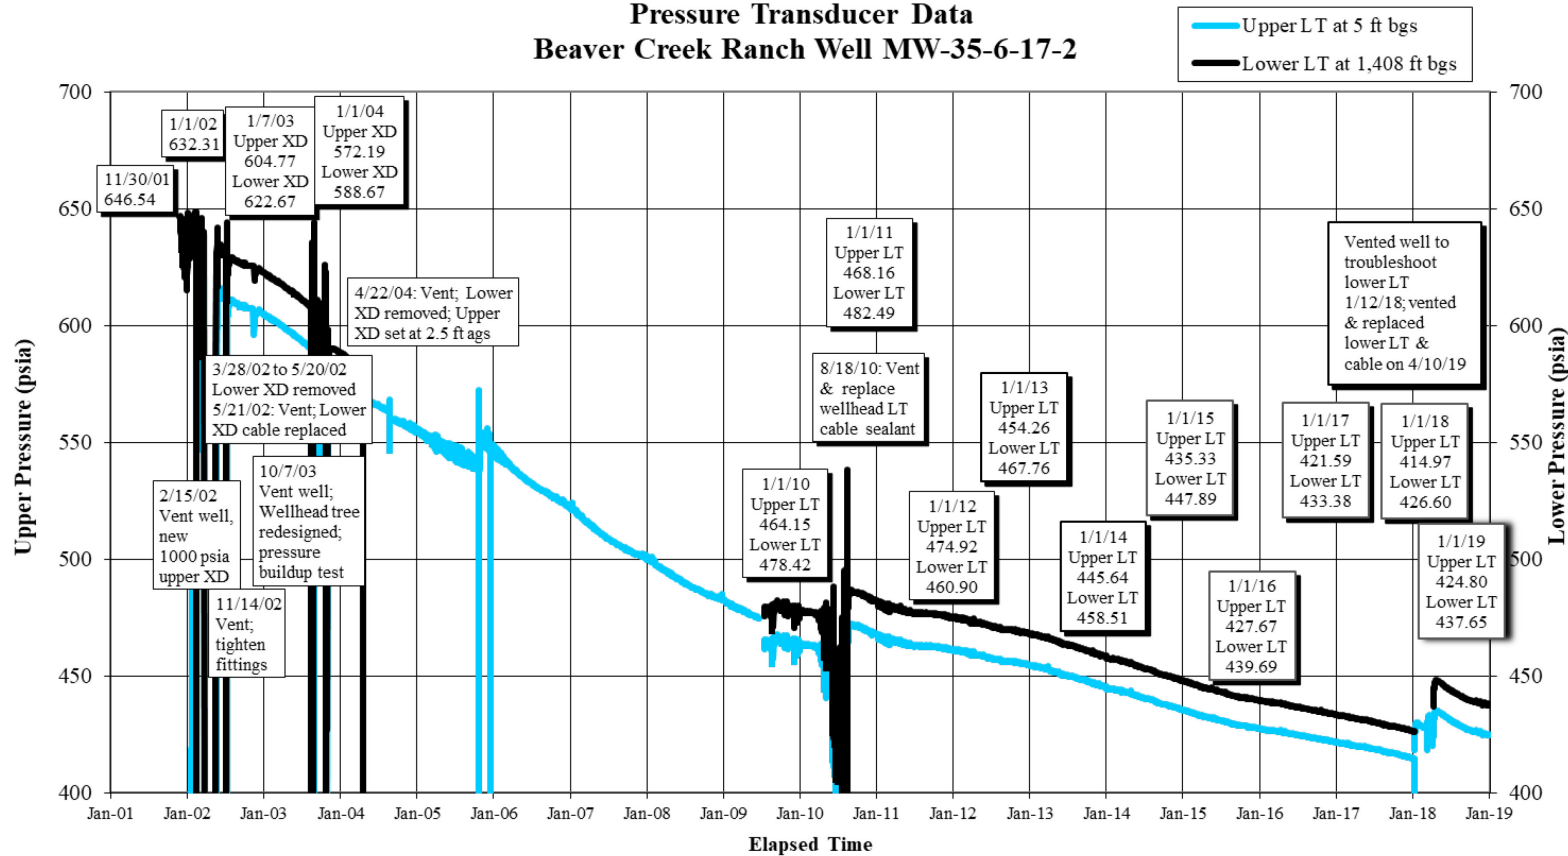
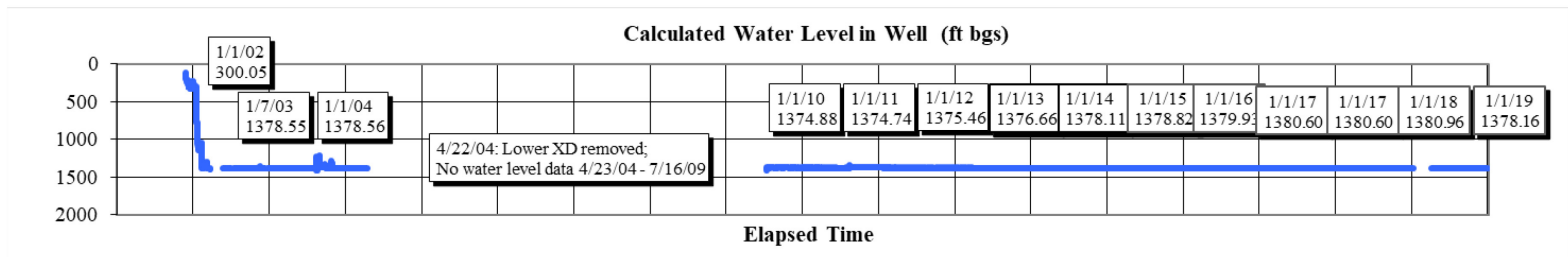
**Figure 2-9
Pressure Transducer Data Beaver Creek Ranch Well MW-35-6-17-2**

Figure 2-9 shows the well pressure in a declining trend for the entire period record. There is a notable shift in the well pressure curve following the installation of Level Troll instruments on July 17, 2009, followed by erratic well pressure fluctuations associated with incomplete shut-in through August 17, 2010. After the well was vented August 18, 2010 to replace the Level Troll cable fitting sealants, there was a steady build-up of well pressure through early September 2010 followed by a return to a declining trend through December 2015.

As shown on Figure 2-9, no water level data is available for the 6-year period of record when there was only one well pressure transducer. Well pressure data available after installation of wellhead and downhole Level Trolls on July 19, 2009 shows very little change in the calculated water level.

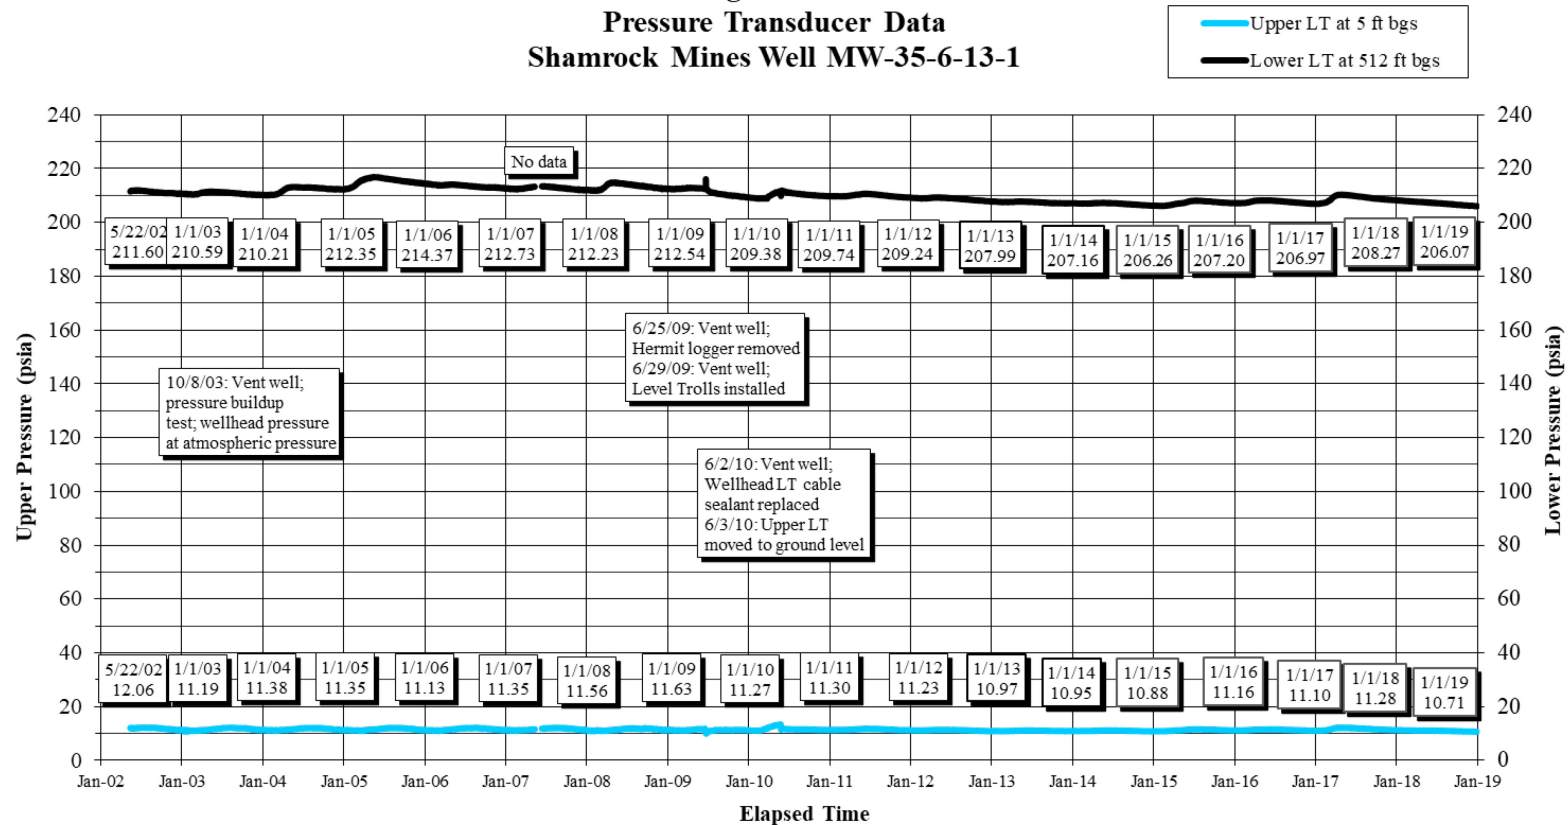
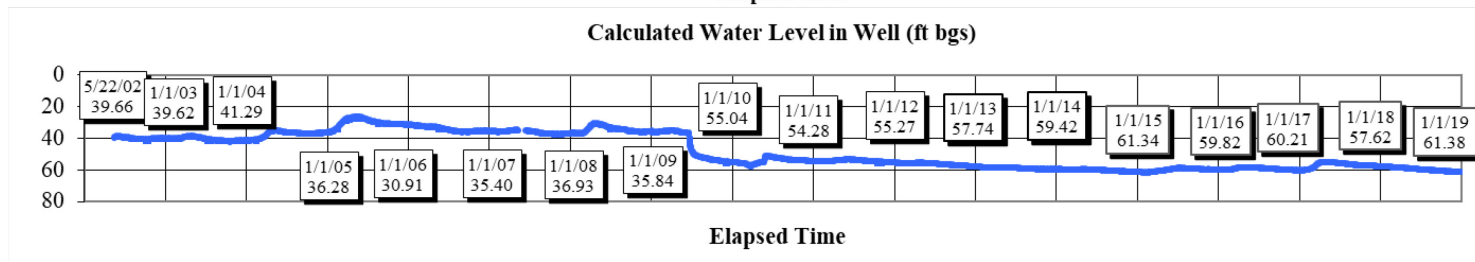
Figure 2-10
Pressure Transducer Data Shamrock Mines Well MW-35-6-13-1

Figures 2-10 shows the wellhead pressure regime continues to be at atmospheric pressure and fluctuates within a range of 2 psi (between 10 psia and 12 psia). During the months of April and May 2010, the wellhead pressure steadily increased to around 13.4 psia. Wellhead pressure returned to the historic atmospheric pressure trend after the Level Troll wellhead cable sealants were replaced on June 2, 2010.

Figure 2-10 also shows the downhole pressure and calculated water level in the well continued to exhibit an overall declining well pressure trend for the period of record since April 2005. With wellhead pressure equal to atmospheric pressure, fluctuation of downhole pressure is associated with the fluctuation of the water level in the well.
