Colorado Oil and Gas Conservation Commission

**Monitor Wells Summary Report
2018**

**4M Project Monitoring Program
Archuleta and La Plata Counties
Colorado**

June 14, 2019

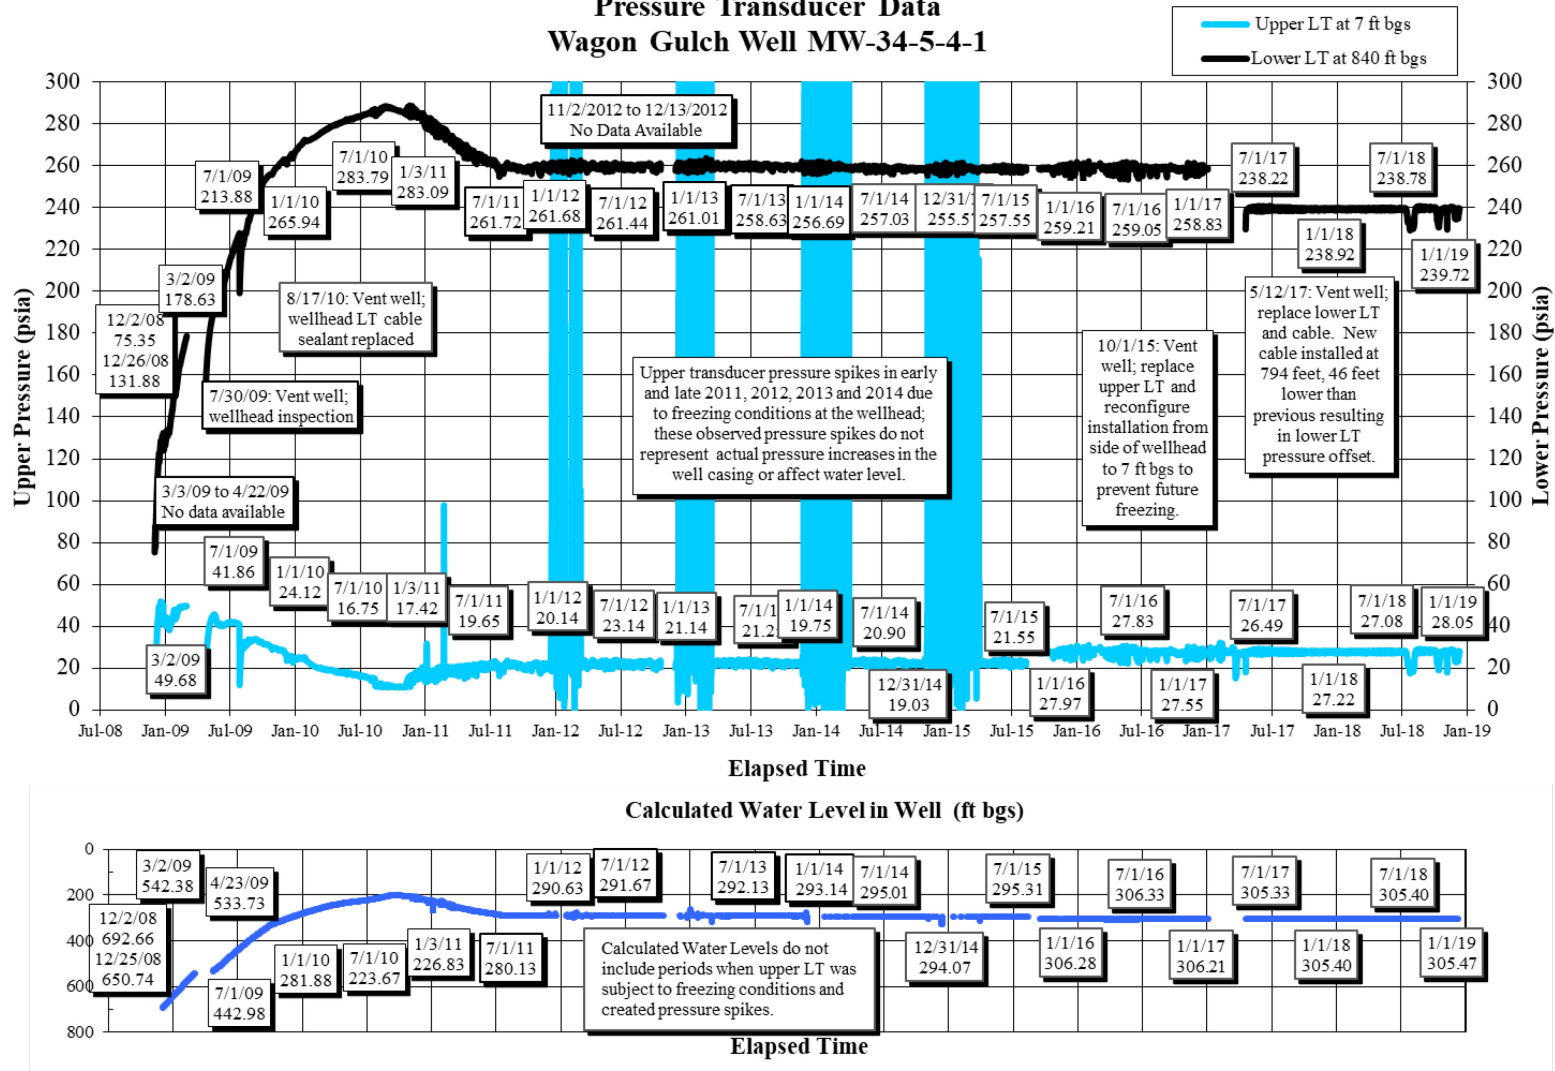
Figure 3-1
Pressure Transducer Data Wagon Gulch Well MW-34-5-4-1

2008. Figure 3-1 shows the trend of rising water level with corresponding increasing downhole pressure continued in 2010 until the trend reversed in mid-September 2010. This may have been related to the transducer cable sealant being changed on August 17, 2010 and possibly eliminating a partial shut-in condition. No leaks were detected during the site inspections in 2012-2014. Between October 1, 2010 and December 31, 2010, Figure 3-1 shows the water level decreased about 21.2 feet while the downhole pressure decreased about 2.7 psia.

During the winters of 2011-2012, 2012-2013, 2013-2014 and 2014-2015 pressure spikes in the upper transducer occurred due to the pressure transducer freezing within its deployment location in the wellhead 2.3 feet above ground surface. These are not actual increases in gas pressure within the well casing, but rather caused when the air volume next to the transducer inlet is trapped and then compressed by expanding frozen water condensate. When the 2011 well inspection was conducted at MW 34-5-4-1 the well was vented to ensure that the transducer would return to atmospheric pressure; this test successfully showed that the transducer continued to function properly and was not damaged. The transducer recovered after surface temperatures warmed each spring. The transducer was inspected for damage in each subsequent site visit since this problem began in 2011 until the 2015 site inspection when the Level Troll was replaced and lowered into the well to 7 ft bgs. As evidenced by the winter 2015 data shown in Figure 3-1, the condensate freezing problem in this location has been corrected by lowering the Level Troll below the ground surface.

Several pressure decreases on the order of 10 psi were observed by both the upper and lower transducers in the second half of 2018. The duration of each event was on the order of days to weeks and full recovery to static pressure conditions occurred after each event. These are possibly responses to local drilling or water production from the monitored coal seam.

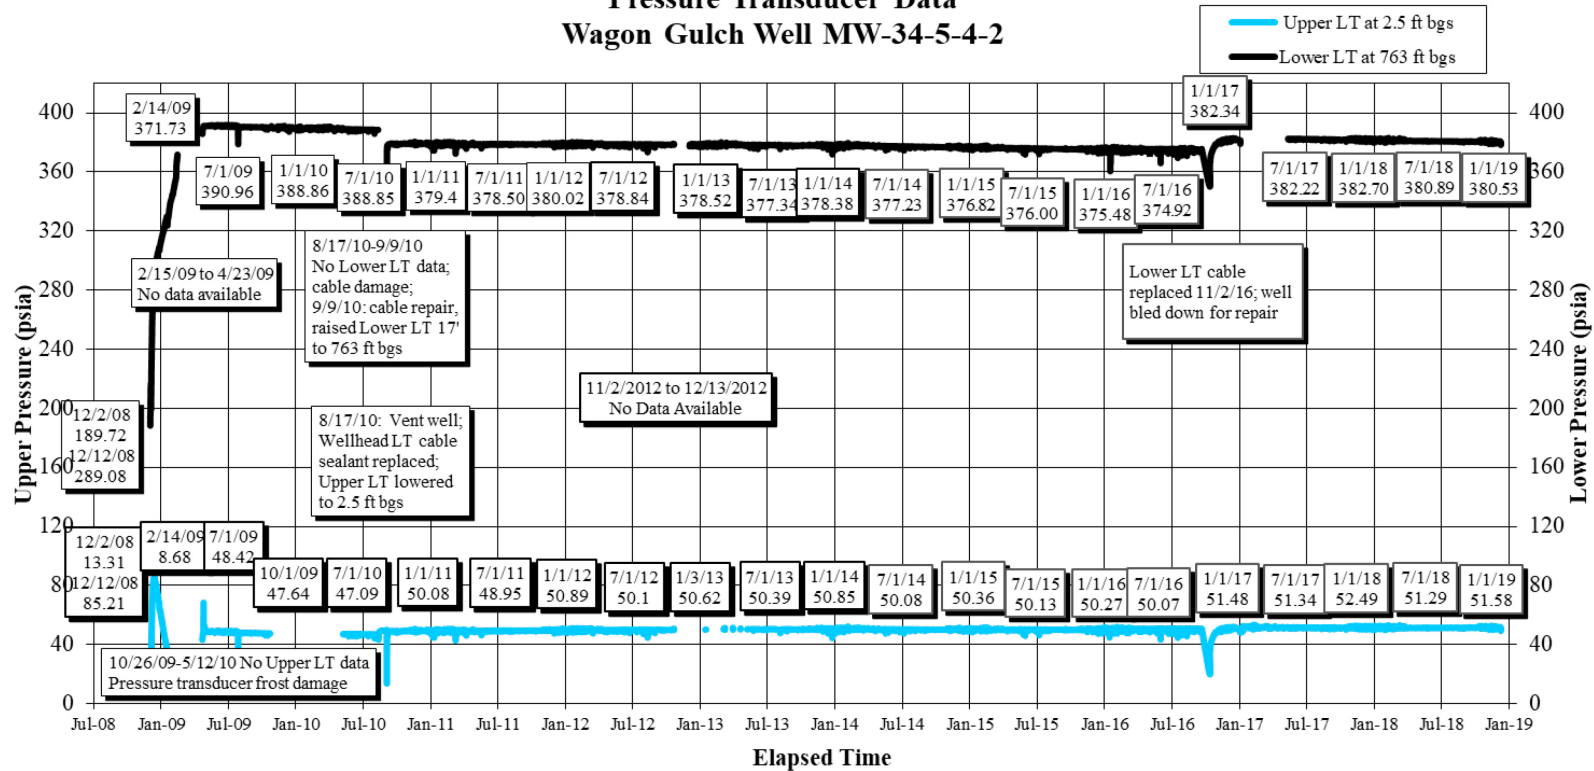
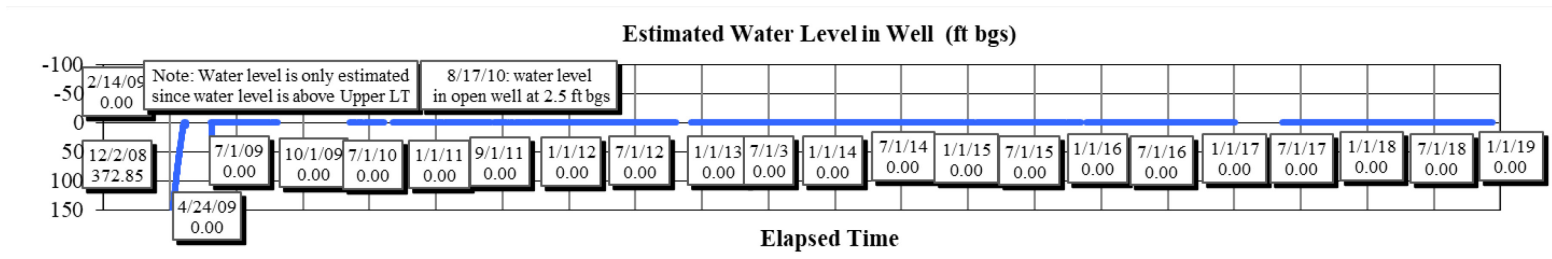
**Figure 3-2
Pressure Transducer Data Wagon Gulch Well MW-34-5-4-2**

Figure 3-2 shows a relatively constant wellhead pressure of about 47 to 48 psia between April 24, 2009 and October 25, 2009. An erratic pressure spiking pattern between October 26, 2009 and May 12, 2010 suggested wellhead Level Troll pressure sensor freeze damage, so the data were omitted from Figure 3-2. Between May 13, 2010 and August 16, 2010, the wellhead pressure remained fairly constant at around 47 psia.

Freeze damage to the upper Level Troll pressure transducer sensor was confirmed after the well was vented on August 17, 2010. As noted on Figure 3-2, the water level inside the open wellhead was at a height of about 2.5 feet above ground level. The new upper Level Troll was changed from an external mount to an internal depth setting of 2.5 ft bgs on August 17, 2010 to protect the transducer sensor from freezing conditions. After well shut-in on August 17, 2010, Figure 3-2 shows a relatively rapid return of wellhead pressure to an average constant pressure of about 50 psia.

The lower Level Troll cable was damaged during replacement of Level Troll wellhead cable sealants on August 17, 2010. Cable repair performed on September 9, 2010 included raising the Level Troll 17 feet from 780 ft bgs to 763 ft bgs. As a result of this change, Figure 3-2 shows a shift in the downhole pressure curve to a corrected constant downhole pressure regime of 378 to 379 psia.

As noted above, the water level was inside the open wellhead at a height of about 2.5 feet above ground level on August 17, 2010. The wellhead pressure build-up after shut-in may reflect water and/or gas pressure build-up. For charting purposes, the water level in the shut-in well is estimated to be at or near ground surface above the upper Level Troll (set at 2.5 ft bgs). However, there is a possibility that the observed build-up in wellhead pressure is from gas pressure, which could result in a downward displacement of the water in the well to some level below the upper Level Troll.

The pressure regime observed in 2018, as well as for the full period of record since post-completion stabilization in 2009, has been quite stable with an overall minor decreasing trend.

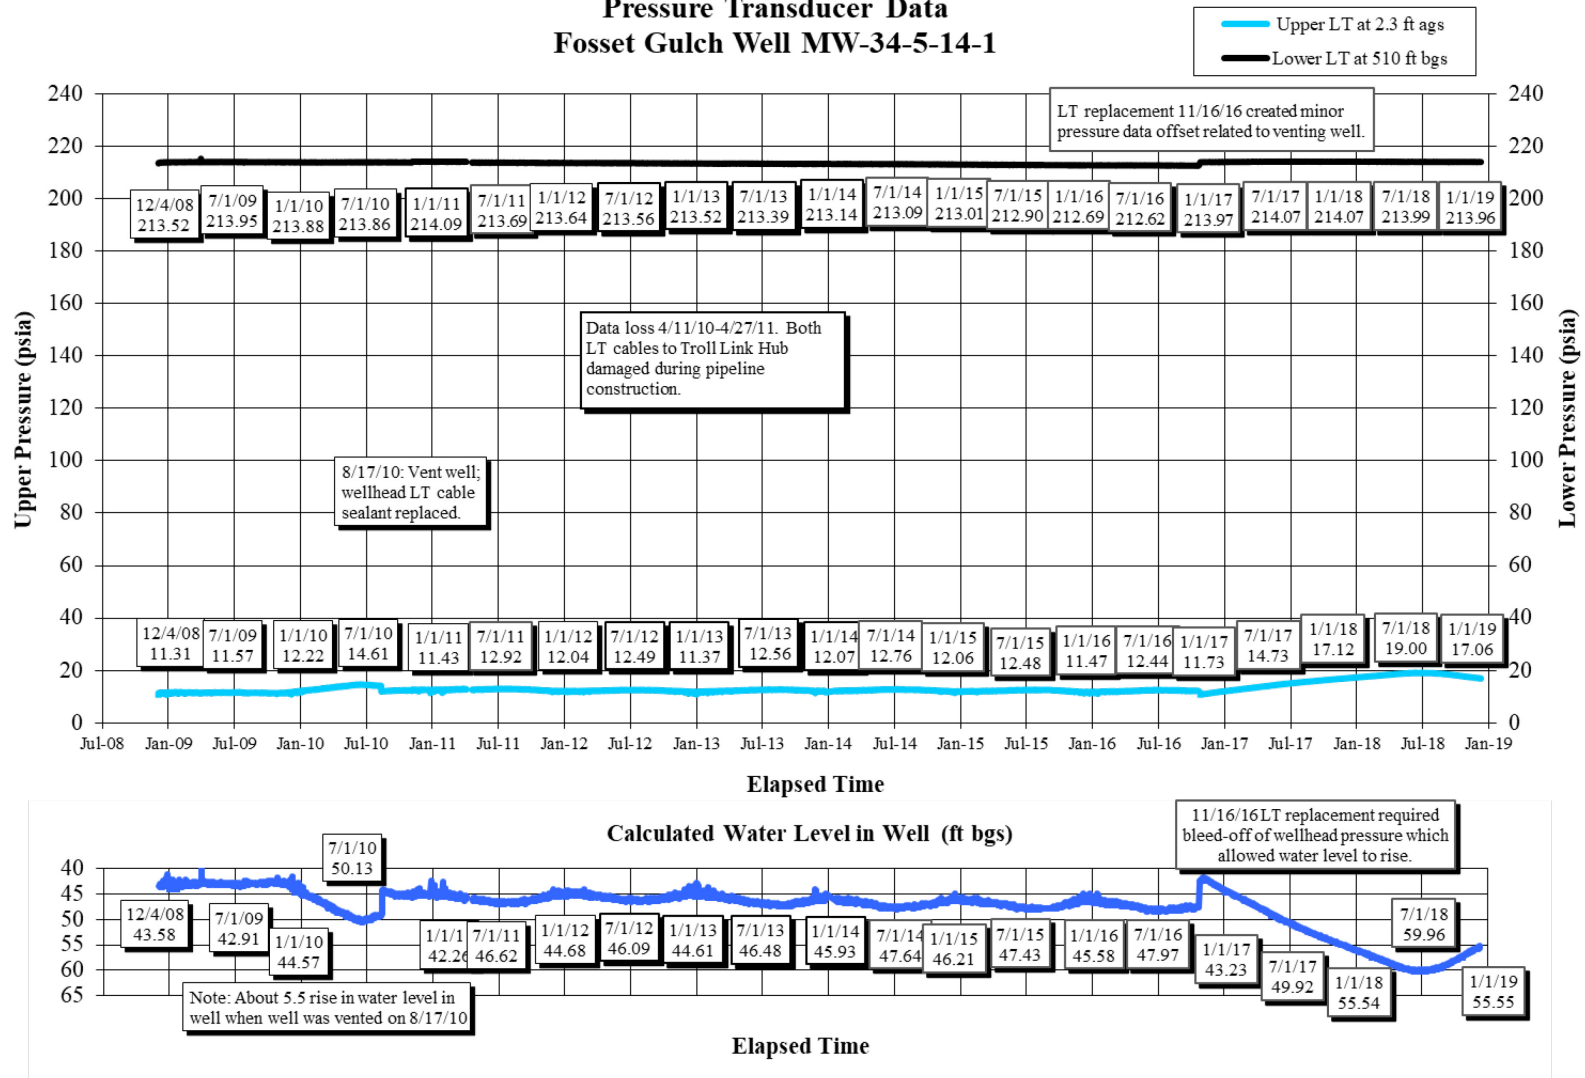
**Figure 3-3
Pressure Transducer Data Fosset Gulch Well MW-34-5-14-1**

Figure 3-3 charts the upper and lower pressure transducer data and the calculated water level in the well. Table 3-2 and Figure 3-3 show the wellhead pressure at atmospheric pressure prior to 2010 followed by a gradual increase in pressure through August 16, 2010 to 14.19 psia. Following the August 17, 2010 well maintenance event including venting, the wellhead pressure has remained relatively constant within a normal atmospheric pressure range through November 16, 2016. At that time, upper transducer replacement required venting the wellhead. Following the maintenance, the wellhead pressure increased slowly until July 2018 when it began to trend down. This is likely a response to gas production stimulation that occurred when the well was vented. Figure 3-3 shows a stable downhole pressure trend (213.52-213.96 psia) for the entire period of record. Figure 3-3 also shows a stable water level averaging 43.0 ft bgs until November 2009, followed by a gradually declining water level trend through July 1, 2010 (50.13 ft bgs). The water level increased to 49.28 ft bgs until the well was vented on August 17, 2010. The water level immediately rose to 44.36 ft bgs when the well was vented on August 17, 2010 but has since followed apparent gentle seasonal fluctuation until November 16, 2016. At that time, the well was vented to replace the upper pressure transducer. Upon replacement, the pressure measured at the wellhead has steadily increased from approximately 12.20 psi to 17 psi on January 1, 2018 and then changed to a decreasing pressure trend. As such, the calculated water level was in steady decline during this time period as gas

pressure has apparently depressed it. Likewise, with the 2018 reversal of the wellhead gas pressure increase trend to a decreasing trend, the calculated water level is now shown to be increasing.

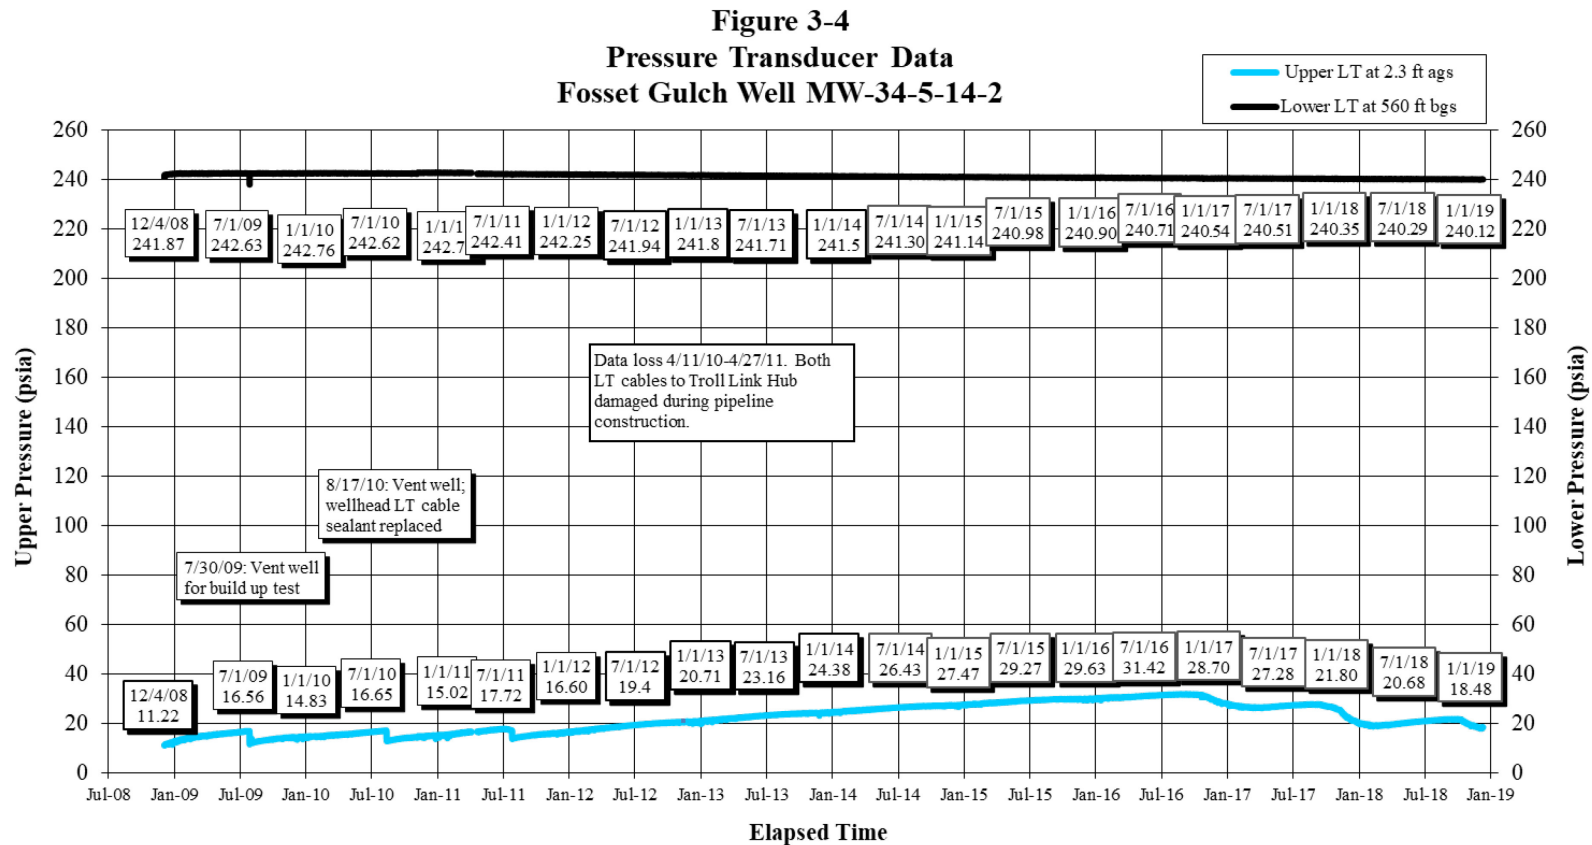
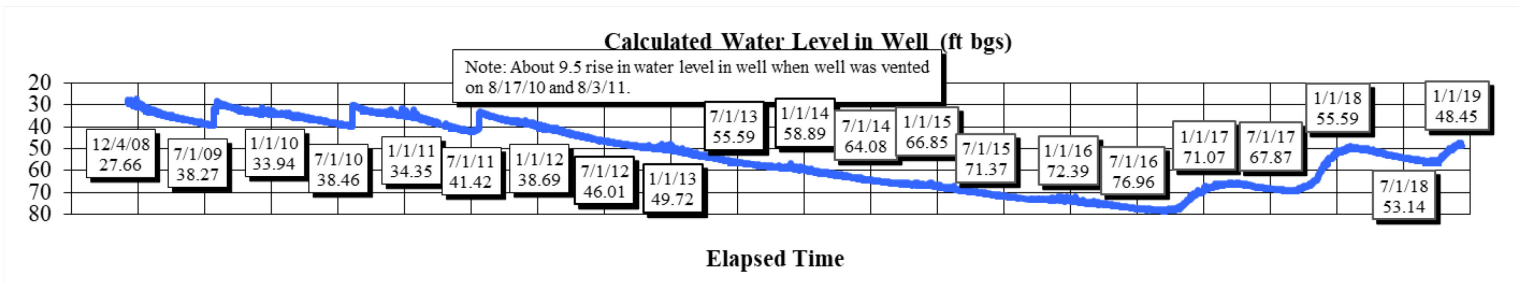
**Figure 3-4
Pressure Transducer Data Fosset Gulch Well MW-34-5-14-2**

Figure 3-4 plots the upper and lower pressure transducer data and the calculated water level in the well. Although the well was shut in for monitoring on December 4, 2008, wellhead pressure did not stabilize at about 17 psia until July 2009. Table 3-2 and Figure 3-4 show a net increase of 7.13 psi in wellhead pressure for the period of record between December 4, 2008 (11.35 psia) and January 1, 2019 (18.48 psia). Figure 3-4 shows a stable but slightly declining downhole well pressure trend for the entire period of record, with fluctuations ranging between a minimum pressure of about 240.12 psia to a maximum pressure of 242.78 psia. The downhole pressure was 240.12 psia on January 1, 2019.

Table 3-2 indicates a net water level drop of 9.16 feet in the well as of January 1, 2019. However, Figure 3-4 shows that the wellhead pressure and water level on January 1, 2019 has possibly shown an effect of venting MW 34-5-14-1 for maintenance on 11/16/16. This would suggest some amount of hydraulic connection between the two wells. Although there is an immediate drop in wellhead pressure and corresponding rise in the water level each time the well is vented to the atmosphere in the past, Figure 3-4 also shows the build-up in wellhead pressure takes approximately 12 months to return to the pressure exhibited prior to each venting event so unless required for servicing the instrumentation, the well will not be vented in attempt to determine the static wellhead pressure.

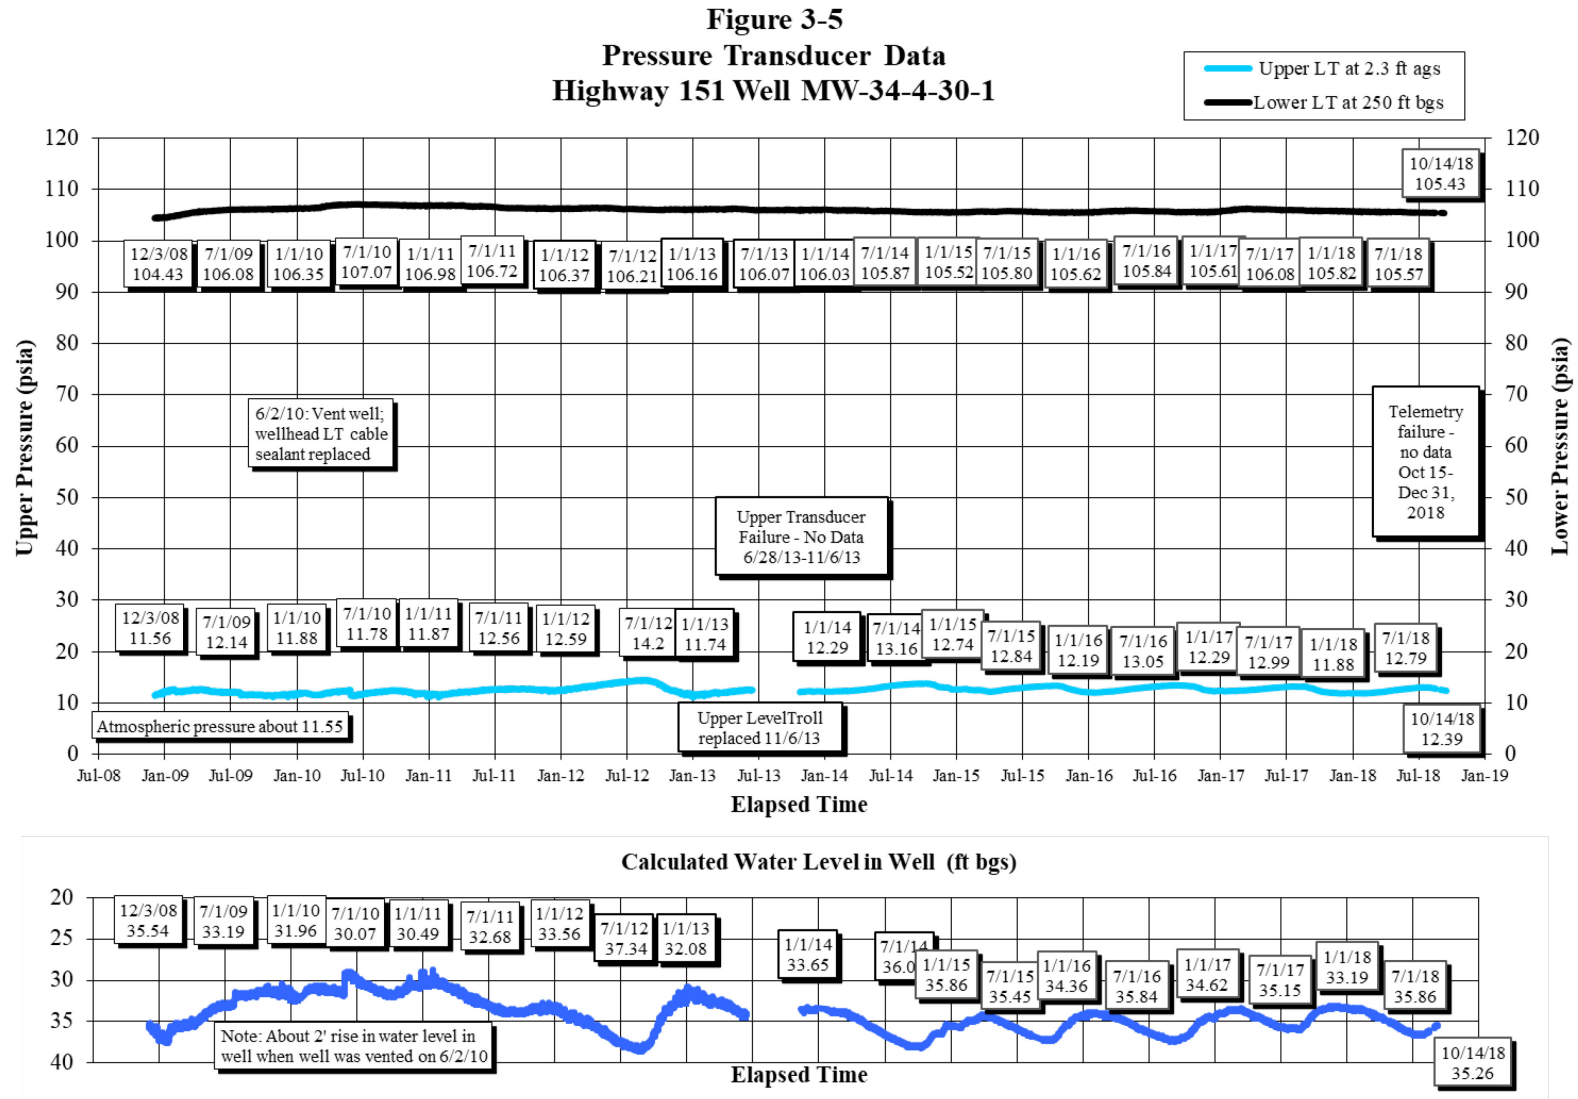
**Figure 3-5
Pressure Transducer Data Highway 151 Well MW-34-4-30-1**

Figure 3-5 charts the upper and lower pressure transducer data and the calculated water level in the well. Table 3-3 and Figure 3-5 show a relatively stable well pressure regime with a stable wellhead pressure trend at atmospheric pressure, a stable downhole pressure trend of about 104-107 psia, and a fluctuating water level trend of 30-37 ft bgs since August 2009. Sharp fluctuations in both wellhead pressure and the calculated water level shown on Figure 3-5 correspond to the immediate loss of pressure when the well is vented (e.g., June 2, 2010), followed by a gradual return to the well pressure regime exhibited prior to venting the well.

In October 2018 the telemetry system failed to send data and after troubleshooting it was found that the lower Level Troll was no longer functional. As such, the final reading reported in Table 3-3 is from October 14, 2018. The cable and Level Troll were replaced in early 2019 and full function has resumed.

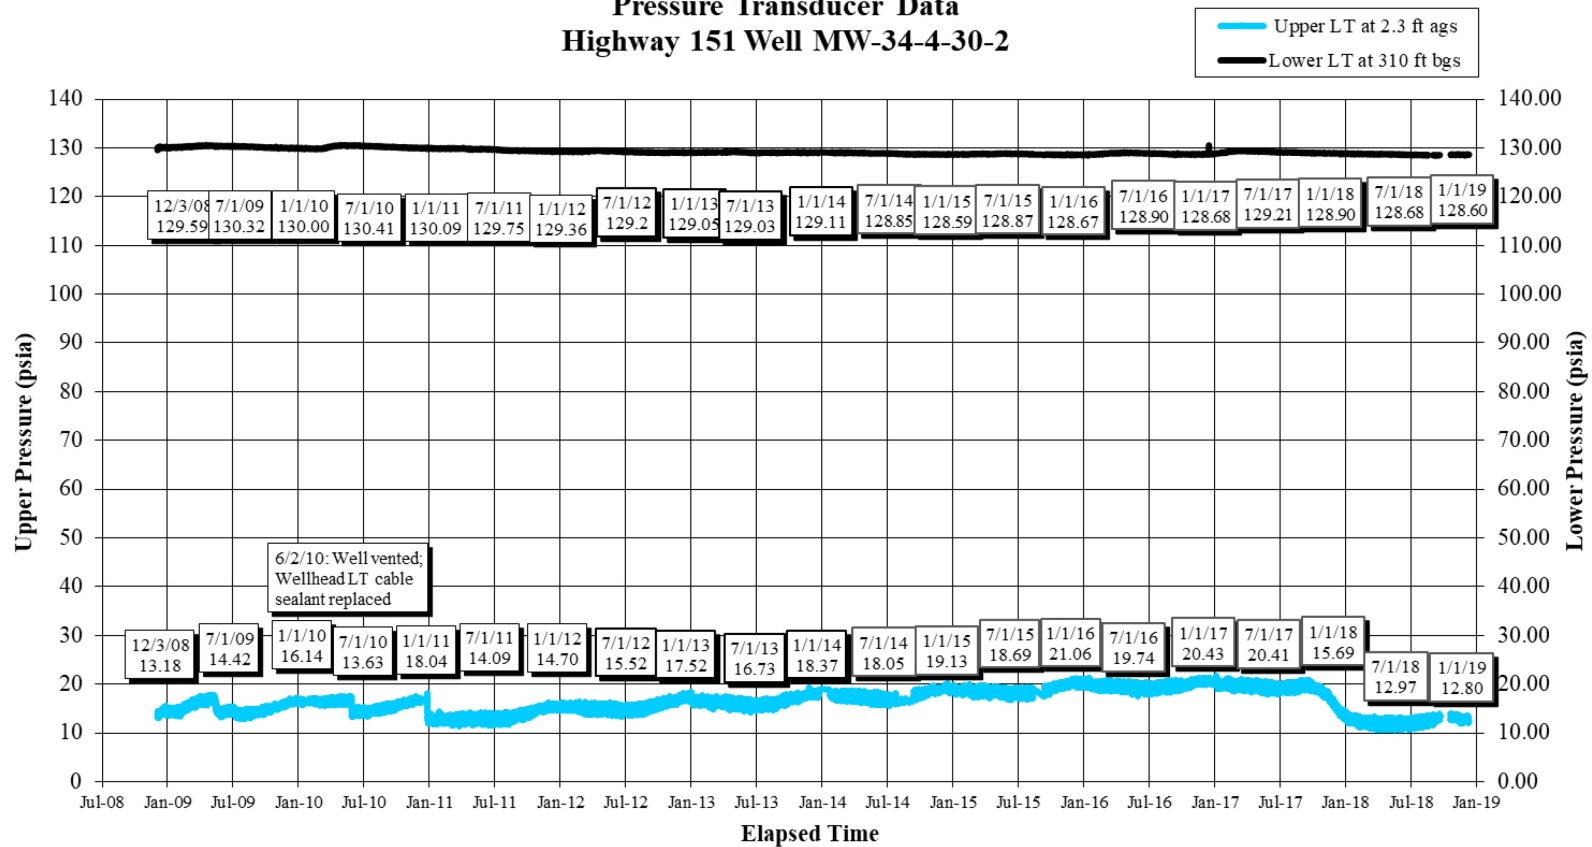
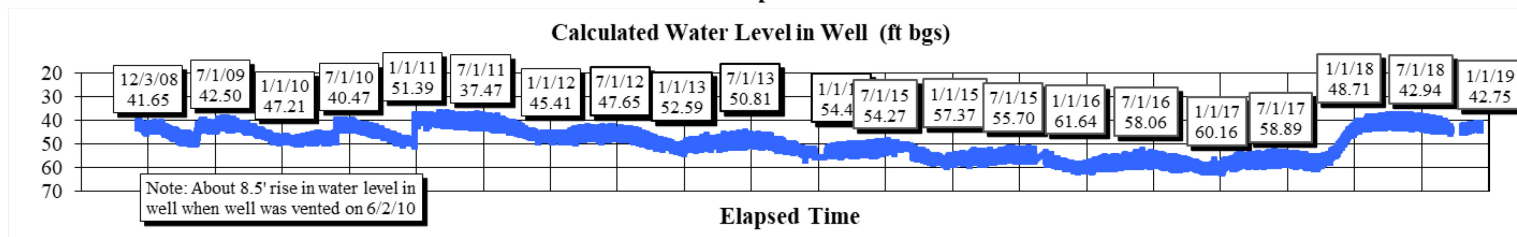
**Figure 3-6
Pressure Transducer Data Highway 151 Well MW-34-4-30-2**

Figure 3-6 charts the upper and lower pressure transducer data and the calculated water level in the well. Table 3-3 and Figure 3-6 shows a stable downhole pressure trend with 0.99 psi change from 129.59 psia on December 3, 2008 to 128.60 psia on January 1, 2019. In addition, there was a net wellhead pressure decrease of 0.38 psi with a corresponding net water level decline of 1.10 feet for the entire period of record from December 3, 2008 to January 1, 2019. However, the wellhead pressure decreased slowly in the fourth quarter of 2017 with a loss measured at approximately 4.3 psi in 3 months. The pressure then stabilized at atmospheric pressure and has remained in that range through 2018. It is possible this was a very slow wellhead fitting leak that allowed wellhead pressure to escape and the water level to rise so this will be re-investigated during the 2019 site visit to confirm if this observation is a well head (gas) pressure decline or was a natural occurrence.

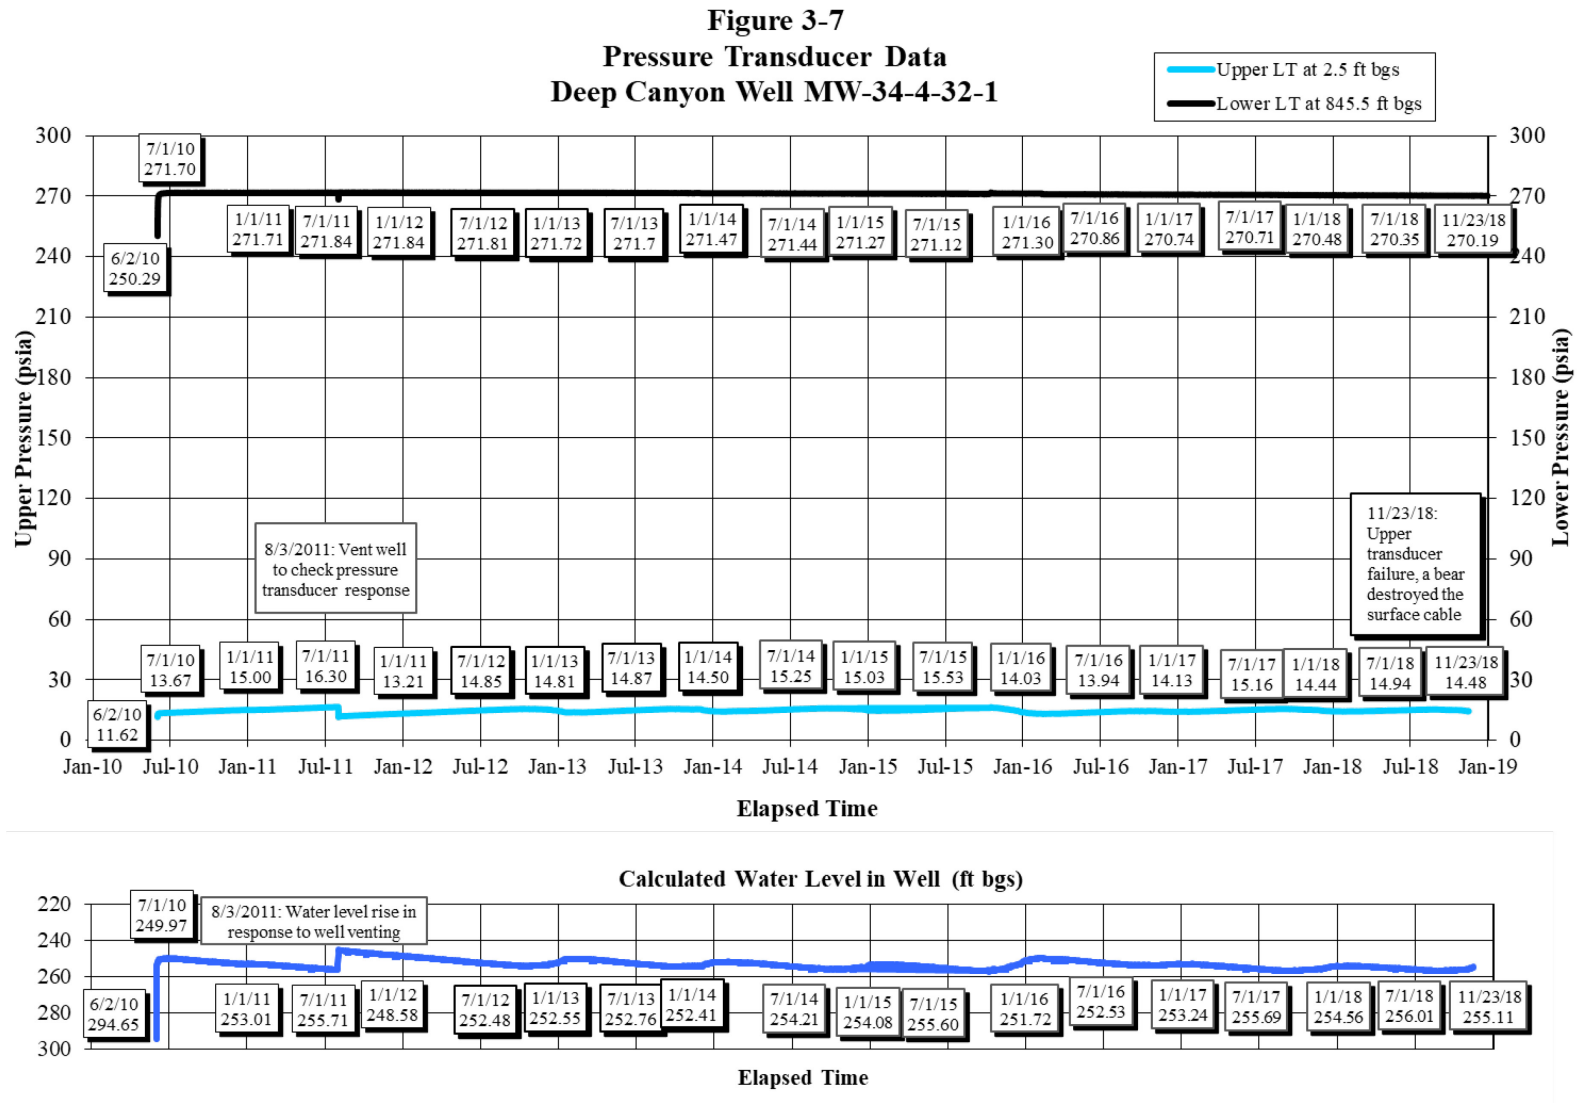
**Figure 3-7
Pressure Transducer Data Deep Canyon Well MW-34-4-32-1**

Figure 3-7 charts the upper and lower pressure transducer data and the calculated water level in the well. Table 3-4 and Figure 3-7 show the well pressure initially stabilized on June 8, 2010, six days after the well was shut in for monitoring on June 2, 2010. Prior to shut-in on June 2, 2010, Figure 3-7 shows the wellhead pressure at 11.62 psia (atmospheric pressure), downhole pressure at 250.29 psia, and water level in the well at about 294 ft bgs. By June 8, 2010, wellhead pressure had increased 1.8 psi to 13.41 psia, bottom-hole pressure had increased 20.4 psi to 270.7 psia, and the water level in the well had risen about 43 ft to 252.21 ft bgs. Table 3-4 and Figure 3-7 also show a relatively stable well pressure regime for the 8.5-year period of record through November 23, 2018 with only a slight increase in well pressure and a corresponding net water level decrease of 3.90 feet in the well. Data for this well is limited from November 23, 2018 due to an upper Level Troll transducer failure. When investigated in early 2019 after the location was accessible it was found that the surface cable for this Level Troll was damaged by what appeared to be a bear mauling. At that time the cable was repaired, the Level Troll was replaced and full function has resumed.
