**Colorado Oil and Gas Conservation Commission**

**Monitor Wells Summary Report  
2019**

**4M Project Monitoring Program  
Archuleta and La Plata Counties  
Colorado**

April 16, 2020

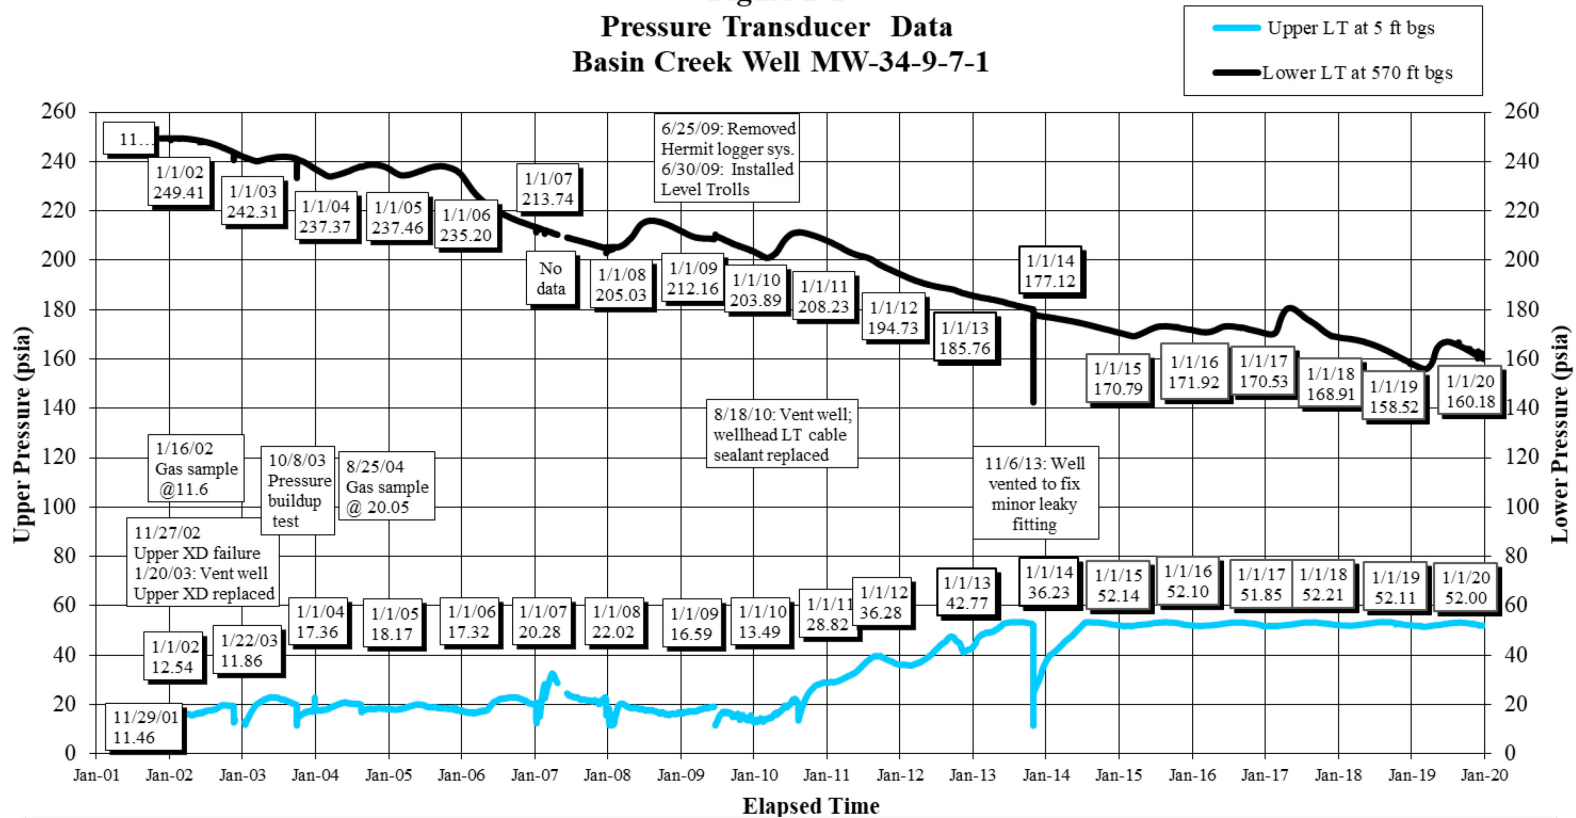
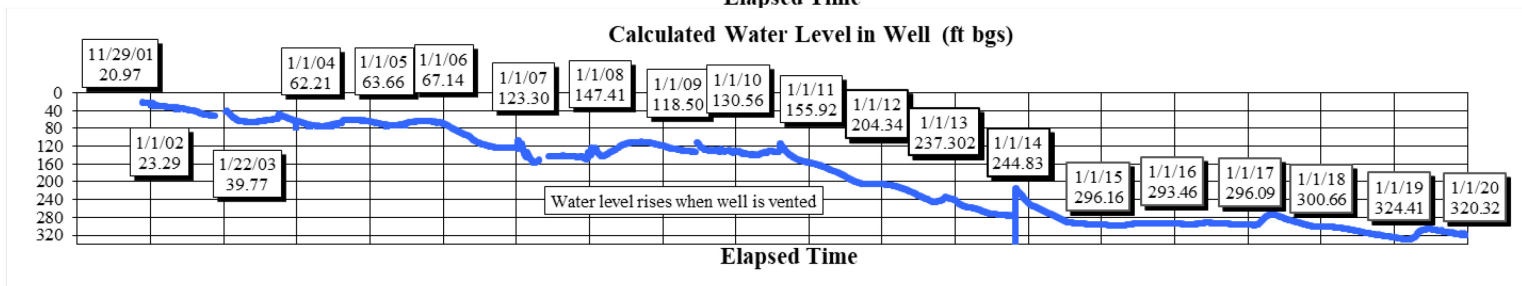
**Figure 2-1  
Pressure Transducer Data Basin Creek Well MW-34-9-7-1**

Figure 2-1 charts the upper and lower pressure transducer data and the calculated water level in the well. Table 2-1 and Figure 2-1 show a net increase of 40.65 psi in wellhead pressure for the entire 18-year period of record from November 29, 2001 (11.46 psia) to January 1, 2020 (52.00 psia). Figure 2-1 generally shows a pattern of minor seasonal fluctuations within an overall stable trend in wellhead pressure prior to wellhead cable gland seal replacement on August 18, 2010, followed by a rise in wellhead pressure to a recorded high of 53.42 psia on September 11, 2013. A very minor leak persisted so on November 6, 2013 the well was vented to allow a safe condition to repair leaking threads at the wellhead. Recovery of the previous wellhead pressure occurred for about nine months following this wellhead venting. Since

In contrast to the wellhead pressure patterns, Table 2-1 and Figure 2-1 show a substantial net decline of 299.35 feet in the calculated well water level and a corresponding net decline in downhole pressure of 89.16 psi for the period of record. Figure 2-1 also shows a pattern of slight seasonal fluctuations within the overall declining trend in the water level and corresponding downhole pressure for the period of record.

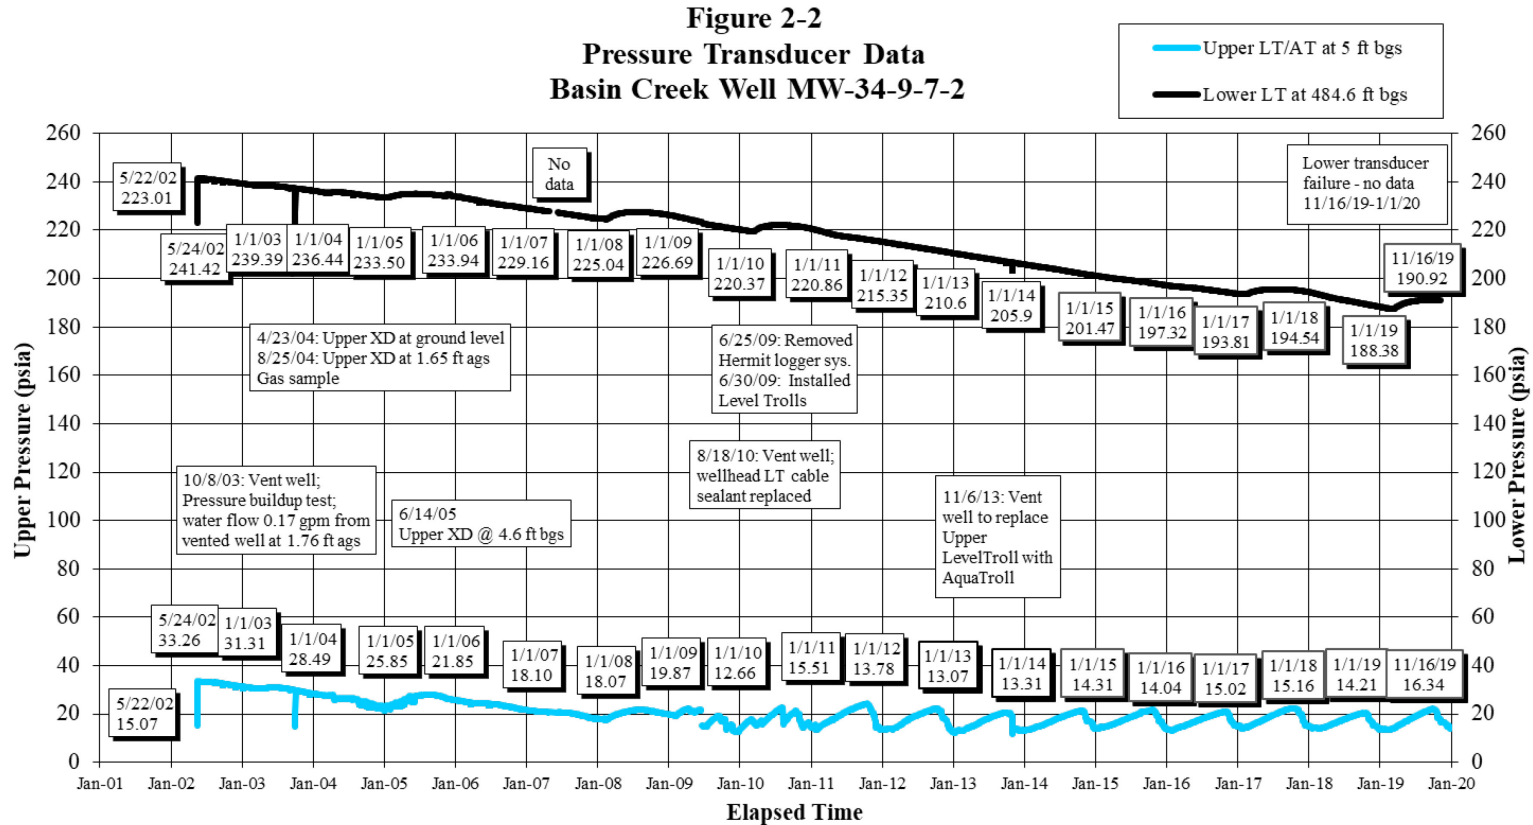
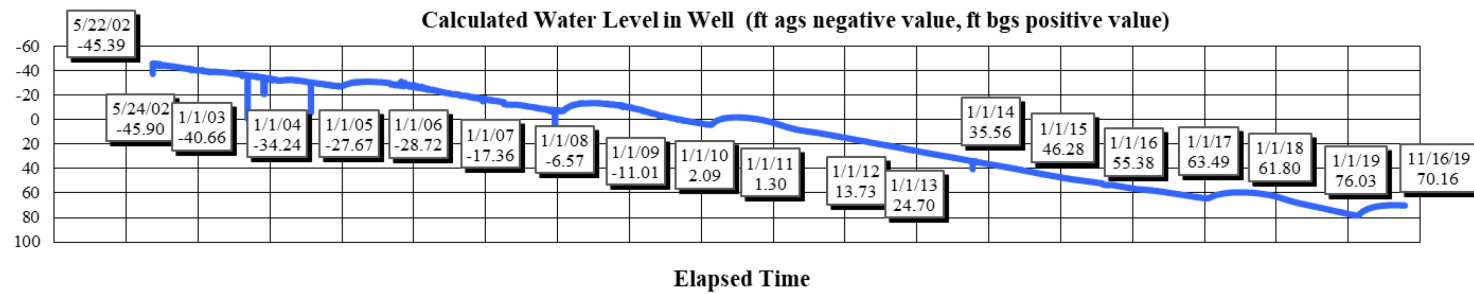
**Figure 2-2  
Pressure Transducer Data Basin Creek Well MW-34-9-7-2**

A small amount of gas was released and artesian flow (~0.2 gpm) from the well consistently occurred each time the well was vented for maintenance during the period of record between 2002 and 2010. The pressure regime documented was relatively high pressure but low volume based on the head pressure versus artesian flow. Artesian flow from the well did not occur when the wellhead was vented on August 18, 2010 to replace the Level Troll wellhead cable Conax gland sealants. The final recorded upper transducer pressure in 2011 of 13.7 PSI was very near atmospheric pressure indicating the well was essentially in hydrostatic balance. The pressure fluctuations since early 2009 suggest that ambient surface temperatures may be affecting the gas pressure as measured by the upper transducer. In order to attempt to distinguish water pressure versus gas pressure being recorded by the upper transducer, the Level Troll was replaced by an Aqua Troll, which records specific conductance (SC) in addition to pressure and temperature. The concept was that if water was present at the Aqua Troll, it would record an SC value greater than zero. If a value of zero was recorded for SC, then a pressure greater than atmospheric pressure would be gas pressure only. The Aqua Troll was installed on November 6, 2013, but it appears by this time the static water level in this well had dropped from the near-surface balance of 2009-2011. 2017 brought a change in trend of the downhole pressure; it increased slightly throughout the first half of 2017, plateaued and then continued to decrease in the linear trend followed since mid-2011. This was a similar trend as observed in 2010. 2019 data demonstrated a groundwater recharge response to the very wet winter of 2018-2019, similar to that observed after the wet winters of 2007-2008, 2009-2010, 2016-2017.

Substantial water level decline has been documented in this well, going from artesian flowing with a calculated shut-in head of approximately 53 feet above ground surface just after construction to 76.03 feet below ground surface on January 1, 2019. This calculated water level data set has been verified by a manual open-well water level measurement on November 6, 2013 of 40.20 ft bgs used as a calibration point for water level calculation using the lower Level Troll data within fifteen minutes on the same date of 40.46 feet below ground surface.

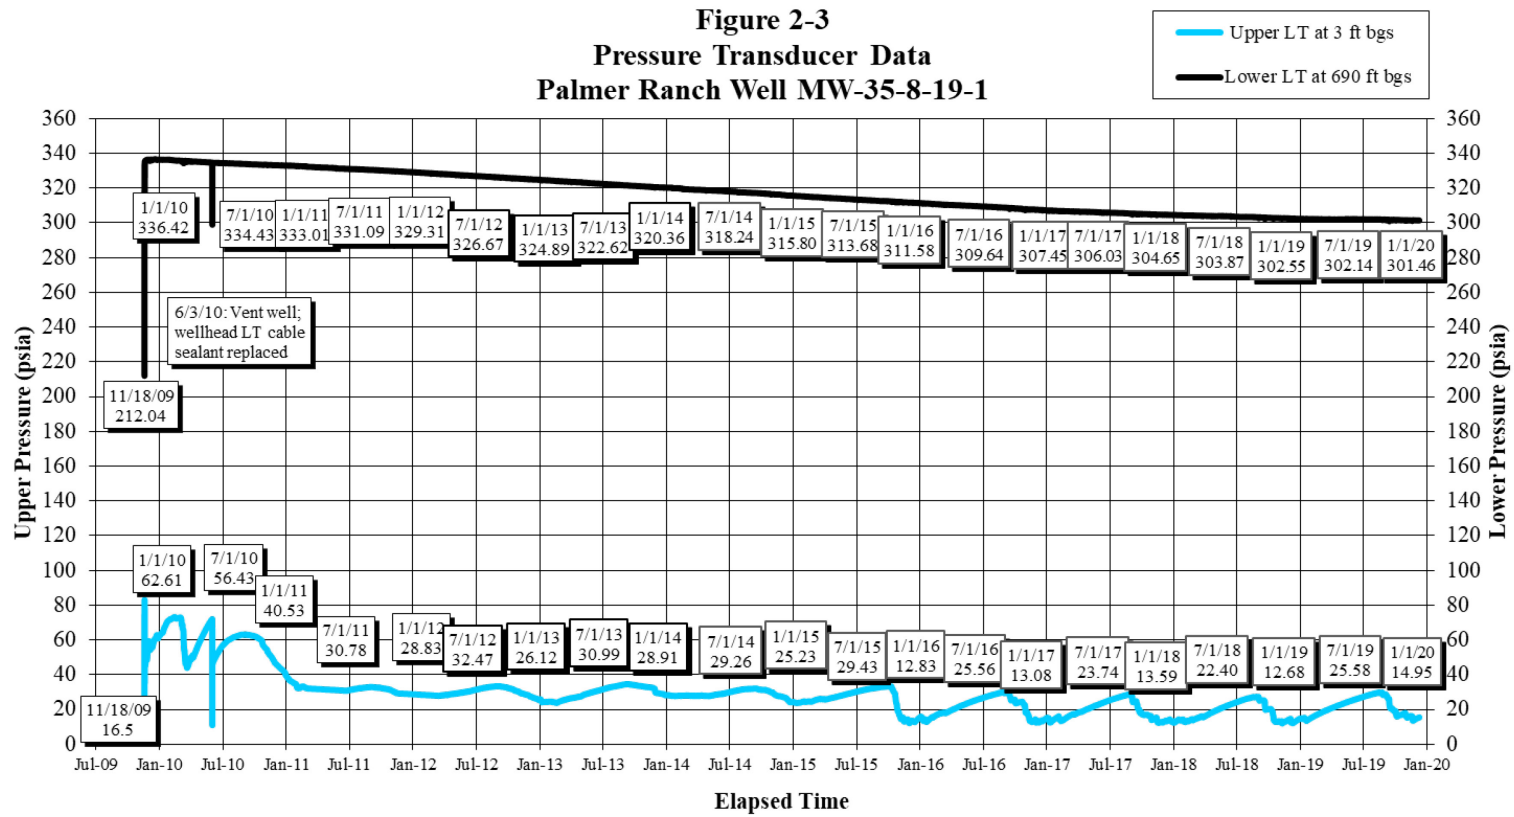
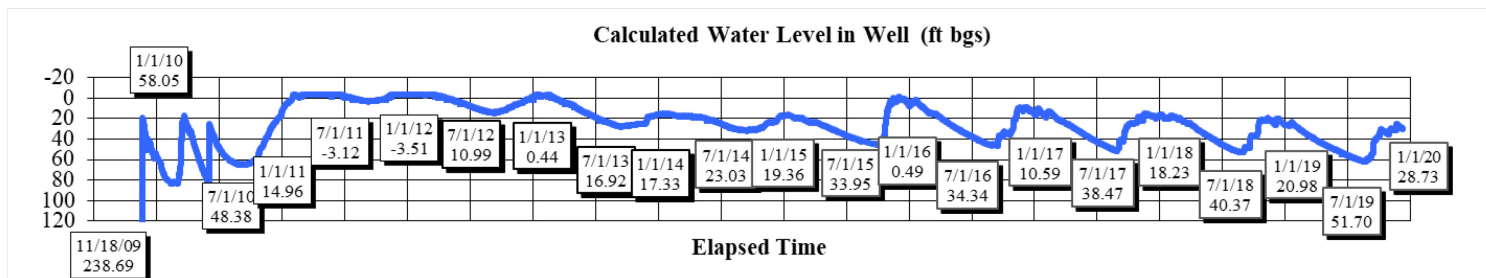
**Figure 2-3  
Pressure Transducer Data Palmer Ranch Well MW-35-8-19-1**

the well has been demonstrating an apparent increased response to seasonal groundwater level changes, increased local groundwater production effects or coal seam reservoir pressure fluctuations. The Florida River runs immediately adjacent to the well and flows are significantly impacted by agricultural irrigation schedules, which may have both direct and indirect effects on observed Fruitland coal seam reservoir pressure and water levels.

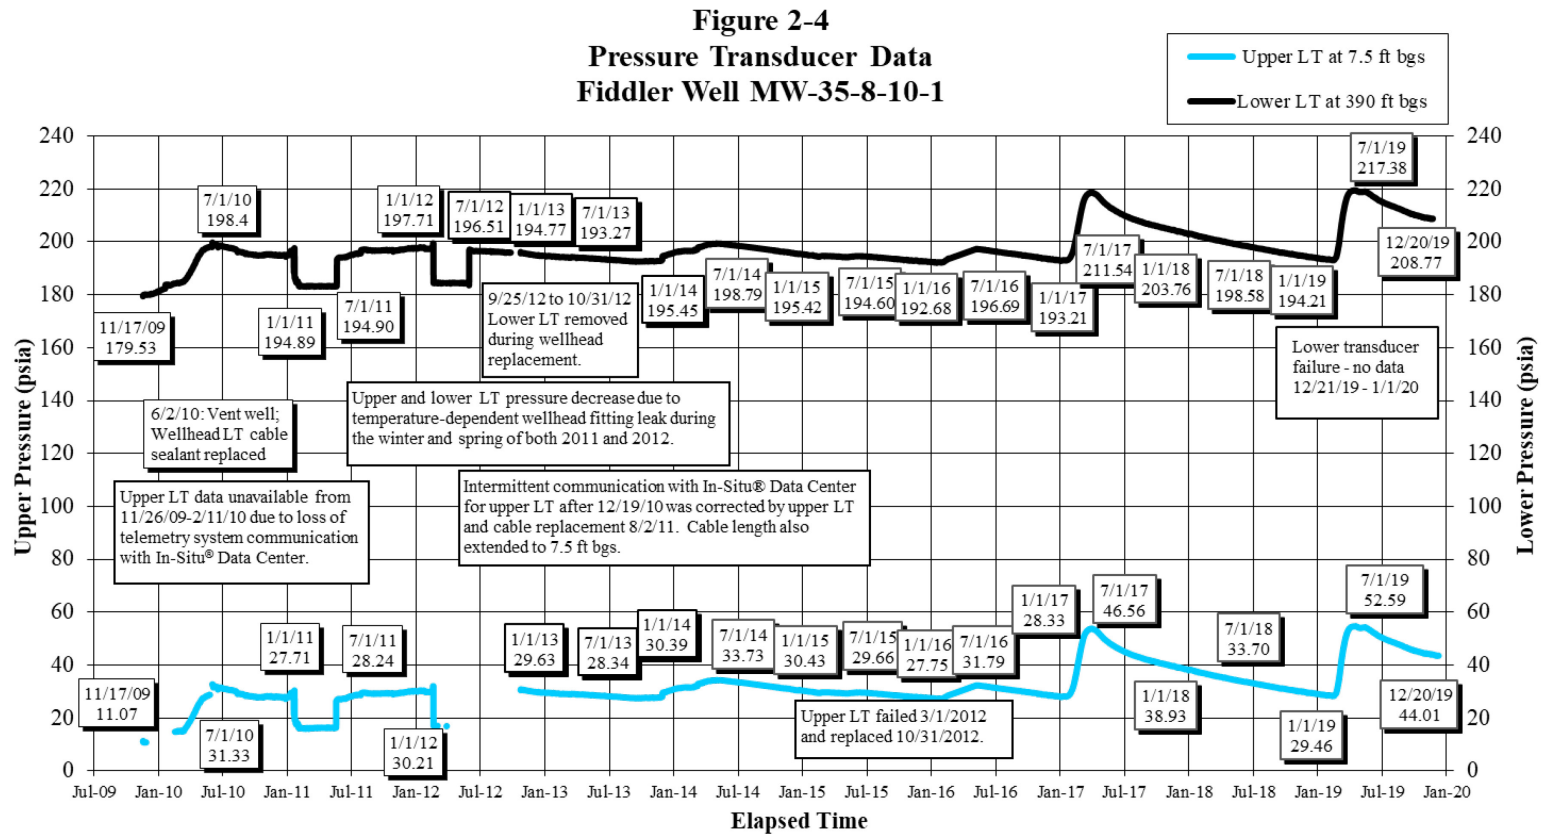
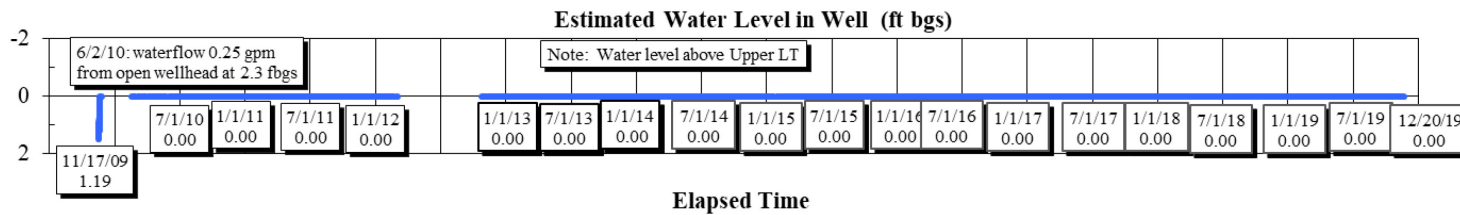
**Figure 2-4  
Pressure Transducer Data Fiddler MW-35-8-10-1**

Monitoring data for MW 35-8-10-1 are plotted in Figure 2-4. The net change in wellhead pressure is 29.17 psi and the net change in downhole pressure is 24.47 psi for the 10-year period of record. As Figure 2-4 shows, both the wellhead pressure and downhole pressure steadily increased from installation on November 17, 2009 to early June, 2010. This well has seen moderate fluctuation in the pressure regime, however instrumentation problems and wellhead leakage occurred until 2013. These issues are discussed below.

As noted on Figure 2-4 the lower Level Troll was removed during wellhead maintenance on September 25, 2012 and reinstalled on October 31, 2012. A net water level change was not calculated because the upper transducer is below the water level in the well. Figure 2-4 documents a natural flow rate from the well at a rate of 0.25 gallons per minute (gpm) when the well was vented for maintenance on June 2, 2010. At the time of the well inspection on October 31, 2012, the flow rate was measured at 0.14 gpm. For charting purposes, the water level in the shut-in well is estimated to be at or near ground surface above the upper pressure transducer (set at 7.5 ft bgs).

Also noted on Figure 2-4, telemetry system communication with the In-Situ<sup>®</sup> Data Center for the upper transducer was lost from November 26, 2009 through February 11, 2010 due to cable connection problem and was intermittent from December 19, 2010 to January 1, 2011. The upper transducer and cable were replaced during the 2011 well inspection and the cable length was extended from 3 ft bgs to 7.5 ft bgs. Additionally, a wellhead fitting leak during the winter and spring of 2011 through the summer of 2012 caused a pressure decrease observed on both the upper and lower transducers. Related to the freeze-thaw cycles the upper transducer failed again March 1, 2012. Inspection of the wellhead on June 6, 2012

revealed the minor water leak at an estimated flow rate of 0.1 to 0.2 gpm. Evidence of the wellhead freezing and then popping the wellhead seal is observed by the minor pressure spiking on both transducers in January 2011 and February 2012. The tubing head threading was cleaned in an attempt to achieve a pressure tight seal at the mandrel head, but both the rubber seals and threading had deteriorated significantly. Documentation was conducted for a later wellhead replacement. Souder Miller Associates supervised installation of the new wellhead on September 25, 2012, which required removal of all instrumentation from the well. Rather than reset the instrumentation at that time, it was planned to remain out of service until the well inspection conducted by COGCC, Norwest and In-Situ, Inc. on October 31, 2012. During that well inspection the upper transducer was replaced with a new 100 psia Level Troll. Also, as planned, the lower transducer and cable was reset, however the new set depth was approximately 15 feet deeper than the previous set depth, so the proper offset has been incorporated into the lower transducer data in Figure 2-4.

Since mid-2014, the Fiddler monitoring well showed a fairly steady decline in bottom-hole and wellhead pressure of approximately 6 psi through January 1, 2016. However, bottom hole and wellhead pressure measurements show a steady increase of approximately 5 psi from late February 2016 through May 2016. This could have been a response related to temporary shut-in of one or more nearby coal bed methane production wells. A similar pressure decline trend as the 2014-2015 resumed in June 2016.

2017 demonstrated a substantial pressure build-up measured on both the upper and lower transducers. It appears to represent significant groundwater recharge to at least one, if not all of the five Fruitland coal seams monitored in the Fiddler well following the wet winter of 2016-2017. This effect is observed again with similar magnitude following the very wet winter of 2018-2019.

Specifically, all site instrumentation enclosure desiccants will be replaced. Additionally, the Fiddler well (MW 35-8-10-1) will be visited for troubleshooting to determine the cause of the missed telemetry data reporting by the lower transducer in late 2019. The lower transducer and/or cable will be replaced as necessary to return full data collection at this location.

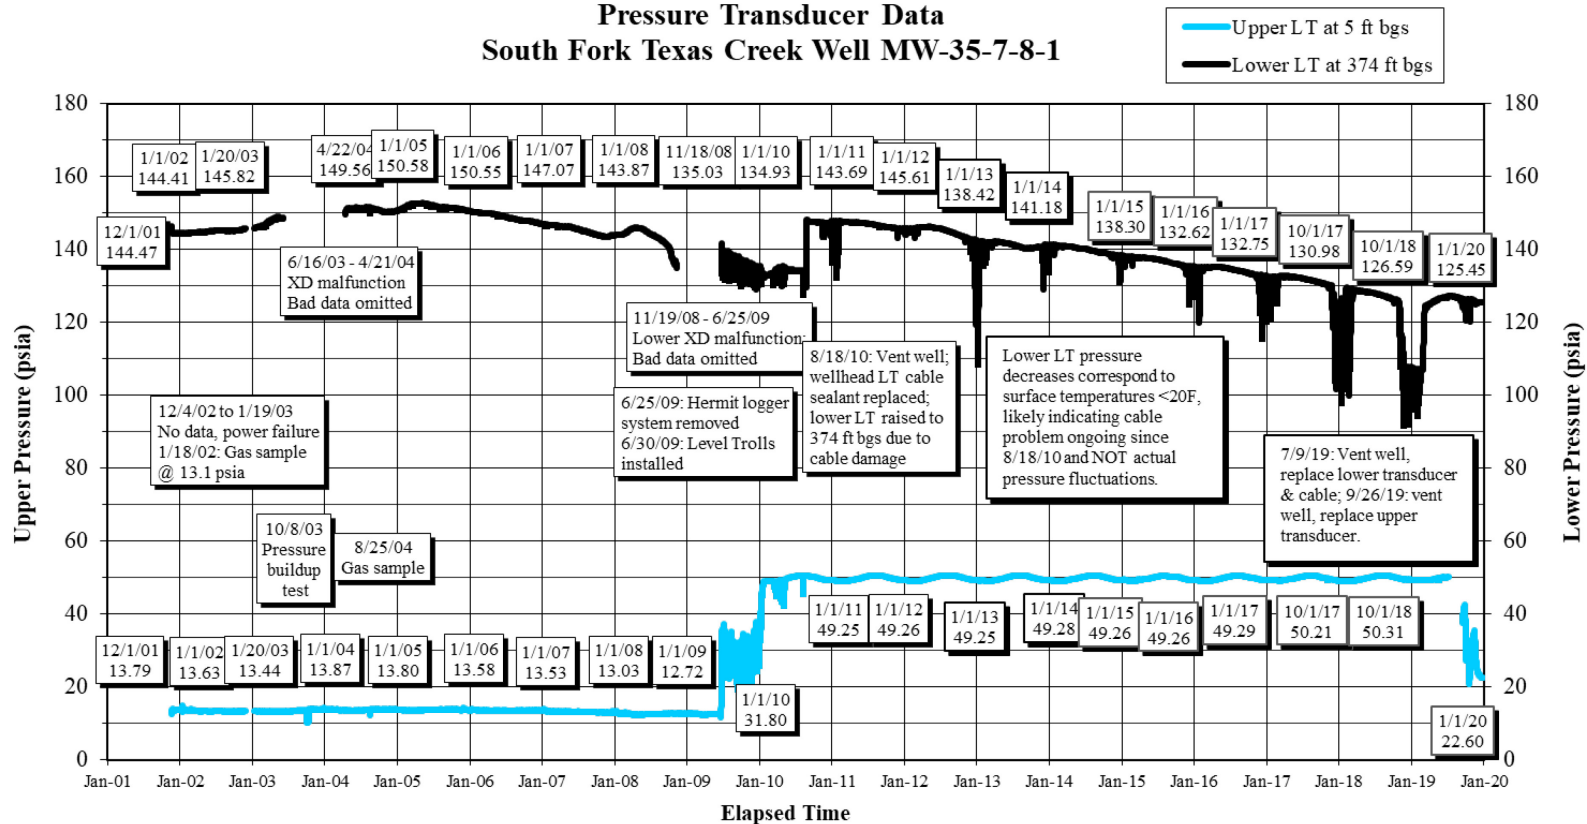
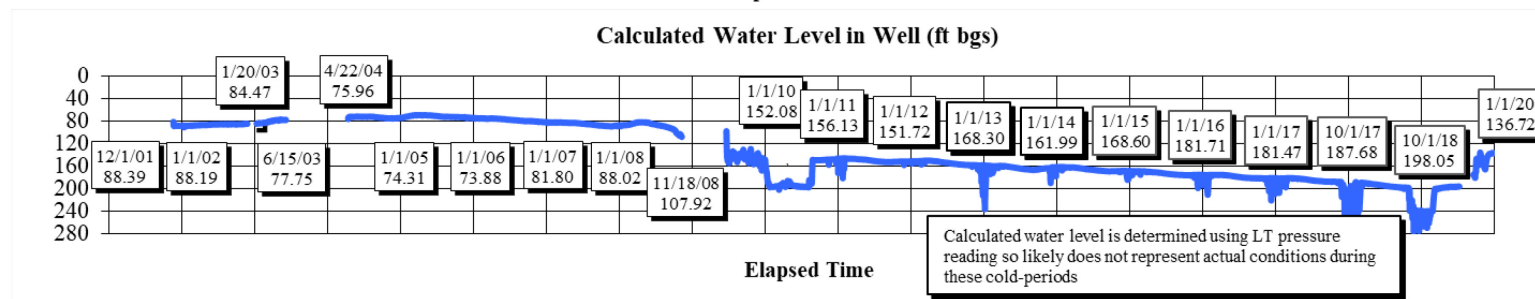
**Figure 2-5  
Pressure Transducer Data South Fork Texas Creek Well MW-35-7-8-1**

and cable were replaced as planned to address the cold weather pressure spikes. Initial data from December 2019 seems to indicate the pressure fluctuations, while minimized compared to the past four years, continue to persist. Since the well was blown down for the instrument replacement, the wellhead pressure has remained approximately 30 psi below the previous fairly static observed pressure for the previous approximate ten years. This pressure likely represented gas trapped in the wellbore above fluid level which after release has yet to build to the previous pressure.

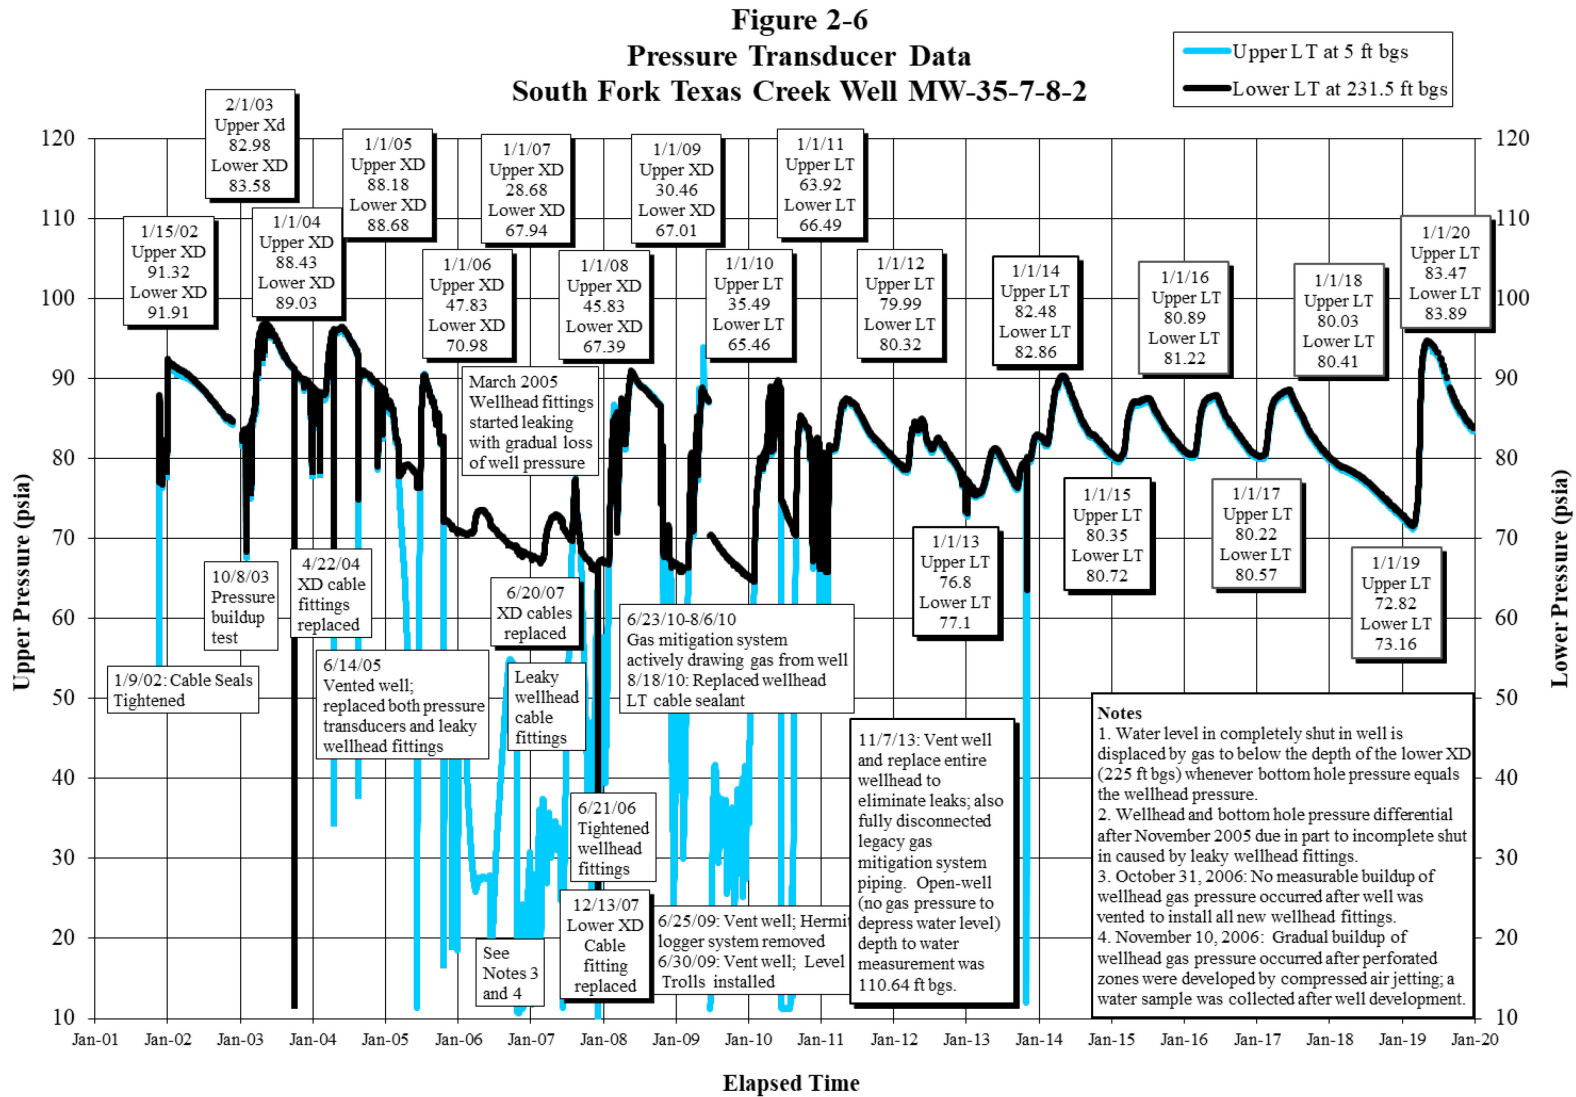
**Figure 2-6**  
**Pressure Transducer Data South Fork Texas Creek Well MW-35-7-8-2**

Figure 2-6 charts the pressure data for well MW 35-7-8-2, which exhibits an entirely different pressure regime than the deeper monitoring well MW 35-7-8-1. Figure 2-6 shows nearly equal wellhead and downhole pressures for the period of record when the well is completely shut in. For example, wellhead and downhole pressures recorded on January 1, 2020 were 83.47 psia and 83.89 psia respectively under shut-in conditions. Based on the period of record to date, incomplete well shut-in is indicated whenever the well pressure drops below about 70 psia.

Figure 2-6 shows a fairly rapid increase in well pressure after the well was shut in on August 18, 2010. The peak build-up pressure of about 85 psia on September 28, 2010 was followed by an erratic decline in well pressure. The inspection of the well in 2013 documented a minor fitting leak at that time; this was a consistent leak on a pipe fitting that has been attempted to be tightened in the past years but required significant replacement of numerous wellhead fittings. The colder air temperatures occurring with early winter of 2012 and again in 2013 appeared to cause some erratic pressure fluctuations documented with the upper and lower transducers in Figure 2-6. This seemed to indicate that the leak was becoming more significant. On November 7, 2013 a site-specific follow-up trip was conducted to repair the leak that had been most recently documented on September 30, 2013. The well gas pressure was allowed to safely bleed down, with continuous gas detector monitoring. Both upper and lower Level Trolls were removed from the well and the wellhead was completely removed down to the 2-inch line pipe that is the well

A fairly consistent well pressure trend was observed for the previous four years, 2014 – 2017, whereby the well pressure builds in the first two quarters of the year and then falls off during the second two quarters. This trend may be documentation of seasonal effects of groundwater recharge and discharge, natural or otherwise. As 2018 was documented with extreme drought conditions, it appears that the monitored interval did not receive the typical magnitude of recharge. The pressure trend continued to decrease during the usual recharge period of early 2018, with minimal superimposed recharge noted as a slight reversal in the pressure curve character. The excessively wet winter of 2018-2019 appears to have caused a substantial well pressure increase in the late winter and early spring of 2019, with the usual pressure fall-off occurring following for the remainder of the year.

casing extending up from the cement pad. The threads were reconditioned with a hand-operated 2-inch pipe die. The wellhead was reconstructed using all new carbon steel pipe fittings, with the exception of the Conax compression fittings secured around each Level Troll Rugged Cable, as they had not been documented as leaking. Several manual water level measurements were taken while the wellhead was open. Initially, the water level recovered fairly quickly as the gas pressure was vented. After approximately 2.5 hours open during the new wellhead installation, the water level was relatively stable and measured 110.64 ft bgs. This is the static water level when no gas pressure is allowed to depress the water column in the well. As can be seen in Figure 2-6, the upper and lower Level Troll pressure readings diverge at this time indicating that for the short period following well shut-in the lower Level Troll was actually submerged in water. The lower Level Troll pressure reading was approximately 63.6 psia, which calculates to 111.06 ft bgs. This gives good confidence in the calculated versus measured water level in this well, given error in the assumption of atmospheric pressure which is not currently recorded at this location. To prevent damage to the existing lower Level Troll cable, the Conax compression fitting was not adjusted to offset the new wellhead's increased height above ground surface of 0.25 feet, so the new set depth is 231.25 ft bgs. No leaks have been detected at this wellhead since the replacement.

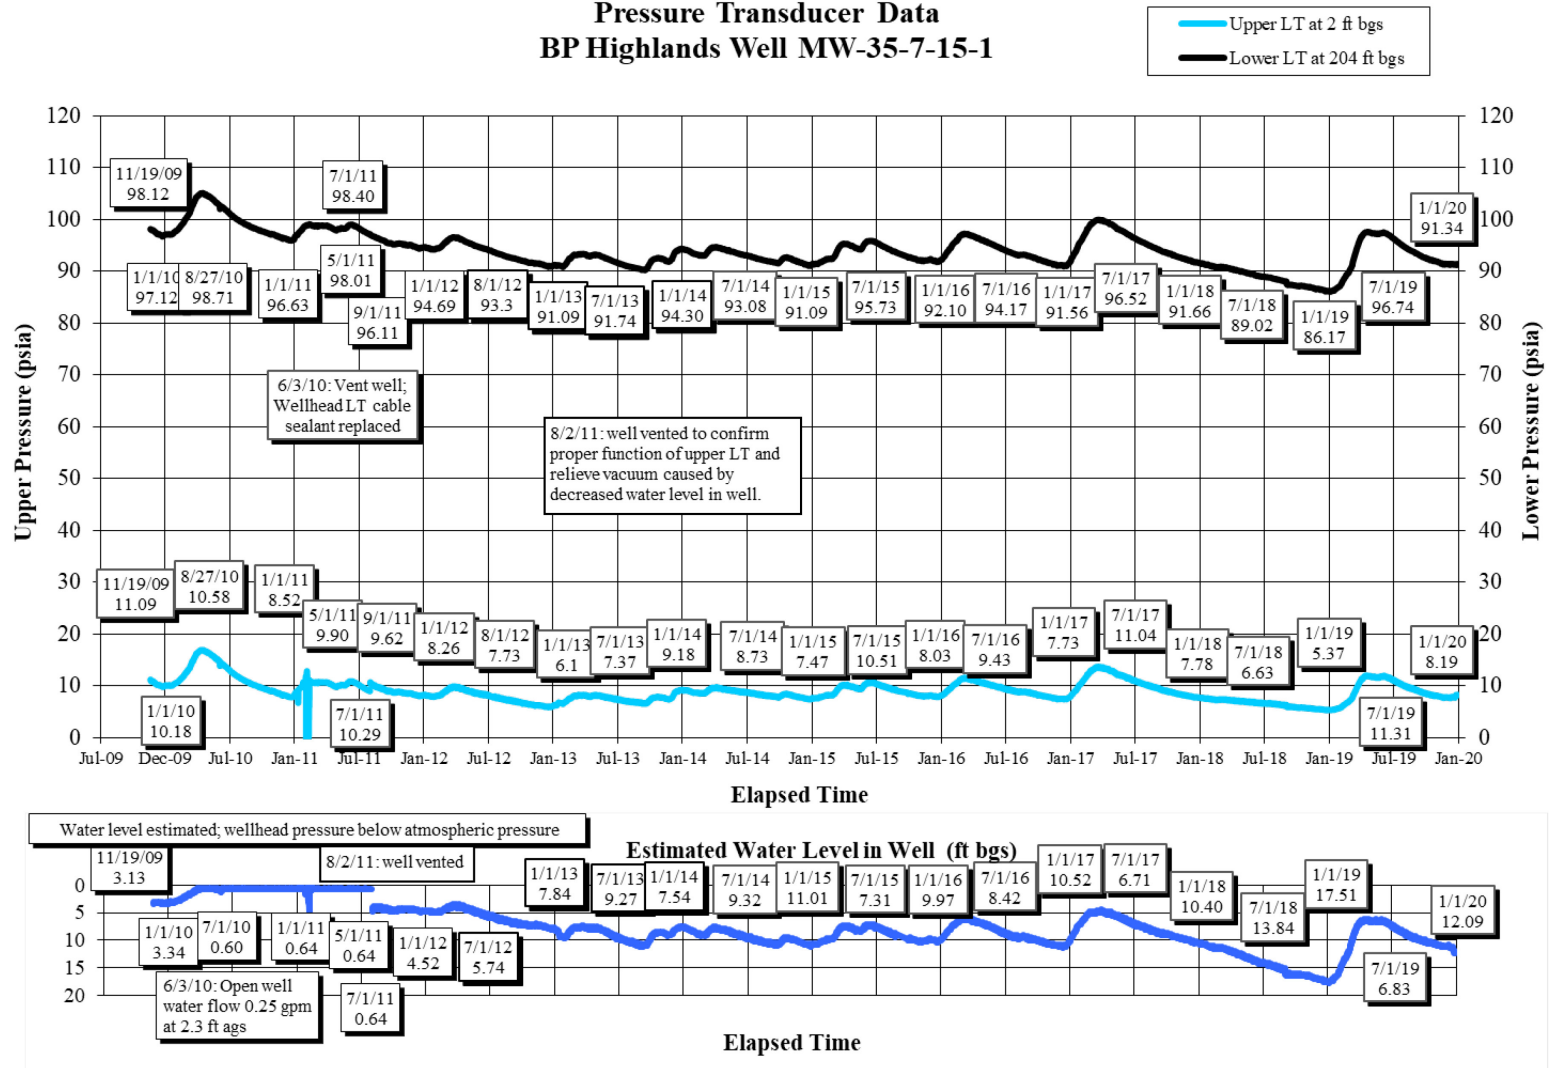
**Figure 2-7  
Pressure Transducer Data BP Highlands Well MW-35-7-15-1**

Monitoring data for MW 35-7-15-1 are plotted in Figure 2-7. As summarized in Table 2-5 for the 10-year period of record, the net change in downhole pressures is a decrease of 6.78 psi. The well follows an overall decreasing pressure trend with seasonal variability dominated by late winter/early spring. The net change in the calculated water level in the well is a decrease of 8.96 feet. The magnitude of this decrease was approximately doubled in 2018 due to extreme drought conditions and complete lack of observable recharge. As noted on Figure 2-7, water flowed from the well at a rate of 0.25 gallons per minute (gpm) when the well was vented for maintenance on June 3, 2010. For charting purposes, the water level in the shut-in well at that time was estimated to be slightly above ground surface with the upper transducer under water at 2 ft bgs.

The wellhead pressure started dropping below atmospheric pressure around August 12, 2010. This condition suggested either a potential problem with the upper transducer or a well pressure vacuum effect created in a completely shut-in well under declining water level conditions. A well instrumentation inspection and atmospheric pressure check conducted during each subsequent site visit through 2013 has confirmed the proper function of the upper transducer. Venting the well allowed for physical confirmation that the well was under vacuum pressure conditions which have continued through January 1, 2020.

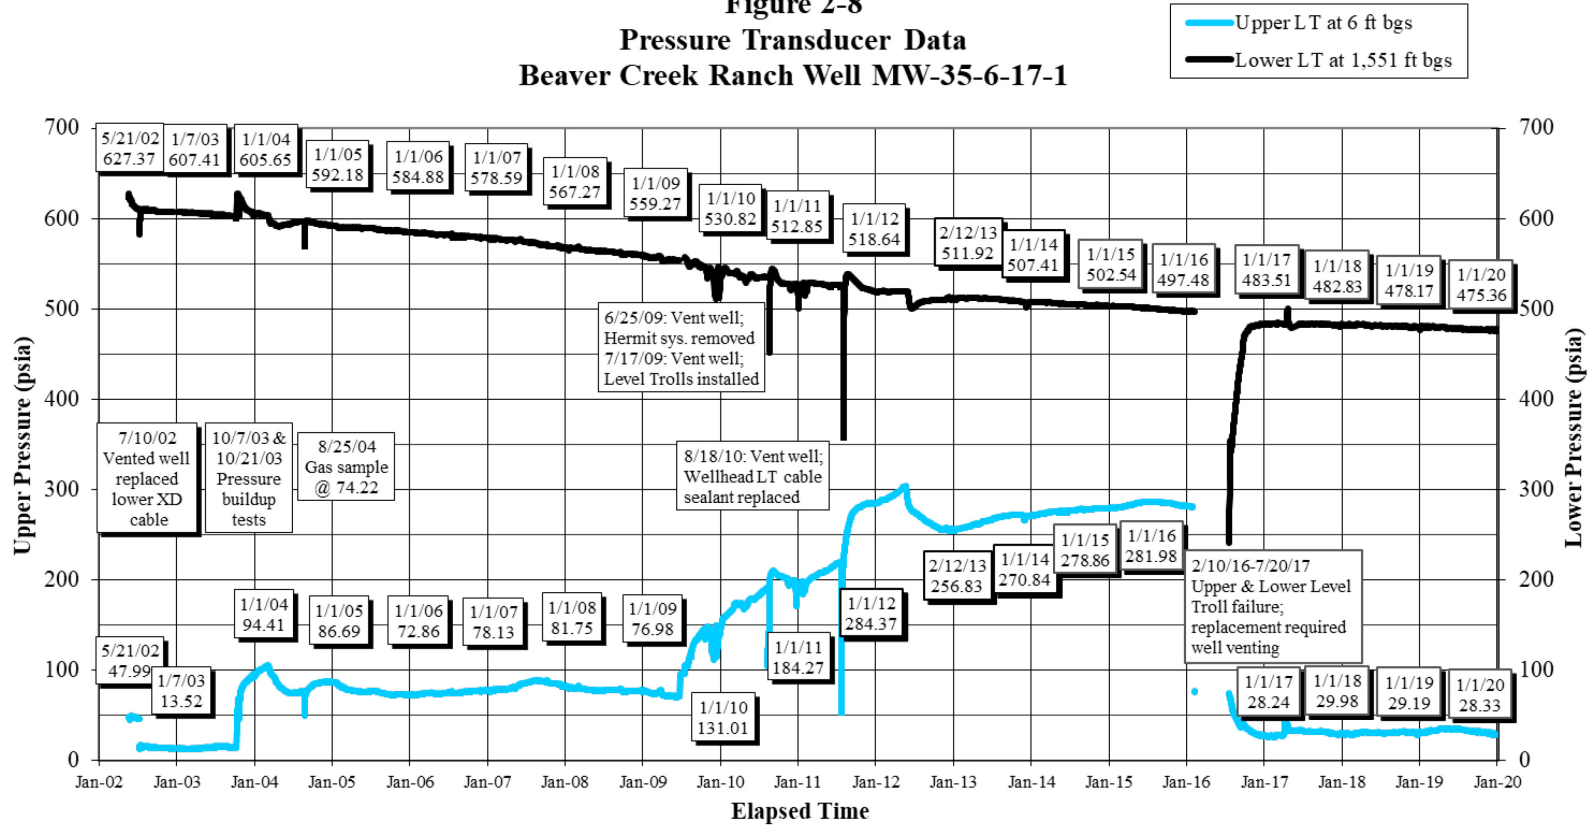
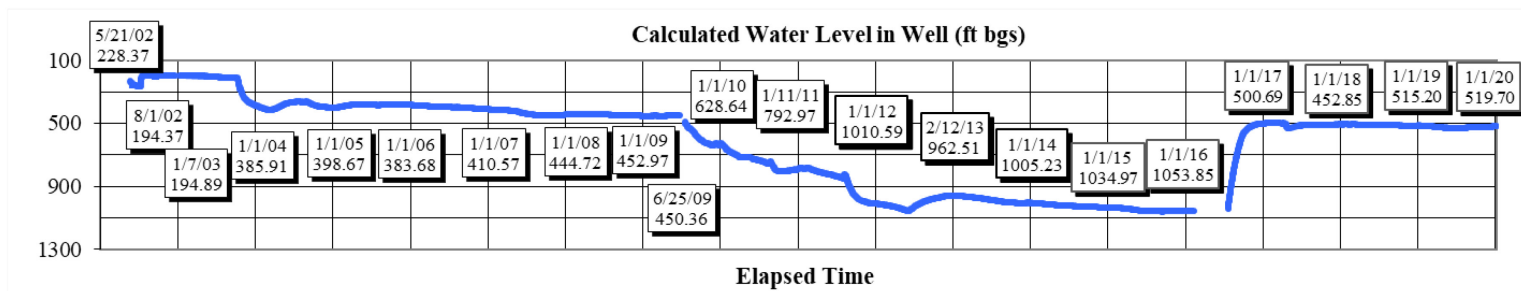
**Figure 2-8  
Pressure Transducer Data Beaver Creek Ranch Well MW-35-6-17-1**

data demonstrates that following this bleed-off the wellhead pressure has remained depressed at approximately 30 psi and relatively stable. This is likely because the water head pressure of approximately 500 feet (215 PSI) is effectively preventing significant gas build-up at the wellhead.

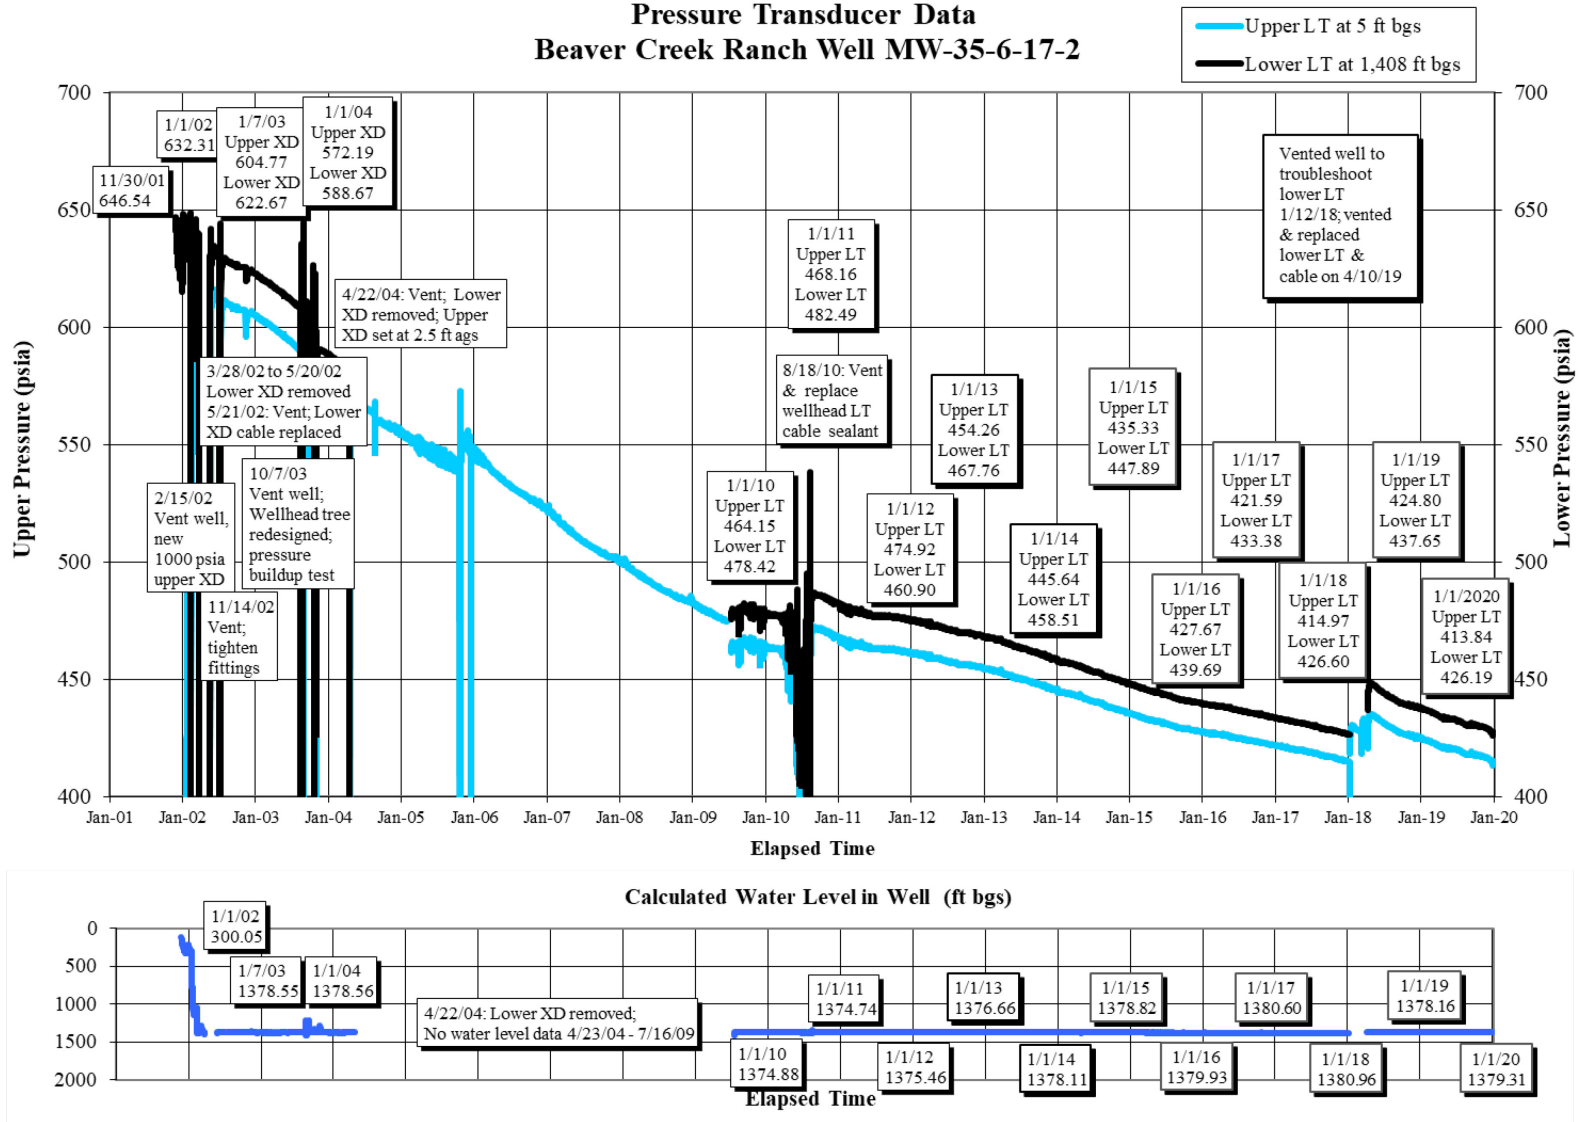
**Figure 2-9  
Pressure Transducer Data Beaver Creek Ranch Well MW-35-6-17-2**

Figure 2-9 shows the well pressure in a declining trend for the entire period record. There is a notable shift in the well pressure curve following the installation of Level Troll instruments on July 17, 2009, followed by erratic well pressure fluctuations associated with incomplete shut-in through August 17, 2010. After the well was vented August 18, 2010 to replace the Level Troll cable fitting sealants, there was a steady build-up of well pressure through early September 2010 followed by a return to a declining trend through the period of record.

As shown on Figure 2-9, no water level data is available for the 6-year period of record when there was only one well pressure transducer. Well pressure data available after installation of wellhead and downhole Level Trolls on July 19, 2009 shows very little change in the calculated water level and very little, if any seasonal influence on the overall well pressure regime, which is relatively linear decrease perhaps due to nearby coalbed methane production.

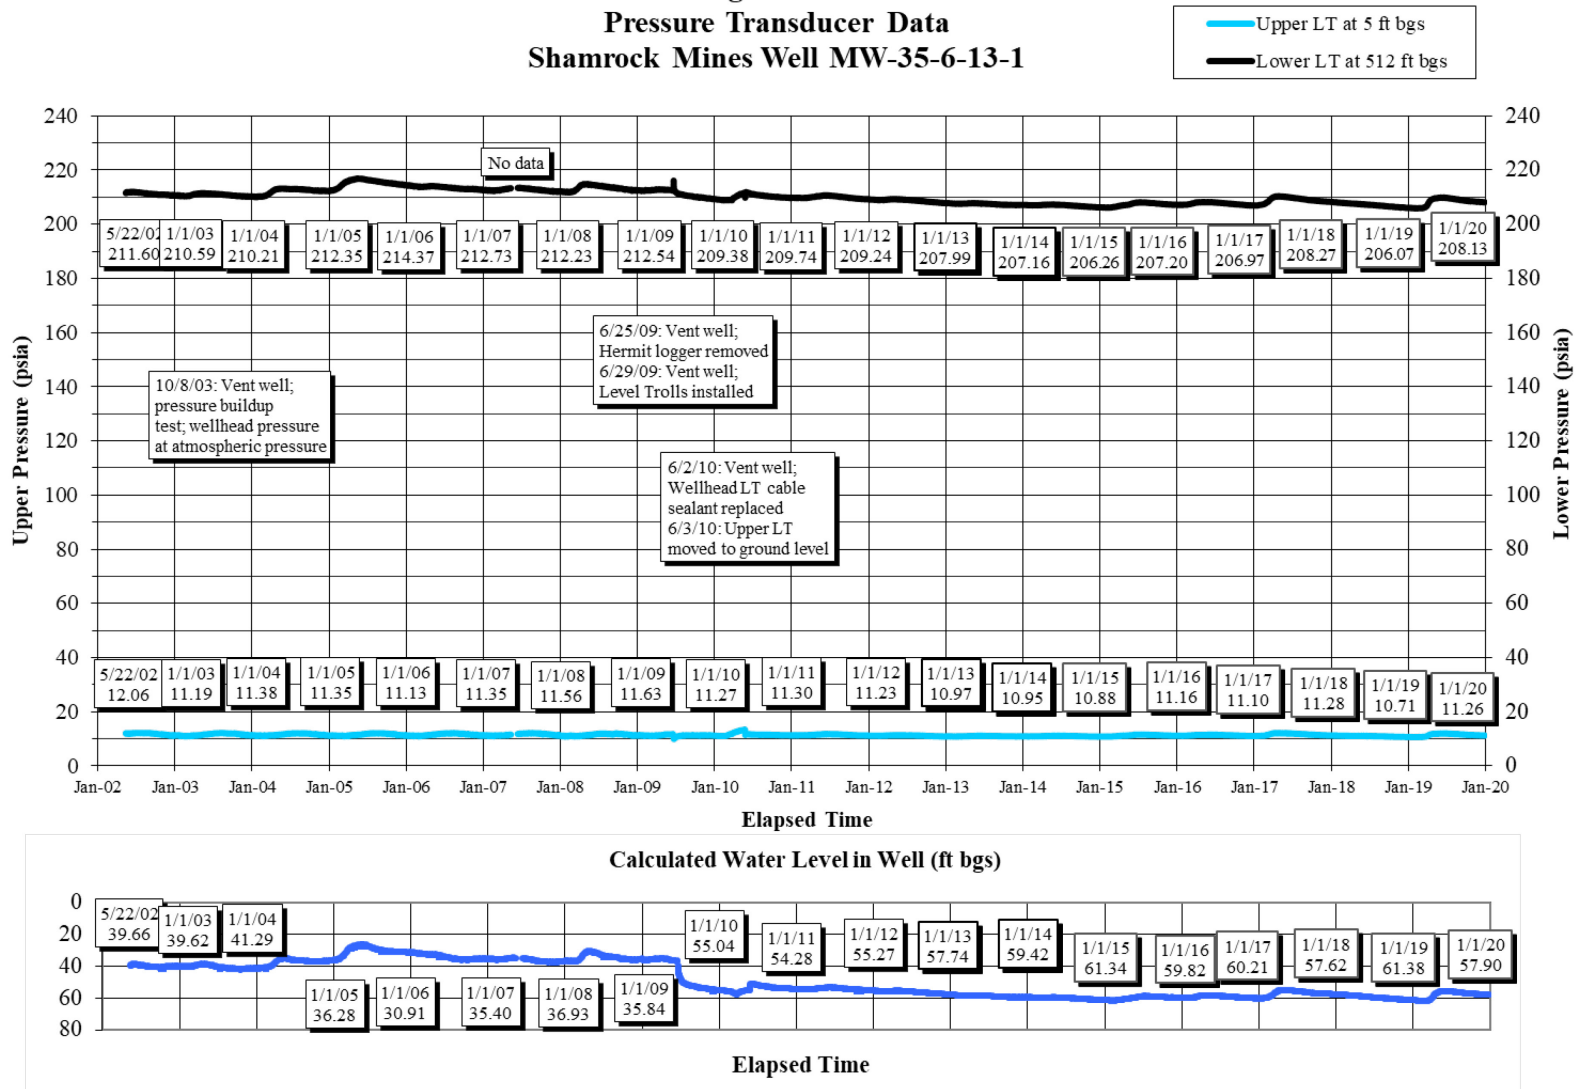
**Figure 2-10**  
**Pressure Transducer Data Shamrock Mines Well MW-35-6-13-1**

Figures 2-10 shows the wellhead pressure regime continues to be at atmospheric pressure and fluctuates within a range of 2 psi (between 10 psia and 12 psia). During the months of April and May 2010, the wellhead pressure steadily increased to around 13.4 psia. Wellhead pressure returned to the historic atmospheric pressure trend after the Level Troll wellhead cable sealants were replaced on June 2, 2010.

Figure 2-10 also shows the downhole pressure and calculated water level in the well continued to exhibit an overall declining well pressure trend for the period of record since April 2005. With wellhead pressure equal to atmospheric pressure, fluctuation of downhole pressure is associated with the fluctuation of the water level in the well. Downhole pressure and corresponding calculated water levels have documented seasonal groundwater recharge events following the wet winters of 2007-2008, 2009-2010, 2016-2017 and 2018-2019.
