**Colorado Oil and Gas Conservation Commission**

**Monitor Wells Summary Report  
2019**

**4M Project Monitoring Program  
Archuleta and La Plata Counties  
Colorado**

April 16, 2020

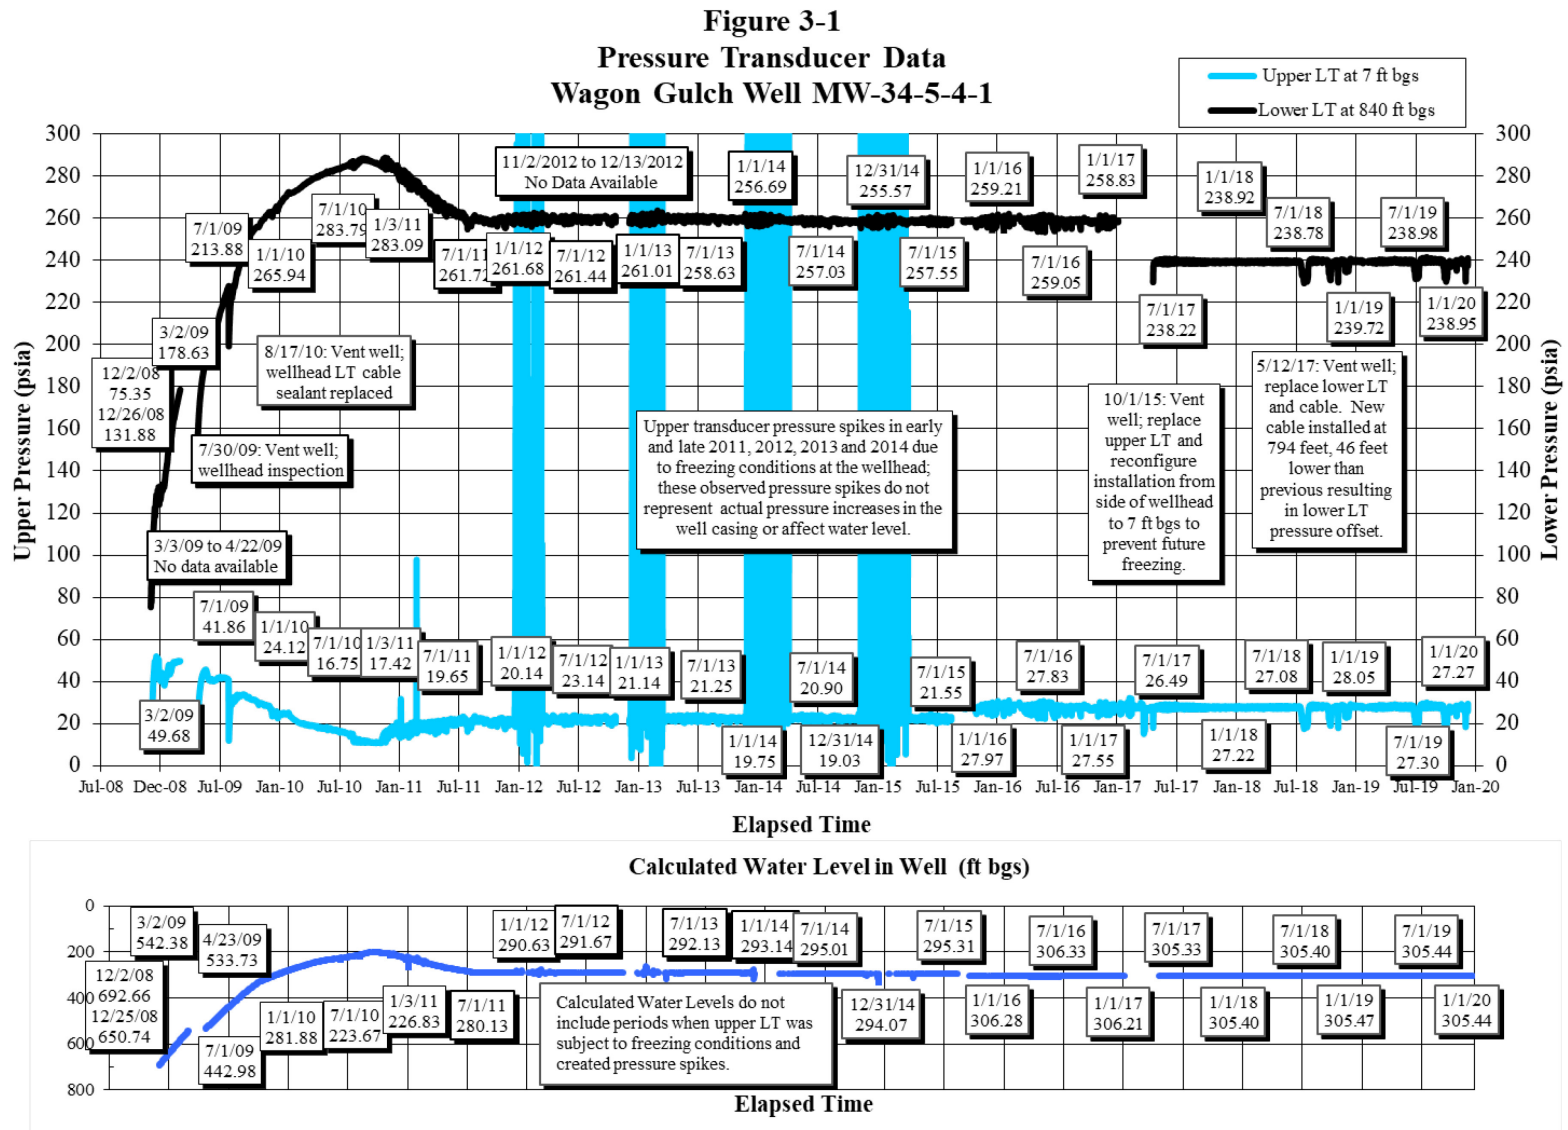
**Figure 3-1  
Pressure Transducer Data Wagon Gulch Well MW-34-5-4-1**

2008. Figure 3-1 shows the trend of rising water level with corresponding increasing downhole pressure continued in 2010 until the trend reversed in mid-September 2010. This may have been related to the transducer cable sealant being changed on August 17, 2010 and possibly eliminating a partial shut-in condition. No leaks were detected during the site inspections in 2012-2014. Between October 1, 2010 and December 31, 2010, Figure 3-1 shows the water level decreased about 21.2 feet while the downhole pressure decreased about 2.7 psia.

During the winters of 2011-2012, 2012-2013, 2013-2014 and 2014-2015 pressure spikes in the upper transducer occurred due to the pressure transducer freezing within its deployment location in the wellhead 2.3 feet above ground surface. These are not actual increases in gas pressure within the well casing, but rather caused when the air volume next to the transducer inlet is trapped and then compressed by expanding frozen water condensate. When the 2011 well inspection was conducted at MW 34-5-4-1 the well was vented to ensure that the transducer would return to atmospheric pressure; this test successfully showed that the transducer continued to function properly and was not damaged. The transducer recovered after surface temperatures warmed each spring. The transducer was inspected for damage in each subsequent site visit since this problem began in 2011 until the 2015 site inspection when the Level Troll was replaced and lowered into the well to 7 ft bgs. As evidenced by the winter 2015 data shown in Figure 3-1, the condensate freezing problem in this location has been corrected by lowering the Level Troll below the ground surface.

Several pressure decreases on the order of 10 psi were observed by both the upper and lower transducers in the second half of 2018 and again in the second half of 2019. The duration of each event was on the order of days to weeks and full recovery to static pressure conditions occurred after each event. These are possibly responses to local drilling or water production from the monitored coal seam.

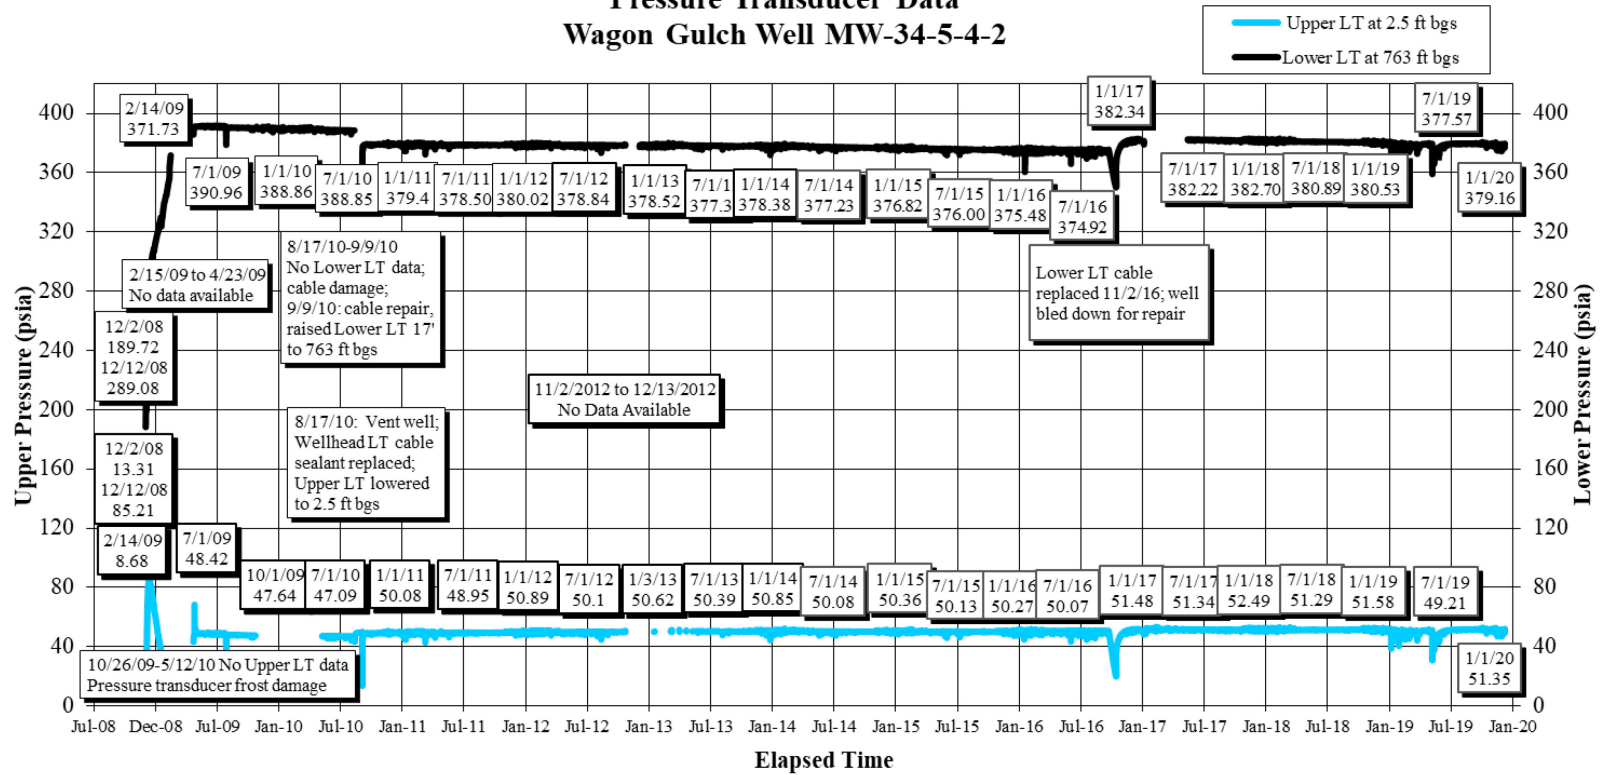
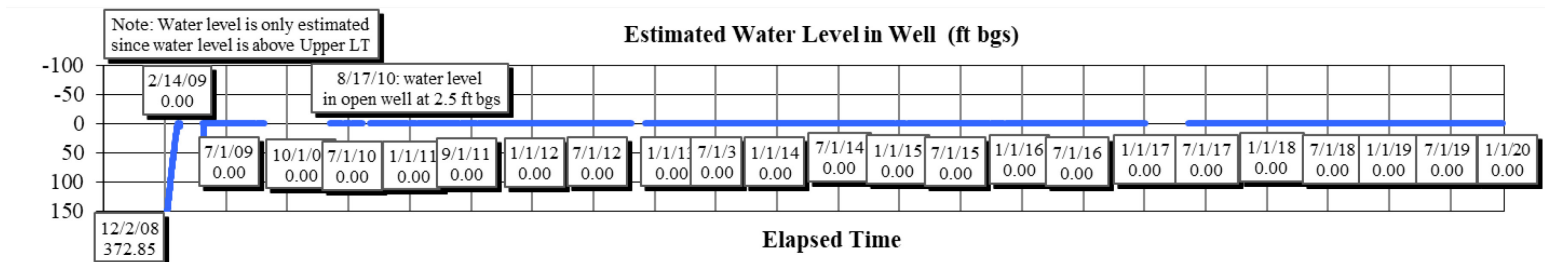
**Figure 3-2  
Pressure Transducer Data Wagon Gulch Well MW-34-5-4-2**

Figure 3-2 shows a relatively constant wellhead pressure of about 47 to 48 psia between April 24, 2009 and October 25, 2009. An erratic pressure spiking pattern between October 26, 2009 and May 12, 2010 suggested wellhead Level Troll pressure sensor freeze damage, so the data were omitted from Figure 3-2. Between May 13, 2010 and August 16, 2010, the wellhead pressure remained fairly constant at around 47 psia.

Freeze damage to the upper Level Troll pressure transducer sensor was confirmed after the well was vented on August 17, 2010. As noted on Figure 3-2, the water level inside the open wellhead was at a height of about 2.5 feet above ground level. The new upper Level Troll was changed from an external mount to an internal depth setting of 2.5 ft bgs on August 17, 2010 to protect the transducer sensor from freezing conditions. After well shut-in on August 17, 2010, Figure 3-2 shows a relatively rapid return of wellhead pressure to an average constant pressure of about 50 psia.

The lower Level Troll cable was damaged during replacement of Level Troll wellhead cable sealants on August 17, 2010. Cable repair performed on September 9, 2010 included raising the Level Troll 17 feet from 780 ft bgs to 763 ft bgs. As a result of this change, Figure 3-2 shows a shift in the downhole pressure curve to a corrected constant downhole pressure regime of 378 to 379 psia.

As noted above, the water level was inside the open wellhead at a height of about 2.5 feet above ground level on August 17, 2010. The wellhead pressure build-up after shut-in may reflect water and/or gas pressure build-up. For charting purposes, the water level in the shut-in well is estimated to be at or near ground surface above the upper Level Troll (set at 2.5 ft bgs). However, there is a possibility that the observed build-up in wellhead pressure is from gas pressure, which could result in a downward displacement of the water in the well to some level below the upper Level Troll.

The pressure regime observed in 2019, as well as for the full period of record since post-completion stabilization in 2009, has been quite stable with an overall minor decreasing trend.

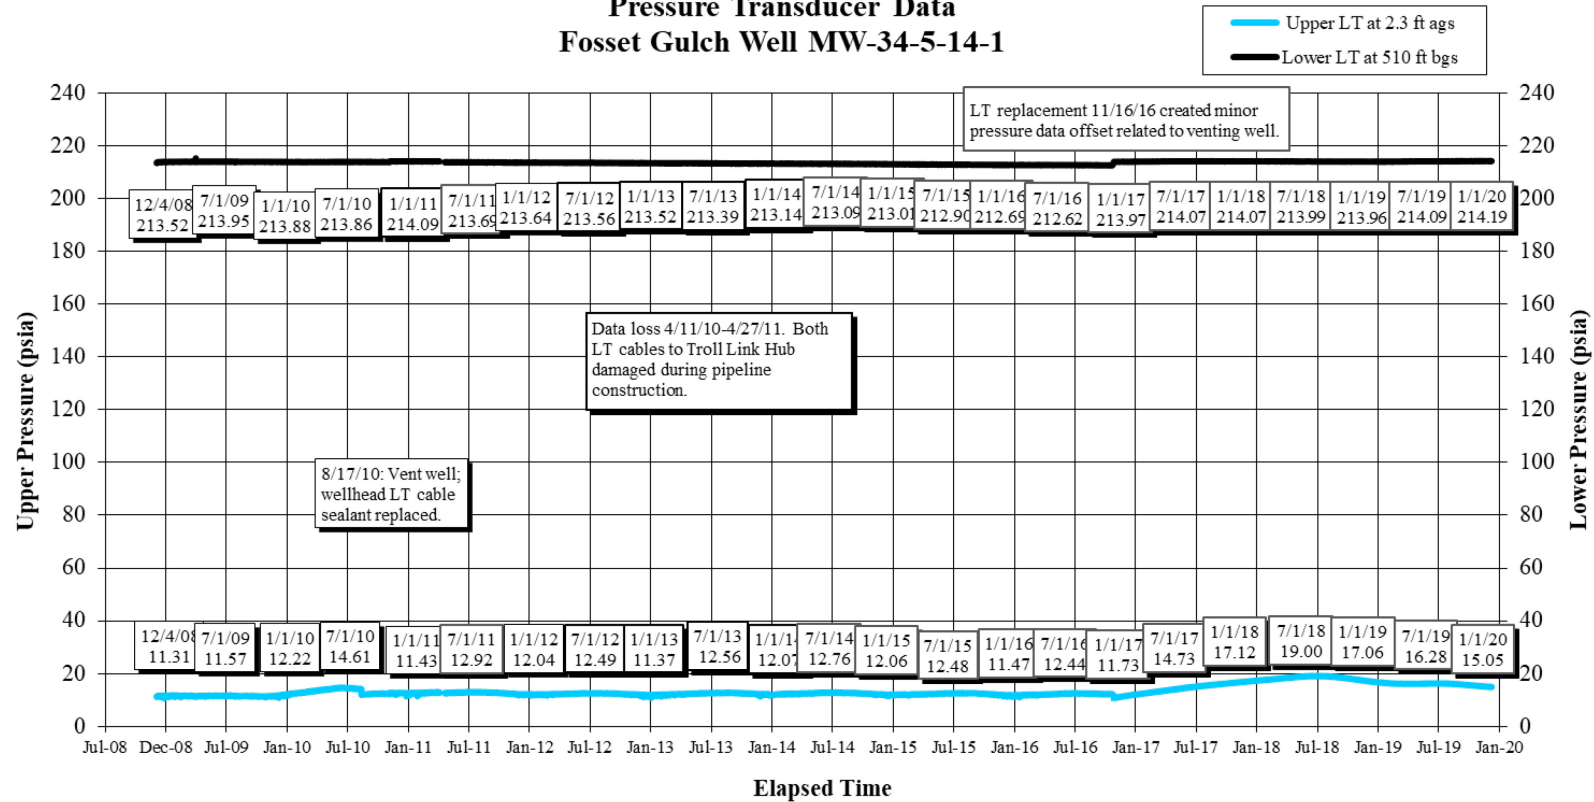
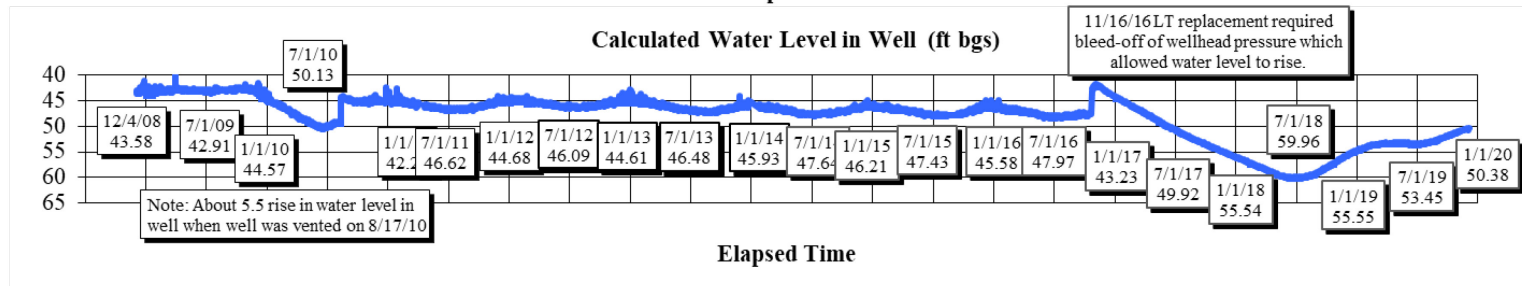
**Figure 3-3  
Pressure Transducer Data Fosset Gulch Well MW-34-5-14-1**

Figure 3-3 charts the upper and lower pressure transducer data and the calculated water level in the well. Table 3-2 and Figure 3-3 show the wellhead pressure at atmospheric pressure prior to 2010 followed by a gradual increase in pressure through August 16, 2010 to 14.19 psia. Following the August 17, 2010 well maintenance event including venting, the wellhead pressure has remained relatively constant within a normal atmospheric pressure range through November 16, 2016. At that time, upper transducer replacement required venting the wellhead. Following the maintenance, the wellhead pressure increased slowly until July 2018 when it began to trend down. This is likely a response to gas production stimulation that occurred when the well was vented. Figure 3-3 shows a stable downhole pressure trend (213.52-214.19 psia) for the entire period of record. Figure 3-3 also shows a stable water level averaging 43.0 ft bgs until November 2009, followed by a gradually declining water level trend through July 1, 2010 (50.13 ft bgs). The water level increased to 49.28 ft bgs until the well was vented on August 17, 2010. The water level immediately rose to 44.36 ft bgs when the well was vented on August 17, 2010 but has since followed apparent gentle seasonal fluctuation until November 16, 2016. At that time, the well was vented to replace the upper pressure transducer. Upon replacement, the pressure measured at the wellhead has steadily increased from approximately 12.20 psi to 17 psi on January 1, 2019 and then changed to a decreasing pressure trend. As such, the calculated water level was in steady decline during this time period as gas pressure has apparently depressed it. Likewise, with the 2018 reversal of the wellhead gas pressure

increase trend to a decreasing trend, the calculated water level is now shown to be increasing through 2019.

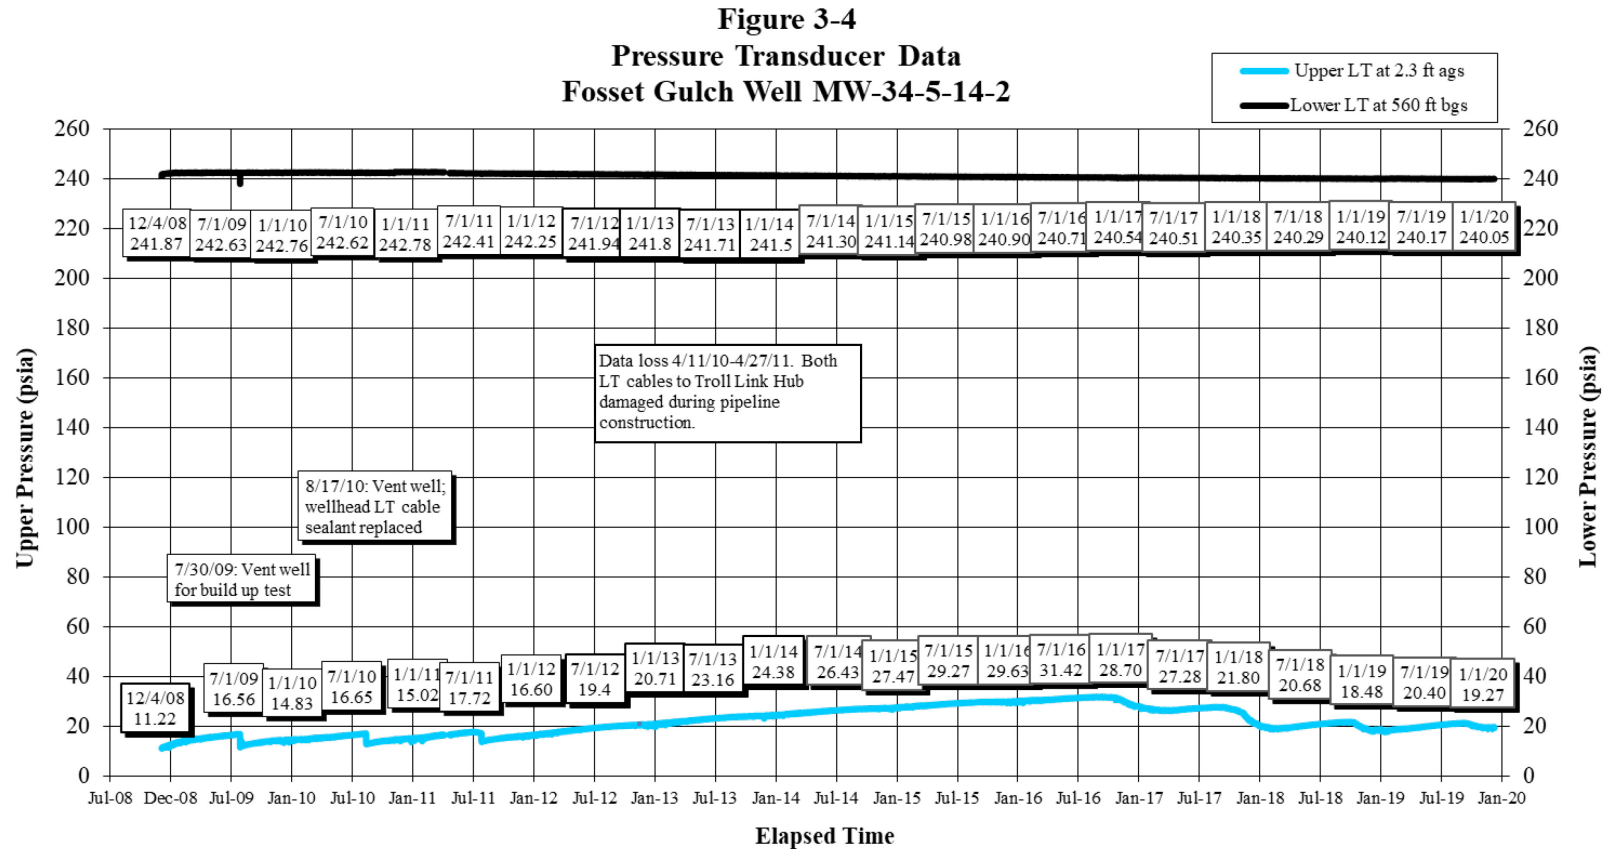
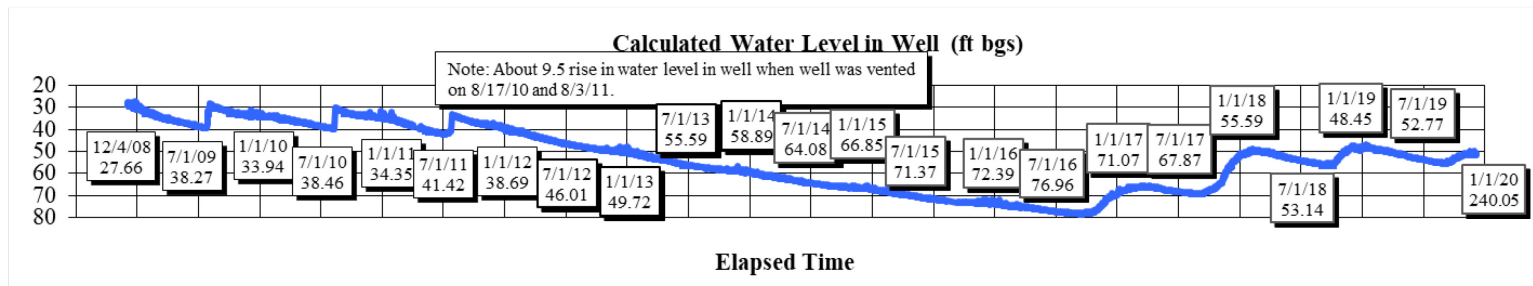
**Figure 3-4  
Pressure Transducer Data Fosset Gulch Well MW-34-5-14-2**

Figure 3-4 plots the upper and lower pressure transducer data and the calculated water level in the well. Although the well was shut in for monitoring on December 4, 2008, wellhead pressure did not stabilize at about 17 psia until July 2009. Table 3-2 and Figure 3-4 show a net increase of 7.13 psi in wellhead pressure for the period of record between December 4, 2008 (11.35 psia) and January 1, 2019 (18.48 psia). Figure 3-4 shows a stable but slightly declining downhole well pressure trend for the entire period of record, with fluctuations ranging between a minimum pressure of about 240.12 psia to a maximum pressure of 242.78 psia. The downhole pressure was 240.05 psia on January 1, 2020.

Table 3-2 indicates a net water level drop of 11.09 feet in the well as of January 1, 2020. However, Figure 3-4 shows that the wellhead pressure and water level on January 1, 2019 has possibly shown an effect of venting MW 34-5-14-1 for maintenance on 11/16/16. This would suggest some amount of hydraulic connection between the two wells. Although there is an immediate drop in wellhead pressure and corresponding rise in the water level each time the well is vented to the atmosphere in the past, Figure 3-4 also shows the build-up in wellhead pressure takes approximately 12 months to return to the pressure exhibited prior to each venting event so unless required for servicing the instrumentation, the well will not be vented in attempt to determine the static wellhead pressure.

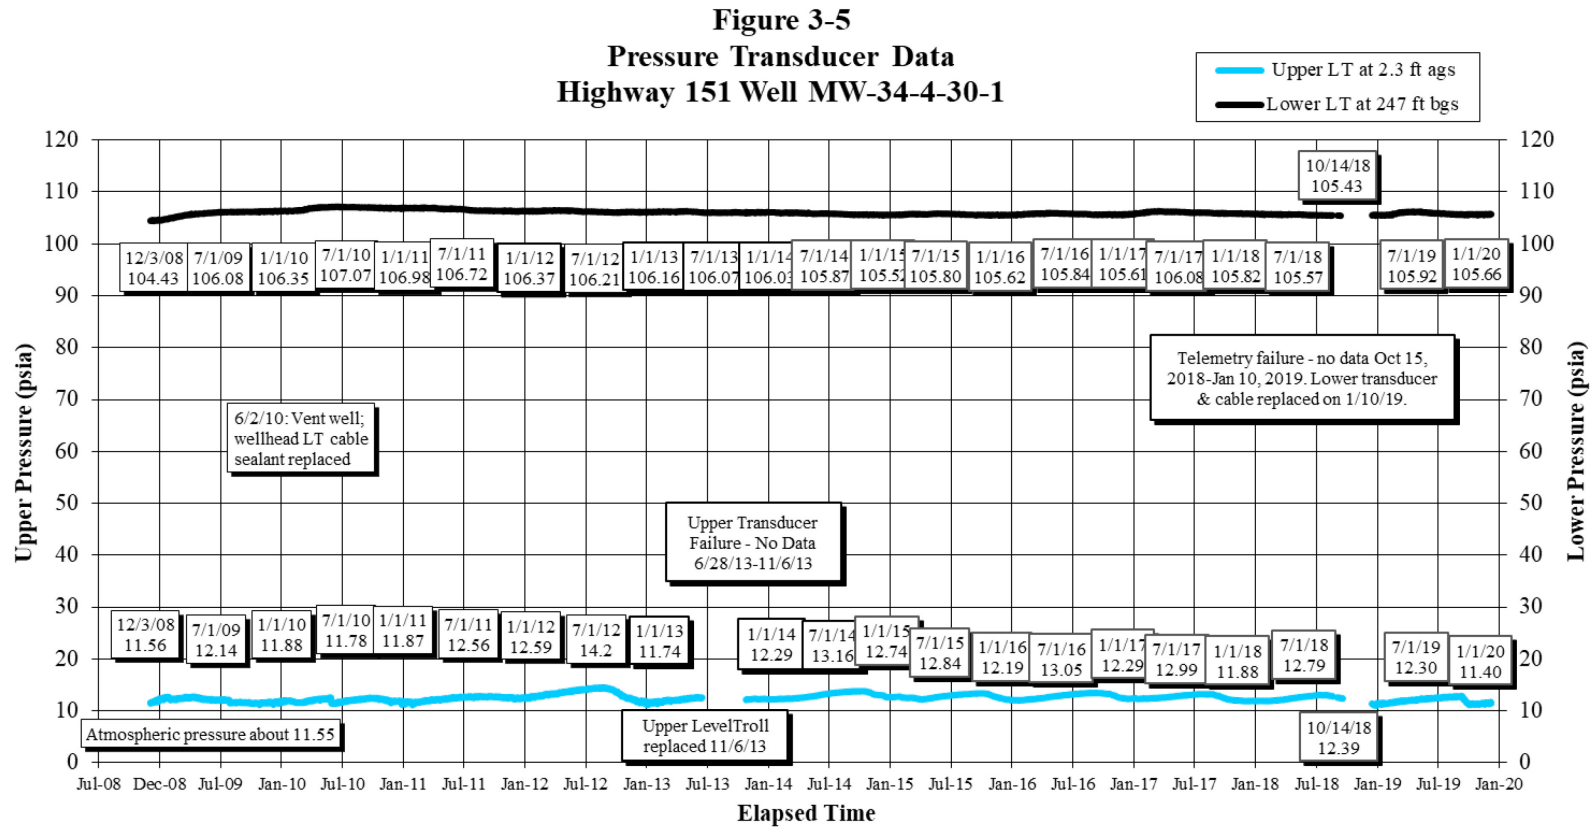
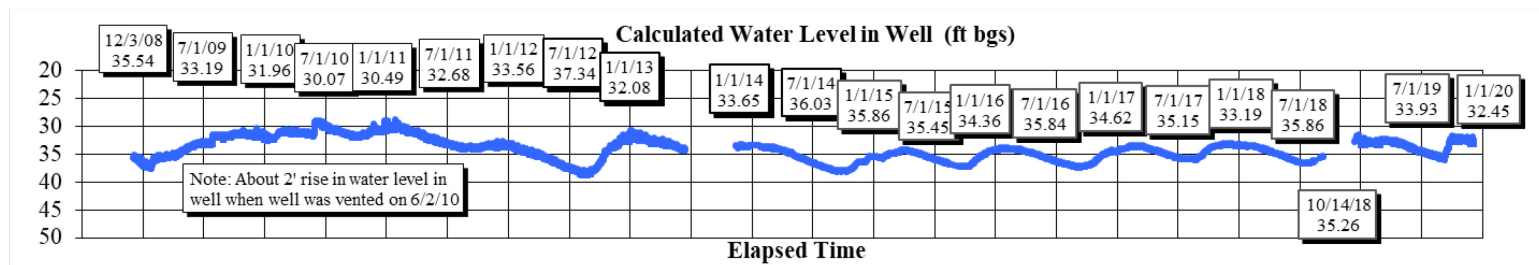
**Figure 3-5  
Pressure Transducer Data Highway 151 Well MW-34-4-30-1**

Figure 3-5 charts the upper and lower pressure transducer data and the calculated water level in the well. Table 3-3 and Figure 3-5 show a relatively stable well pressure regime with a stable wellhead pressure trend at atmospheric pressure, a stable downhole pressure trend of about 104-107 psia, and a fluctuating water level trend of 30-39 ft bgs since August 2009. Sharp fluctuations in both wellhead pressure and the calculated water level shown on Figure 3-5 correspond to the immediate loss of pressure when the well is vented (e.g., June 2, 2010), followed by a gradual return to the well pressure regime exhibited prior to venting the well.

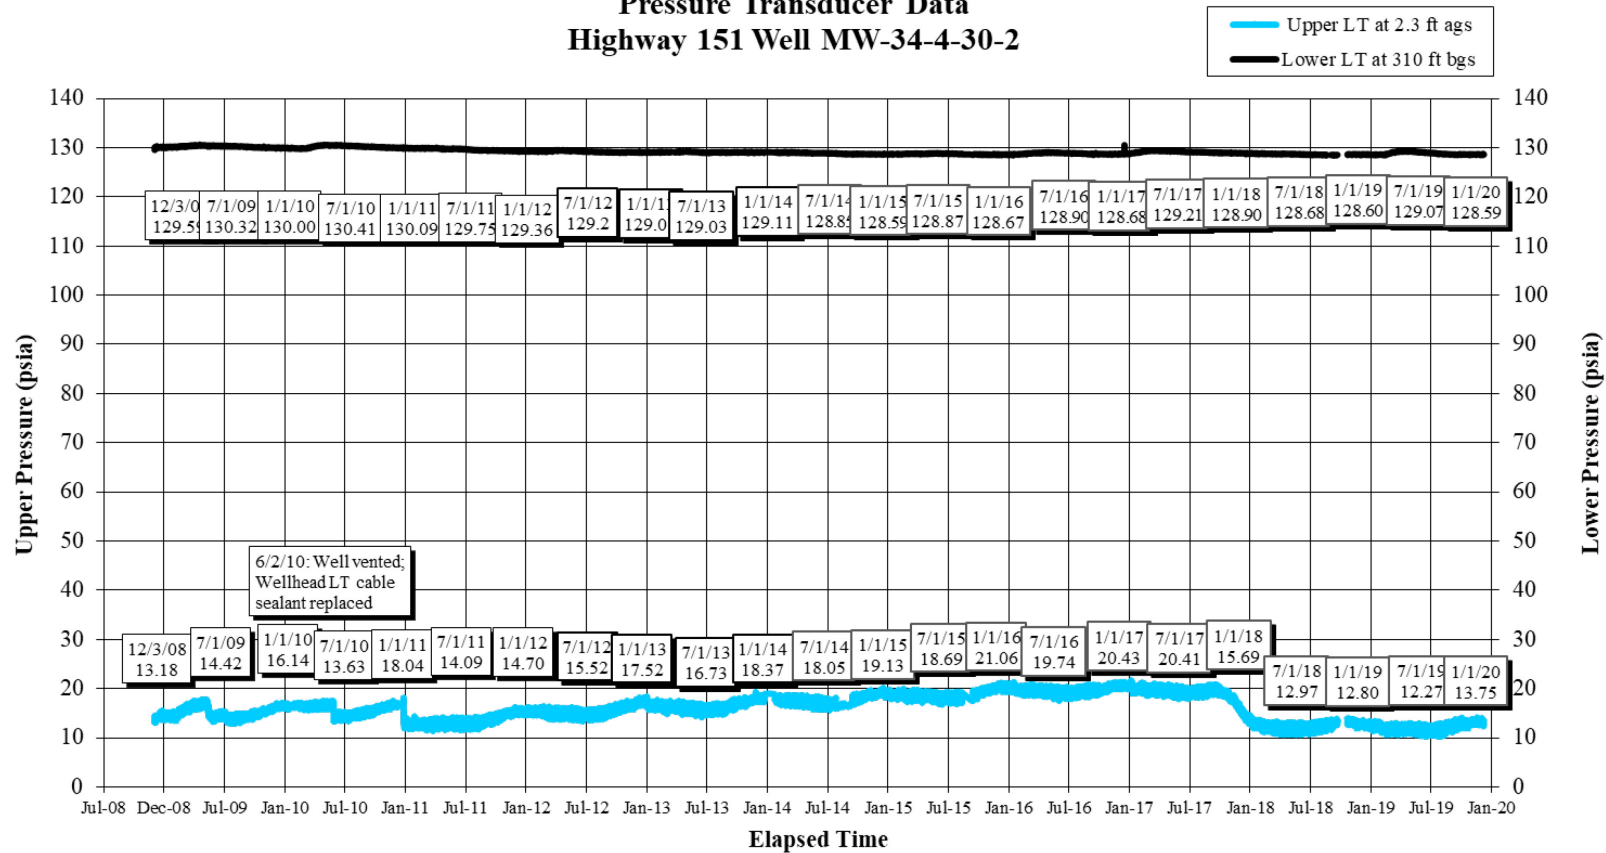
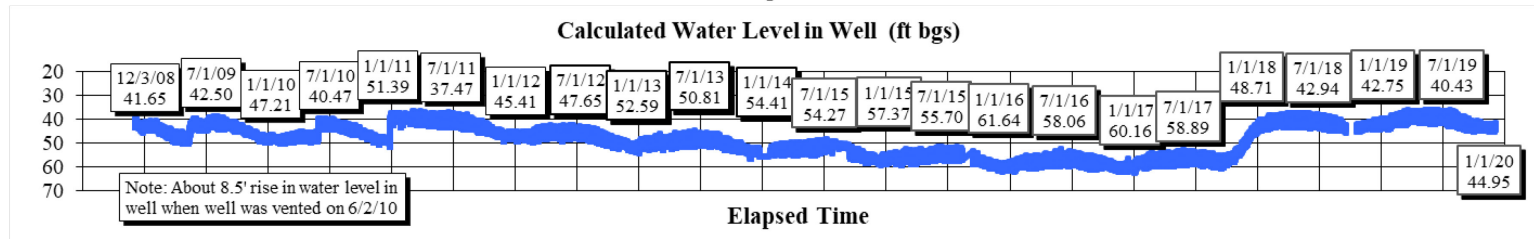
**Figure 3-6  
Pressure Transducer Data Highway 151 Well MW-34-4-30-2**

Figure 3-6 charts the upper and lower pressure transducer data and the calculated water level in the well. Table 3-3 and Figure 3-6 shows a stable downhole pressure trend with 1.00 psi change from 129.59 psia on December 3, 2008 to 128.59 psia on January 1, 2020. In addition, there was a net wellhead pressure decrease of 0.57 psi with a corresponding net water level decline of 3.30 feet for the entire period of record from December 3, 2008 to January 1, 2020. However, the wellhead pressure decreased slowly in the fourth quarter of 2017 with a loss measured at approximately 4.3 psi in 3 months. The pressure then stabilized at atmospheric pressure and has remained in that range through 2019. The well was inspected in 2019 during routine maintenance and no wellhead pressure leaks were found.

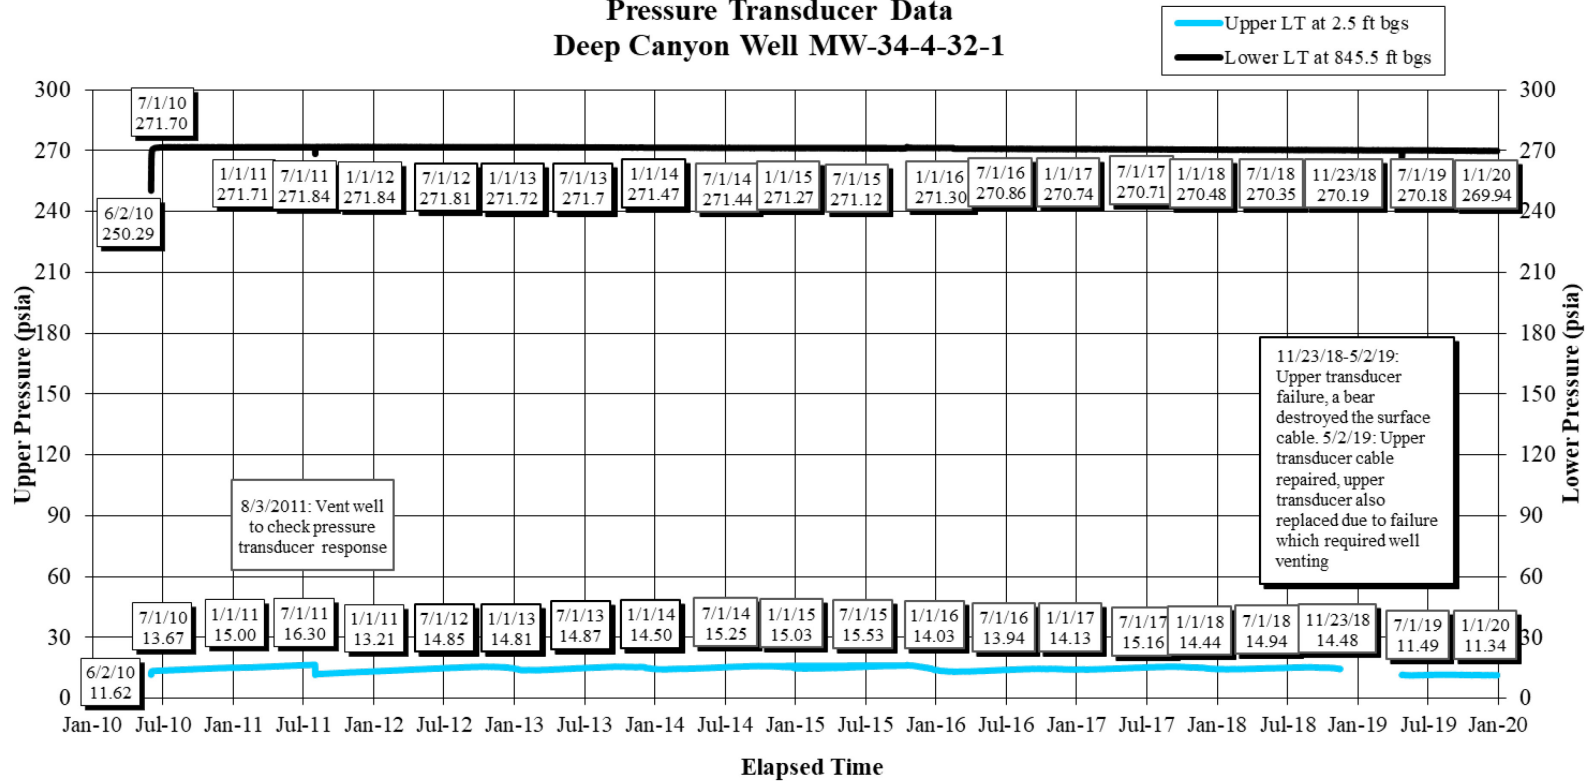
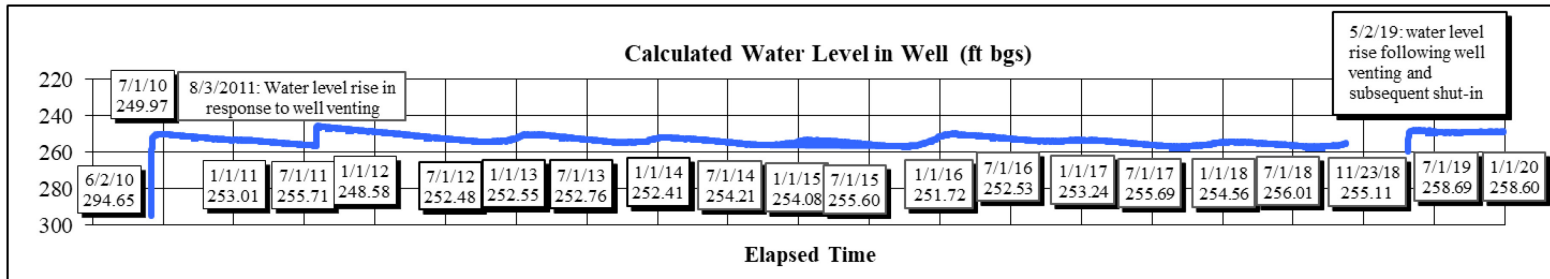
**Figure 3-7  
Pressure Transducer Data Deep Canyon Well MW-34-4-32-1**

Figure 3-7 charts the upper and lower pressure transducer data and the calculated water level in the well. Table 3-4 and Figure 3-7 show the well pressure initially stabilized on June 8, 2010, six days after the well was shut in for monitoring on June 2, 2010. Table 3-4 and Figure 3-7 also show a relatively stable well pressure regime for the 9.5-year period of record through November 23, 2018 with only a slight increase in well pressure and a corresponding net water level decrease of 7.39 feet in the well. Data for this well is limited from November 23, 2018 due to an upper Level Troll transducer failure. When investigated in early 2019 after the location was accessible it was found that the surface cable for this Level Troll was damaged by what appeared to be a bear mauling based on the type of cable damage and muddy paw prints on the telemetry instrumentation enclosure. At that time the cable was repaired, the Level Troll was replaced and full function has resumed.
