**Compliance Inspection Report for the Colorado Oil and Gas
Conservation Commission**

Drilling Operations on Encana's PC22 Site

**In Accordance with
Rulison Sampling and Analysis Plan, Rev 3**

June 27, 2013

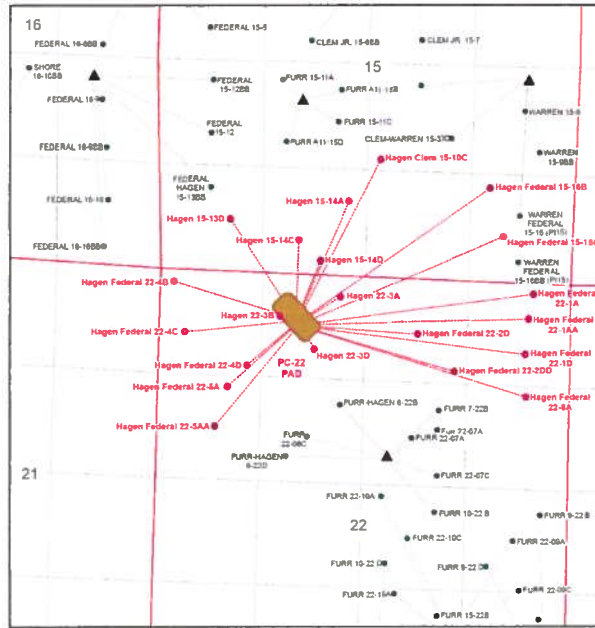
A total of 21 wells have been, or will be, drilled from the PC22 well pad. The wells drilled from this site are not the closest wells in Sector 11 to Project Rulison surface ground zero. See Figure 3, taken from document number 400381118 in the COGCC database, for location reference with respect to Furr Hagen 15-22B well which is closer to surface ground zero.

Figure 3. PC22 wells in relationship to existing Sector 11 wells.

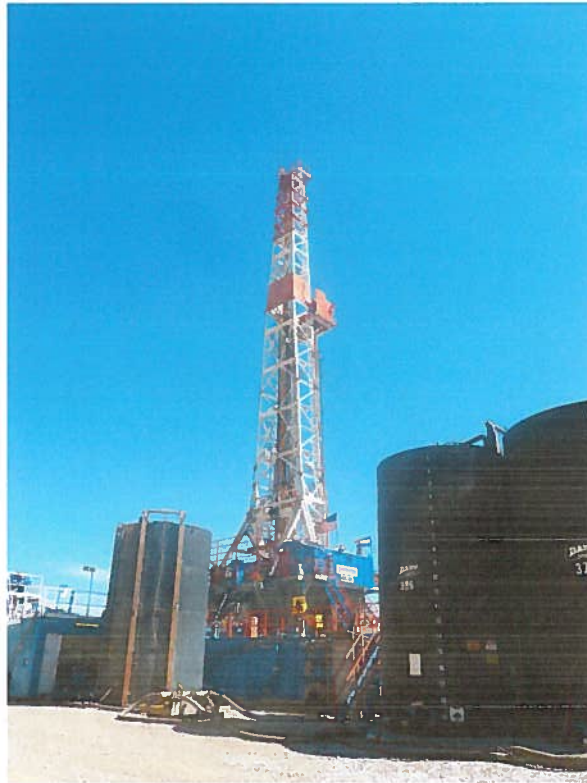
Figure 4 is a photograph taken on June 11, 2013 of drilling operations at PC22.

Figure 4. View of drilling Rig 303 on PC22.
