COLORADO
Energy & Carbon Management
Commission
Department of Natural Resources
1120 Lincoln Street, Suite 801
Denver, CO 80203

February 16, 2024

K.P. Kauffman Company, Inc.
Attn: Ross Watzman
1700 Lincoln Street, Suite 4550
Denver, CO 80203

DIRECTOR'S ORDER PURSUANT TO RULE 901.a.

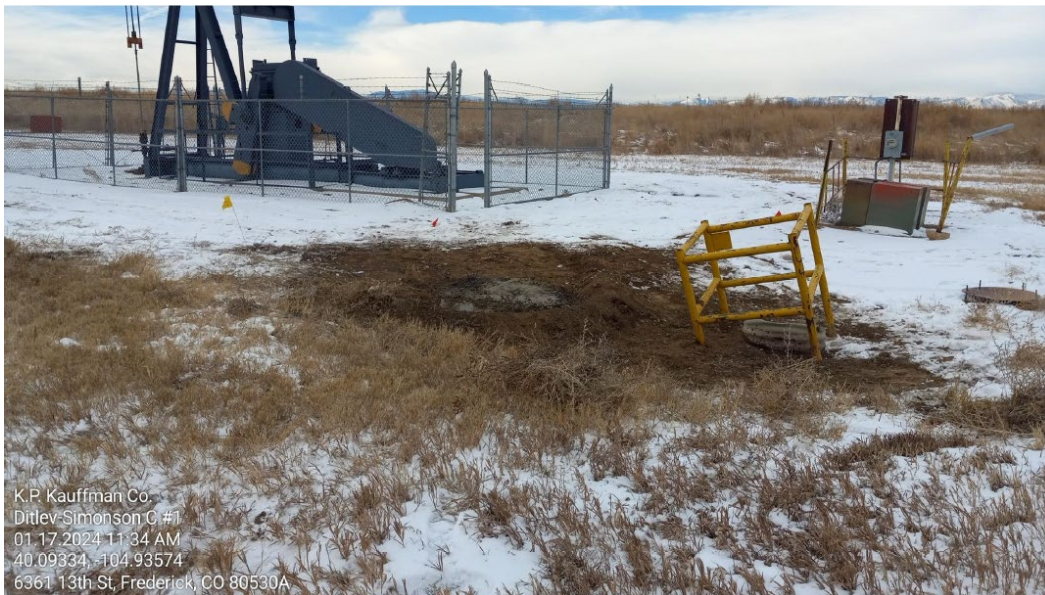
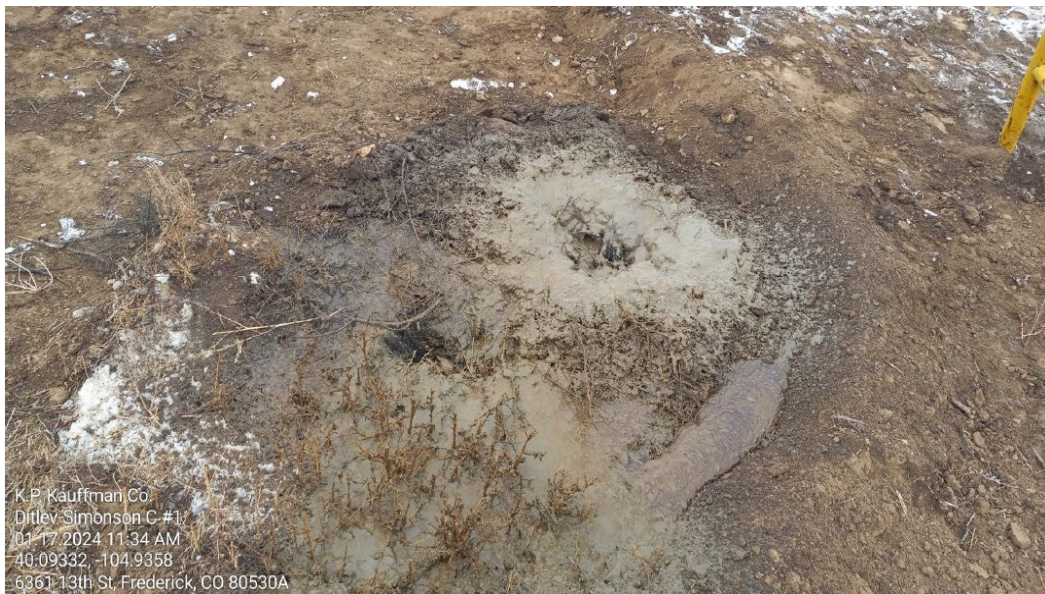
“During a routine inspection, a KPK employee discovered the presence of oil surfacing at near the Ditlev-Simonson C1 well. appropriate personnel were notified, and the line was immediately isolated and remaining fluid was evacuated. Emergency locates were called in and once cleared, crews began excavating to investigate and repair the failed line.”

(Form 19 Doc Num 403661051). The following photos were taken from the spill report:

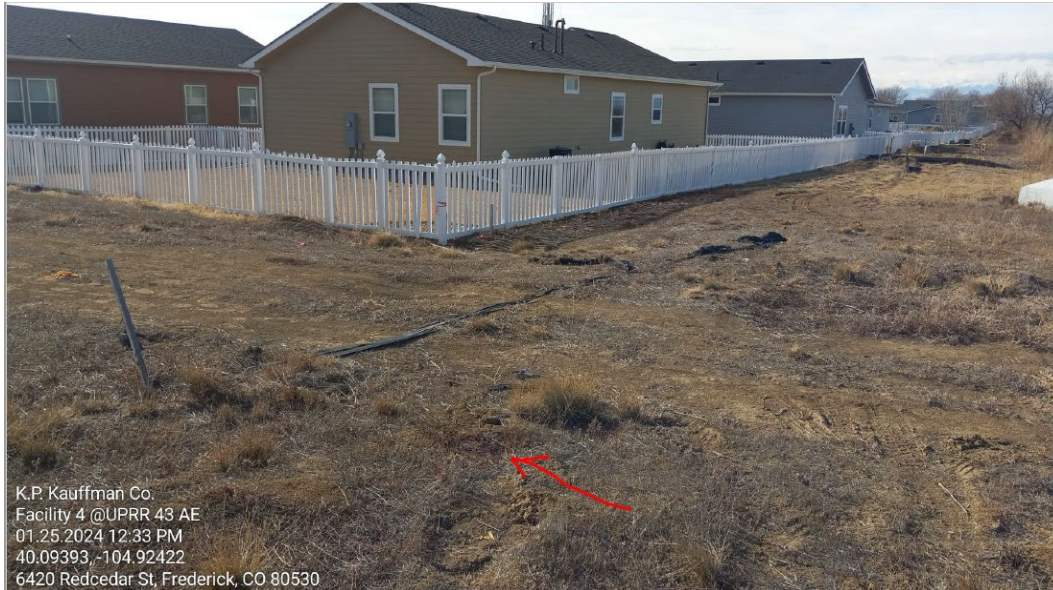
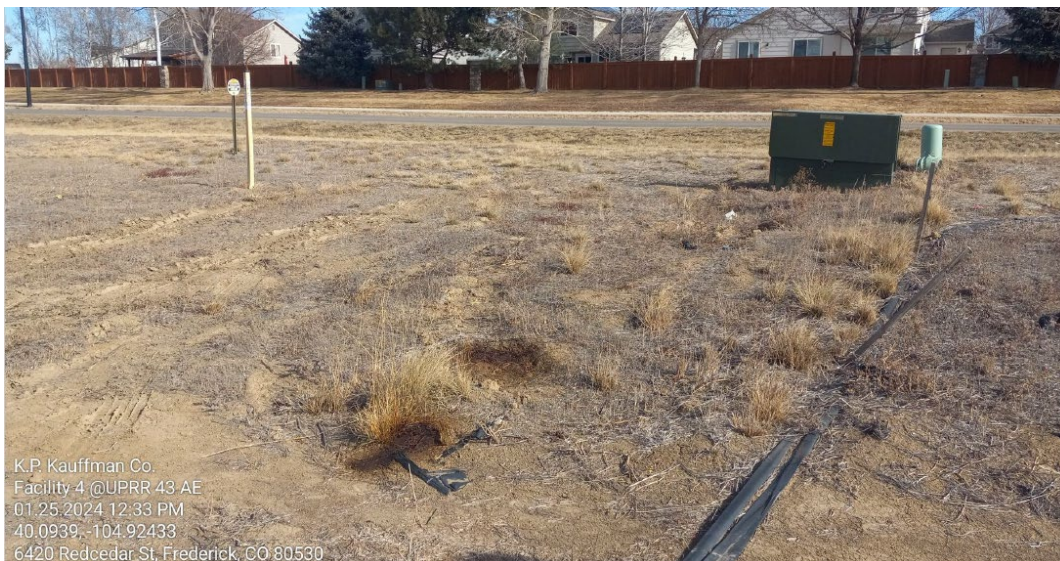
“KPK had a spill (ID 485898) on 1/19/2024. On 1/23/24, KPK had repaired the leaking line and was performing a pressure test and found that the flowline would not pressure up. KPK immediately began walking the line to identify any leak points causing the pressure failure. This spill reported on 1/25/2024 was identified on the same flowline approximately 3300 feet east of the 485898 spill. KPK’s pumper immediately went to the site, shut in the wellheads, and isolated the flowline. KPK mobilized a vac truck to evacuate the flowline. A soil berm was created surrounding

the spill, and booms and snow fence were placed around the spill. The surface staining was approximately 8 square feet (2'x4').”

(Form 19 Doc Num 403667163). The following photos were taken from the spill report:
