FRUITLAND OUTCROP MONITORING REPORT

ARCHULETA COUNTY, COLORADO

JANUARY 2006

LT ENVIRONMENTAL, INC.
4400 West 46th Avenue
Denver, Colorado 80212
(303) 433-9788

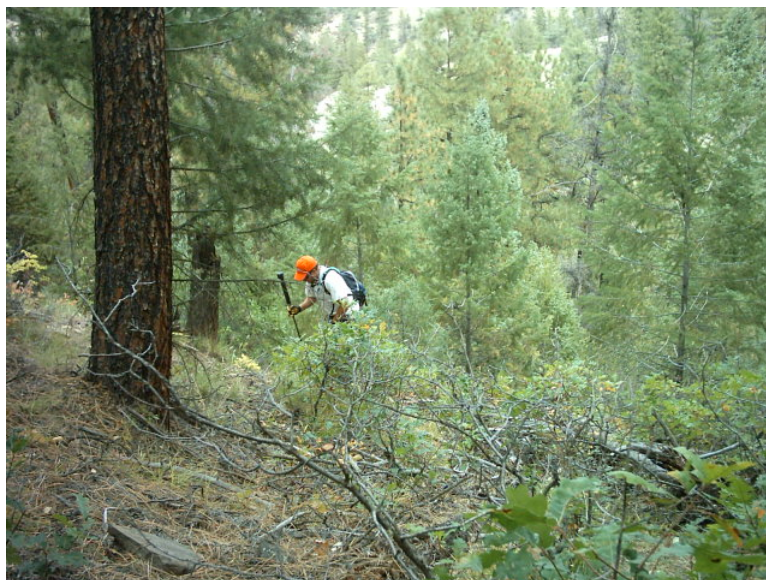
LTE identified several suspect areas on the southeast side of Pole Gulch (Map J). The areas were in an upland area approximately 0.25 miles from the bottom of the valley. The mortality noted in the imagery consists of scattered pine tree mortality and fallen down pine trees. Pine beetle infestation was noted in the trees. No methane was detected at any of these suspect areas.

Southeast of
Pole Gulch

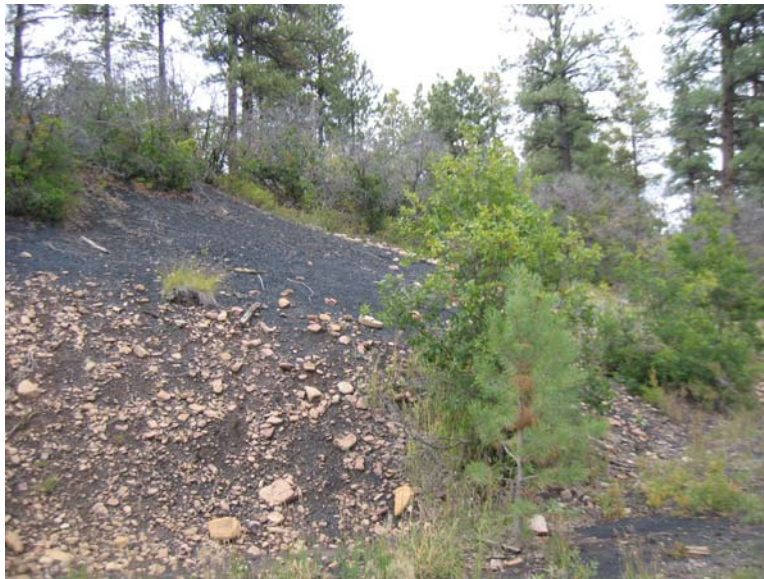
Two smaller suspect areas were noted southeast of the alluvial valley (Map L). The anomalies noted in these two areas were the result of brown and black exposed soil. Coal outcrops were noted. Sandstone and shale was exposed in several gullies. No methane was detected in either of these areas. GPS signal could not be obtained in the northern most suspect area on Map L, therefore, the five subsurface methane measurement points were not mapped but are noted on the map.

Exposed coal near Peterson Gulch.

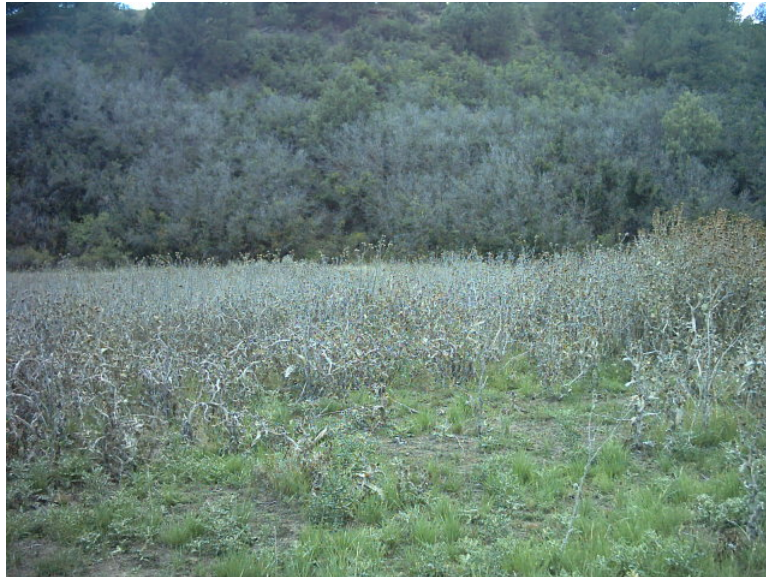
LTE noted several suspect areas in the vicinity of the Candelaria Residences (Map M). In the valley north of the residences, LTE noted senescent forbs and erosional soil deposits within the valley. It appears as if this valley experiences significant runoff during storm events based on the observed sediment deposition in the area. No methane was detected in the alluvial valley.

Senescent forbs in alluvial valley north of Candelaria residences.

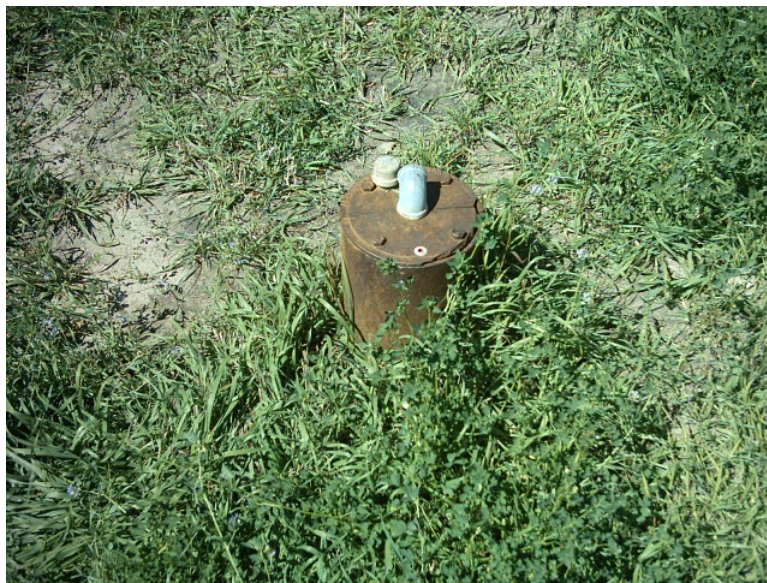
As part of the inspection of the Candelaria properties, LTE noted a former water well located behind the Susie Candelaria residence. Mr. Gilbert Candelaria could not recall the construction specifications of this well but it is believed to be relatively shallow. Since the well is located on the Kf outcrop, it is likely that the well is screened in the Kf. No permit for this water well could be located at the SEO. LTE detected methane gas in the well casing of this water well at a concentration of 5,000 ppm (10% LEL). No methane was noted in the soil surrounding the well. A detailed map of the soil gas survey performed at the Candelaria Ranch is presented as Figure 6.

Inactive well at Candelaria residence.

LTE recommends abandonment of the inactive well behind the Candelaria residence. The well is currently seeping methane gas at a concentration of 5,000 parts per million (ppm) which is 10% of the lower explosive limit (LEL). The close proximity of the well to the residential structures increases the risk for the accumulation of explosive vapors in confined spaces.

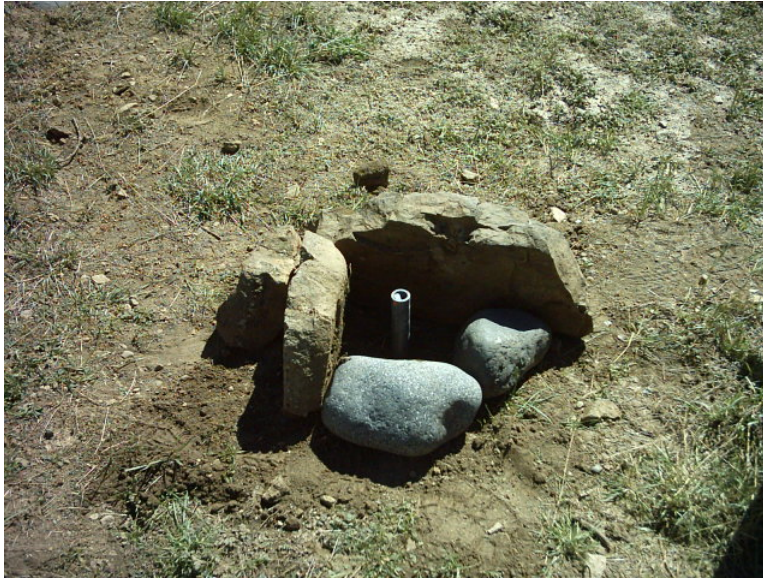
LTE conducted the survey on September 14, 2005. LTE used a GPS to measure the location of the abandoned well marker. LTE advanced five temporary soil probes in the area to measure for the presence or absence of methane. No methane was detected at any of the sample locations. In addition, LTE constructed a permanent monitoring probe adjacent to the abandoned well marker.

No methane was detected in the permanent monitoring probe. Figure 7 illustrates the area surveyed at the Schomburg #1 well site.

Permanent monitoring probe at Schomburg #1.

LTE recommends annual monitoring of the Schomburg #1 well site to assess the potential for methane seeps over time. Annual monitoring of the well is required by the Conditions of Approval for the Pargin Mountain 10U #3 permit.

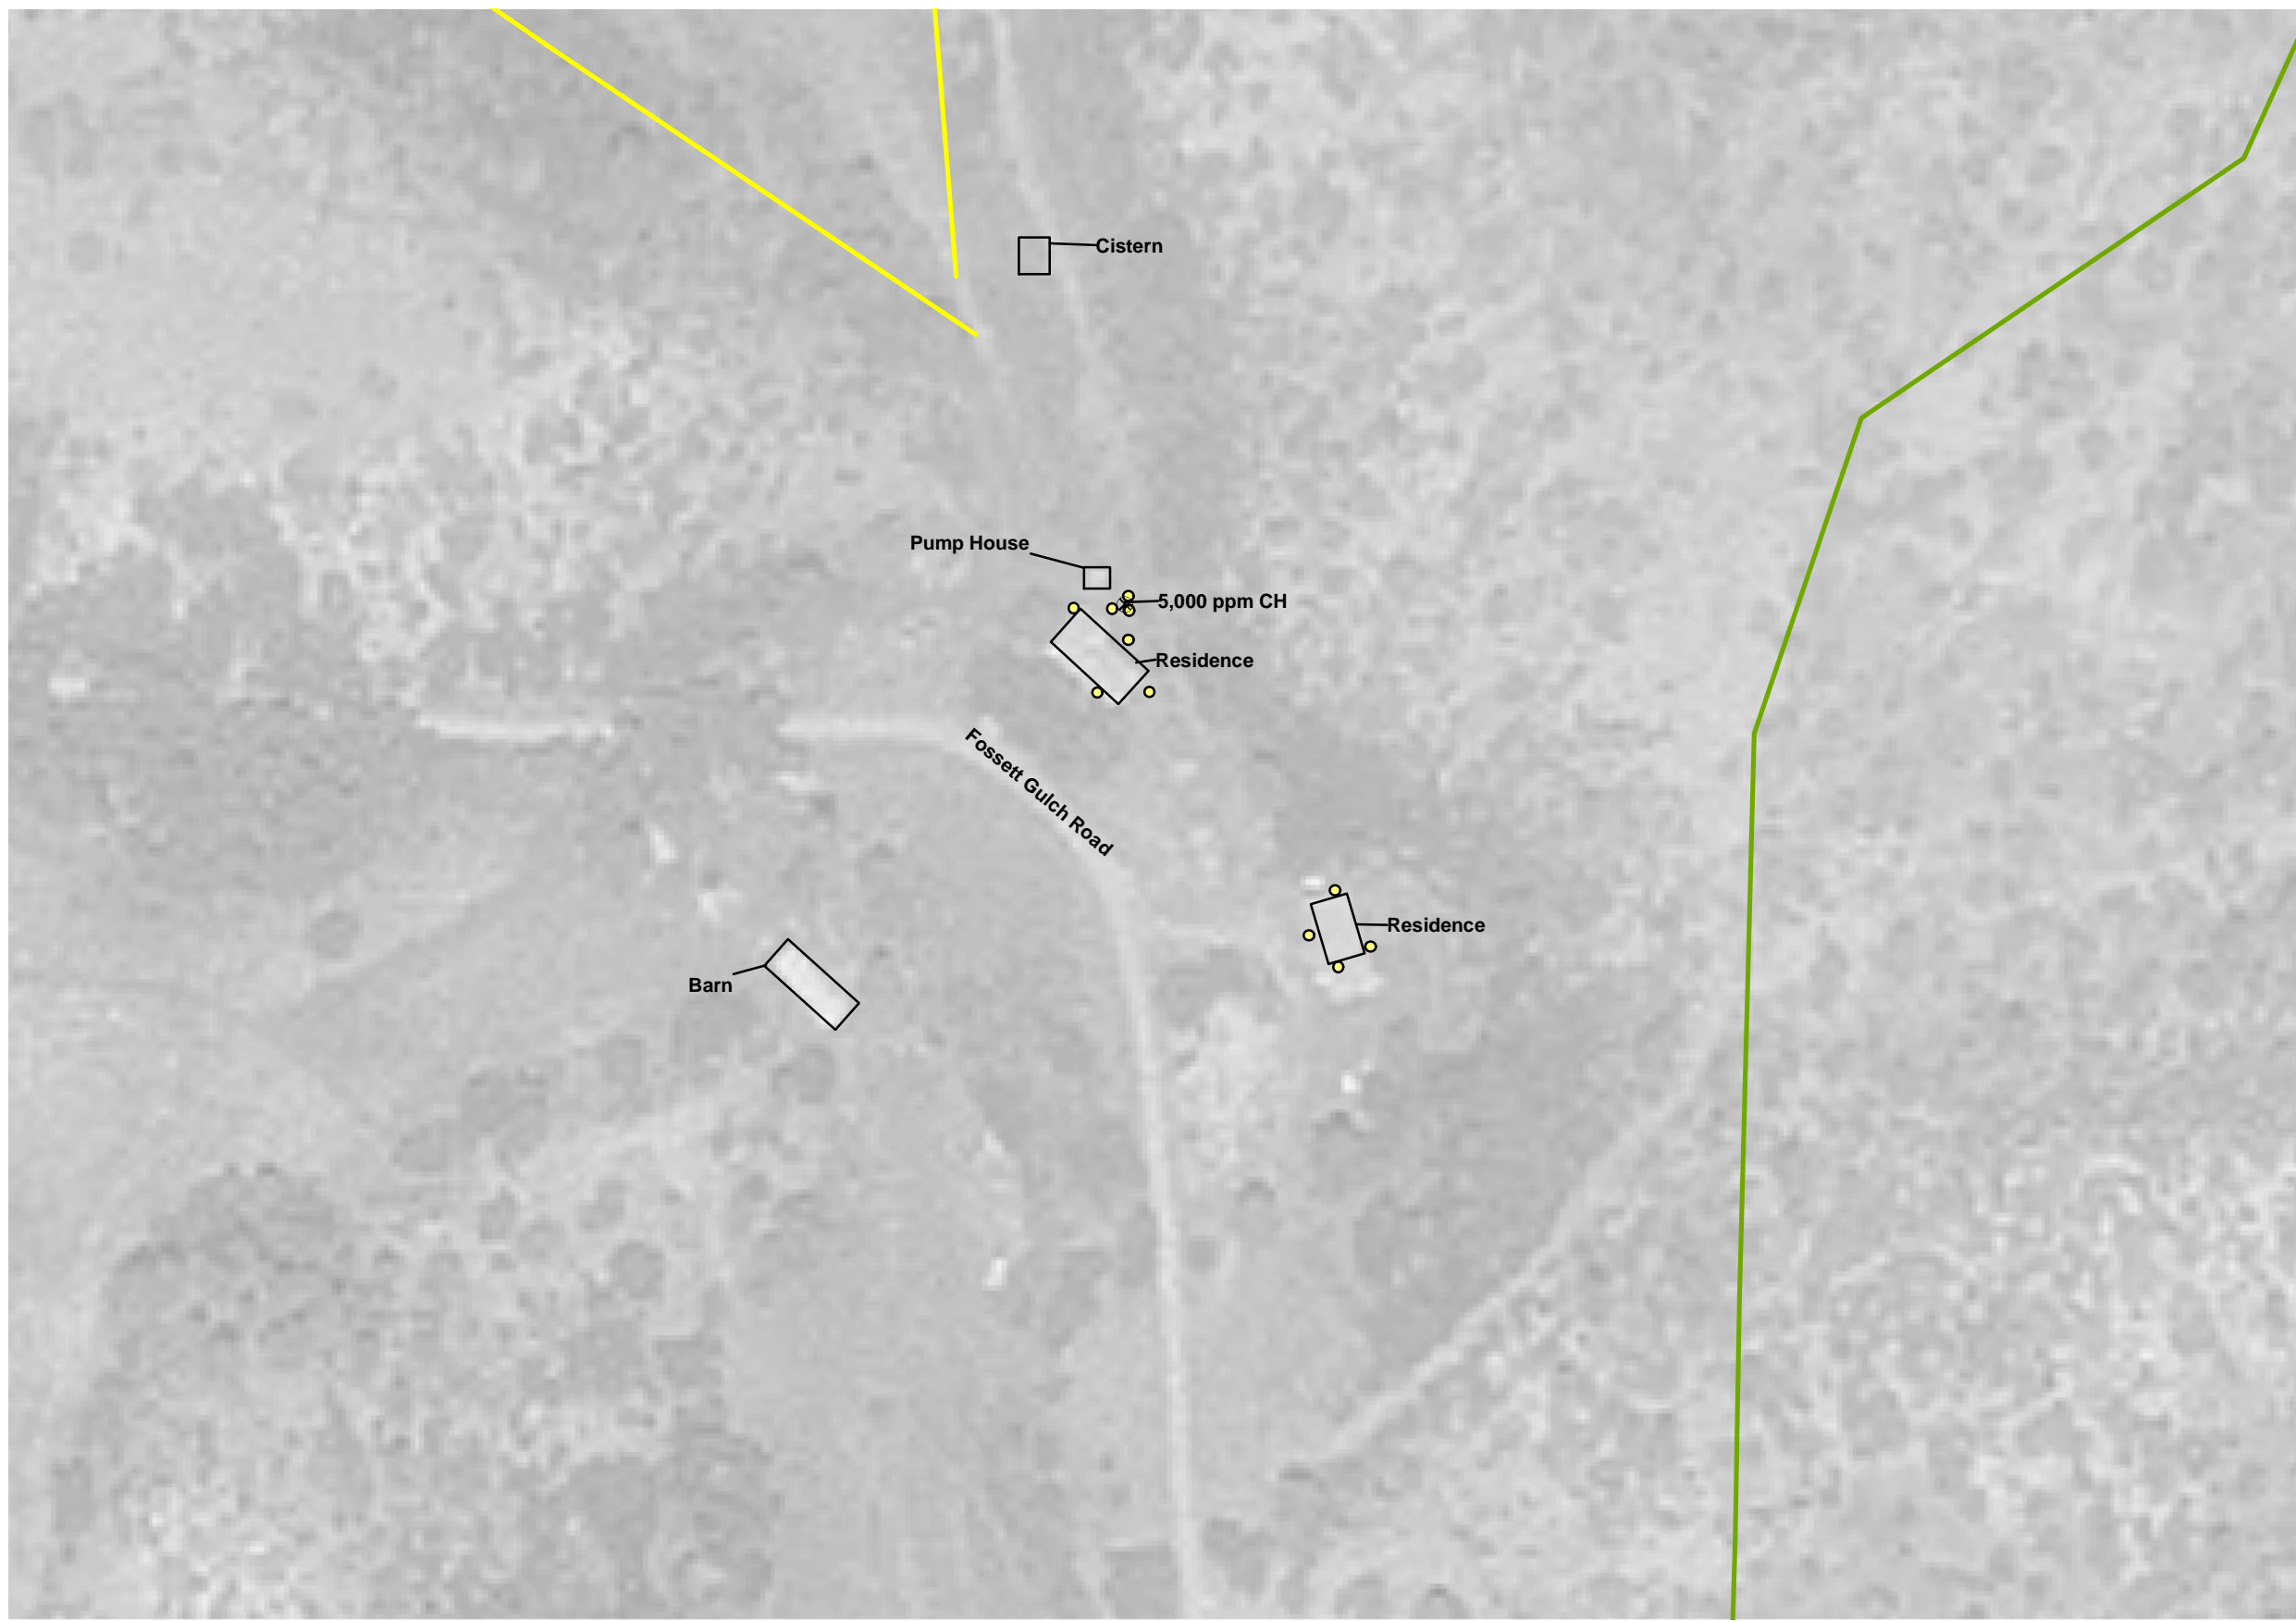
FIGURE 5
CANDELARIA RANCH - DETAIL
NATURAL SPRING LOCATION MAP
2005 FRUITLAND OUTCROP MONITORING
ARCHULETA COUNTY, COLORADO
 ELM RIDGE RESOURCES AND PETROX RESOURCES

Special attention was focused on Spring 3424 and the tributary spring. These springs are located north of the Candelaria residences. The springs begin to channelize approximately 900 feet north of the Susie Candelaria residence (northern residence). A cistern is located along the main channel and collects water from the springs. Water is then gravity fed to the well pump house approximately 20 feet north of the residence. The water enters a pressure tank system and water softener and is then piped into both of the Candelaria residences. By the time the water passes by the northern residence approximately 30 feet west of the building, flow in the channel is greater than 20 gallons per minute (gpm). Figure 5 contains a detailed view of the Candelaria Ranch area.

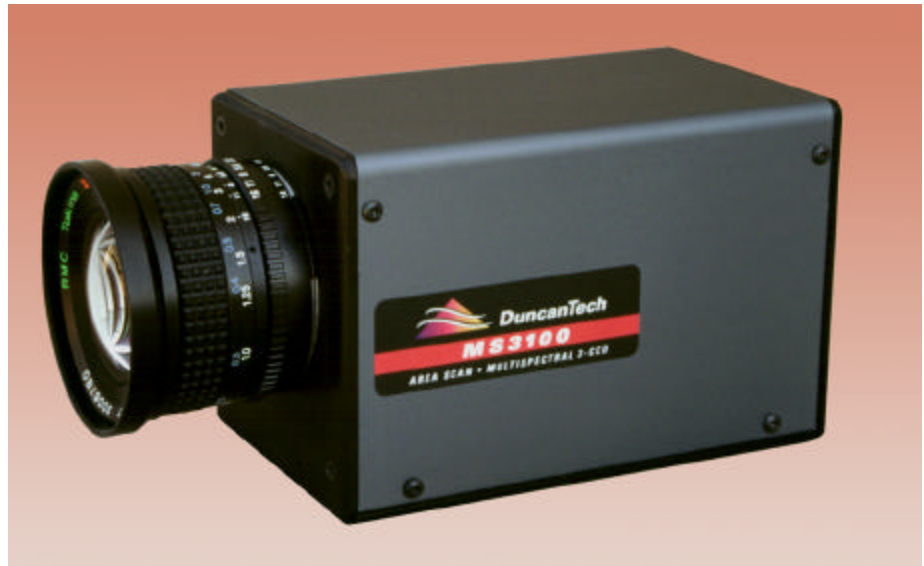
- Color separating prism with three CCD imaging sensors
- 1392(H) x 1040(V) resolution (x3) for 4.3 Million pixels of data
- Image 3-5 spectral bands from 400-1100 nm
- Standard models for RGB, CIR, and RGB/CIR
- Custom multispectral configuration to meet your needs
- Frame rates up to 7.5 fps
- "Smart Camera" features for advanced control and processing
- Display composite, false color, or individual color plane images
- Digital Image Output - EIA-644 or RS-422
- Compact, rugged package
- Independent gain, offset, and exposure control for each channel
- External trigger input with three operating modes
- RS-232 input for configuration and control
- Optional *DirectView* video preview via NTSC/PAL or Progressive Scan
- Optional on-board image processing
- OEM Customization Available
