FRUITLAND OUTCROP MONITORING REPORT

LA PLATA COUNTY, COLORADO

OCTOBER 2003

LT ENVIRONMENTAL, INC.
4400 West 46th Avenue
Denver, Colorado 80212
(303) 433-9788

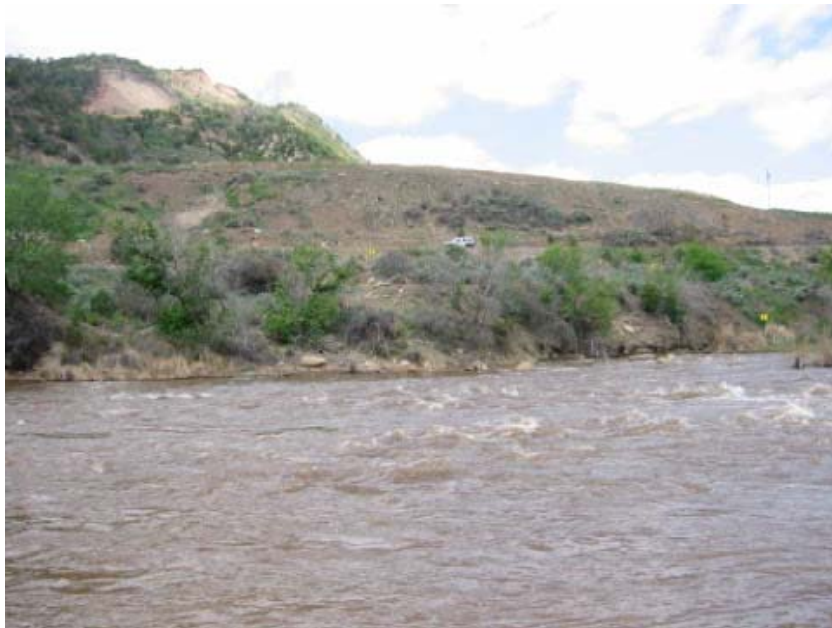
A dead scrub oak area located south of the gas flux chamber reported a subsurface methane concentration of 27,500 ppm (2.75%). A subsurface methane concentration of 320,000 ppm (32%) was recorded in a dead vegetation area (100 feet by 150 feet) on the west side of the Animas River that corresponds with the middle portion of the Kf (CJ-2, Figure 3). Directly west from location CJ-2 a smaller dead vegetation area (30 feet by 75 feet) reported a subsurface methane concentration of 950,000 ppm (95%). A dead vegetation area (75 feet by 175 feet) at location CJ-3 reported subsurface concentrations as high as 120,000 ppm (12%) methane (Figure 3). Subsurface H₂S concentrations ranged from two to nine ppm along the west side of the Animas River.

View of west side
of Animas River
(Location CJ-2)

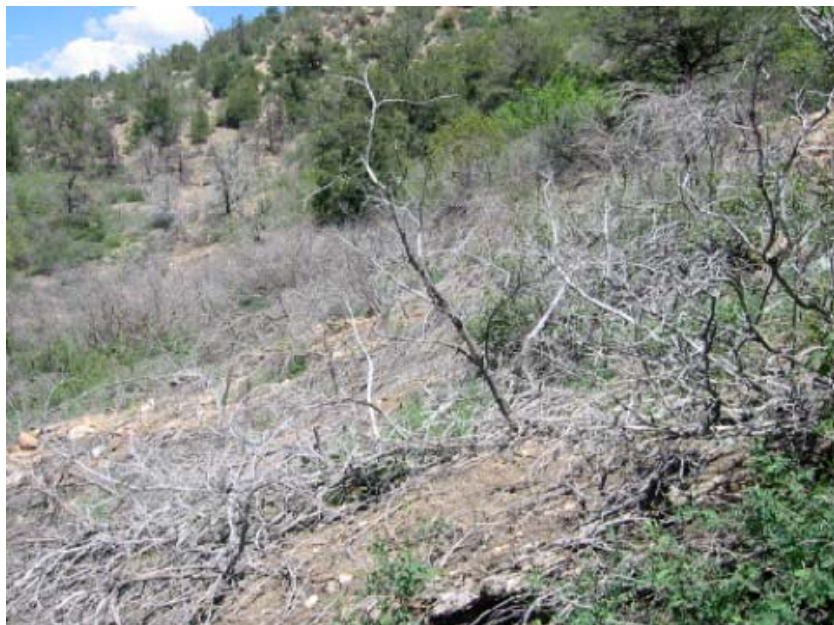
Concentrations of subsurface methane were detected closer to the bottom of the drainage in the lower section of the Kf. A dead pine tree area reported methane concentrations of 190,000 ppm (19%) at location CJ-4 (Figure 4). Subsurface methane concentrations in a dead vegetation area ranged from 39,500 ppm (3.95%) to 80,000 ppm (8%) (CJ-5, Figure 4). Dead pine trees located along the basal contact of the Kf were associated with subsurface methane readings ranging from 21,000 ppm (2.1%) to 100,000 ppm (10%). Subsurface H₂S was not detected in the upland areas on the west side of the Animas River during the 2003 detailed mapping event. In the upland area on the east side of the Animas River subsurface H₂S concentrations ranged from two to three ppm during the 2003 detailed mapping event.

Location CJ-5
View northeast

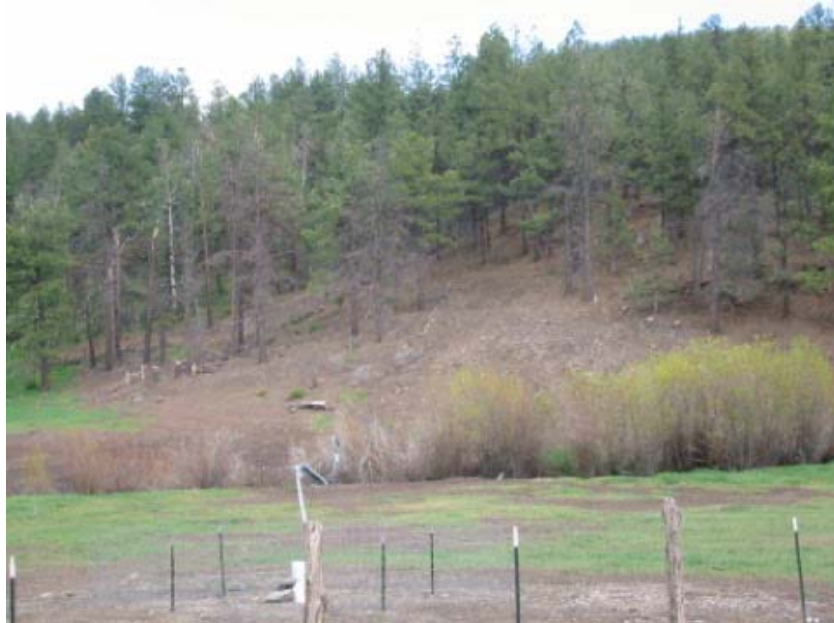
The creek water level was relatively high but not turbulent during the time of mapping making methane seeps within the creek more visible. Numerous methane seeps were noted in the creek surrounding the gas flux chamber for approximately 100 feet north and south of the flux chamber (TC-1, Figure 8). Approximately 0.34 miles west of location TC-1, a seep area (100 feet by 200 feet) was observed where the creek had flooded the meadow (TC-3, Figure 7).

View east facing
location TC-1

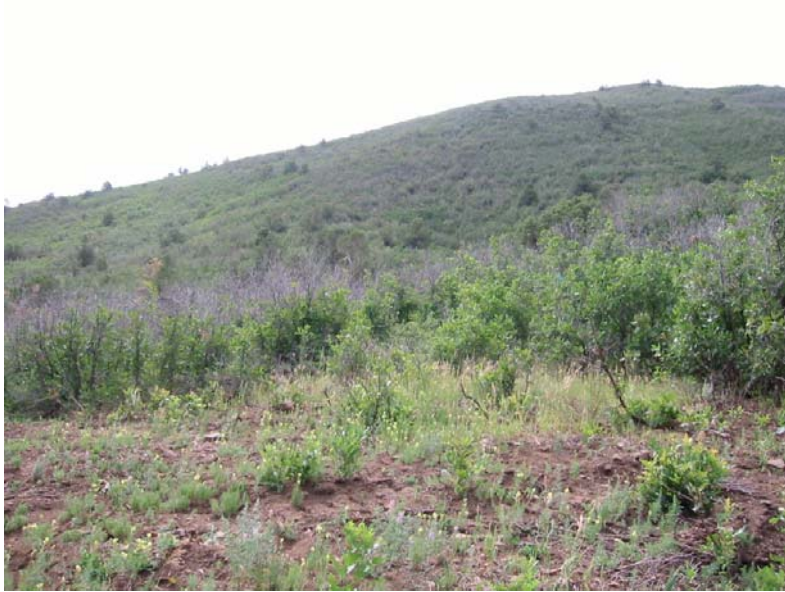
Location M03-1.

The large suspect area adjacent to the Southern Ute Indian Reservation boundary was identified because mortality or stressed vegetation patterns mimicking the stratigraphy is clearly evident in the IR image (see location M03-1, Figure 9). LTE collected seven subsurface methane measurements in the vicinity of this suspect area but did not detect methane. It is possible that the vegetation patterns observed are more related to moisture variation or varying soil types. Much of this area is covered with Gamble's Oak (scrub oak) which experienced significant die back due to the drought conditions.

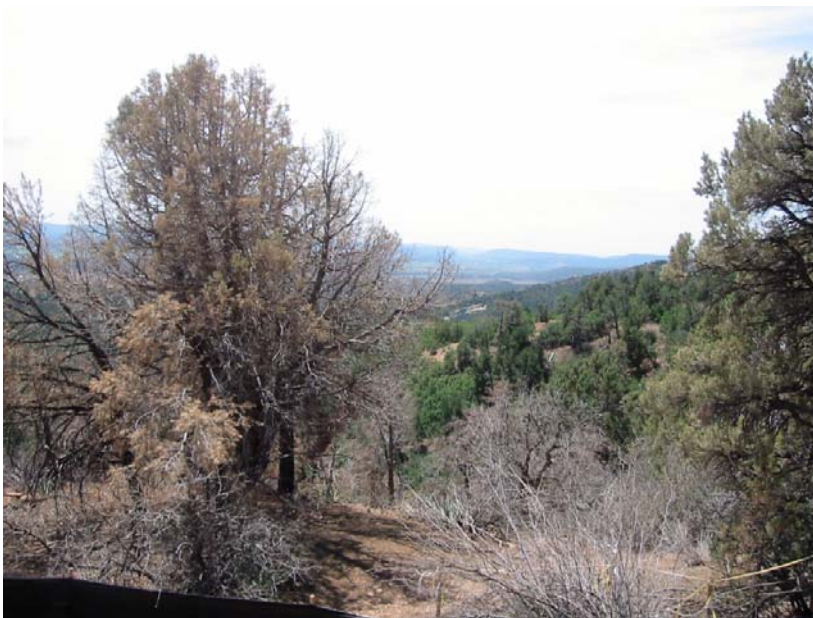
Dead vegetation
north of Basin Creek
road.

Dead vegetation was noted in the three suspect areas identified north of the Basin Creek road. Two of the three areas contained detected concentrations of methane up to 1%. Coal outcrops and large dead trees were noted in these two areas (M03-3, Figure 10).

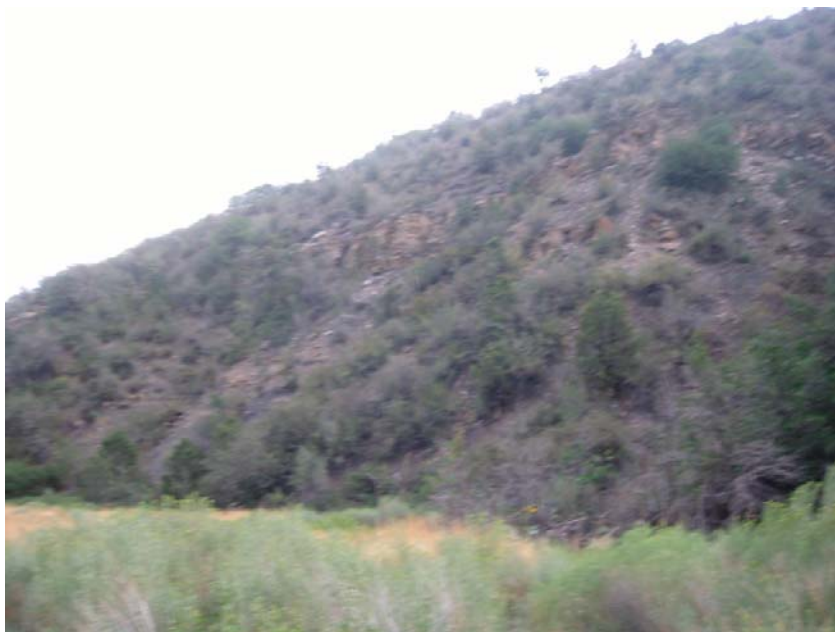
Location M03-4

The largest suspect area on "moving mountain" consists of a large area of dead scrub oak, sage, and other vegetation on a steep hillside (M03-4, Figure 11). LTE initiated field activities in this area with methane detected at concentrations ranging from less than 25 ppm to 1% when weather conditions forced the field crew off the mountain. Unfortunately, field crews were unable to return to this area during the July 2003 field event. The presence of methane was detected at this location during the October 2002 detailed mapping event.

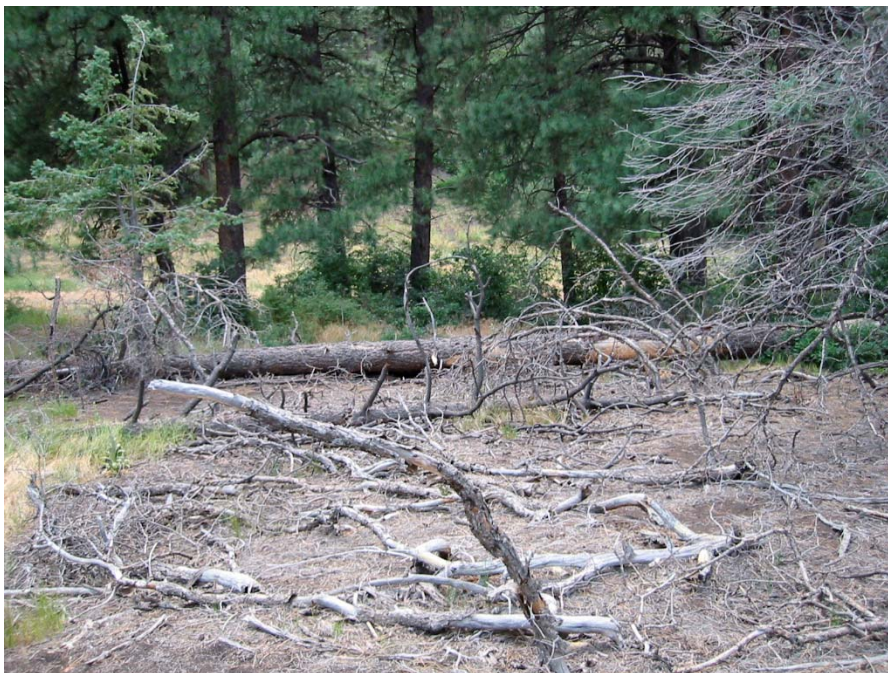
Location M03-15

Three suspect areas identified further east of the main mapping area were relatively small in size but contained significant vegetation mortality. Methane measurements in the area reported concentrations ranging from less than 25 ppm to 76% (M03-15, Figure 22).

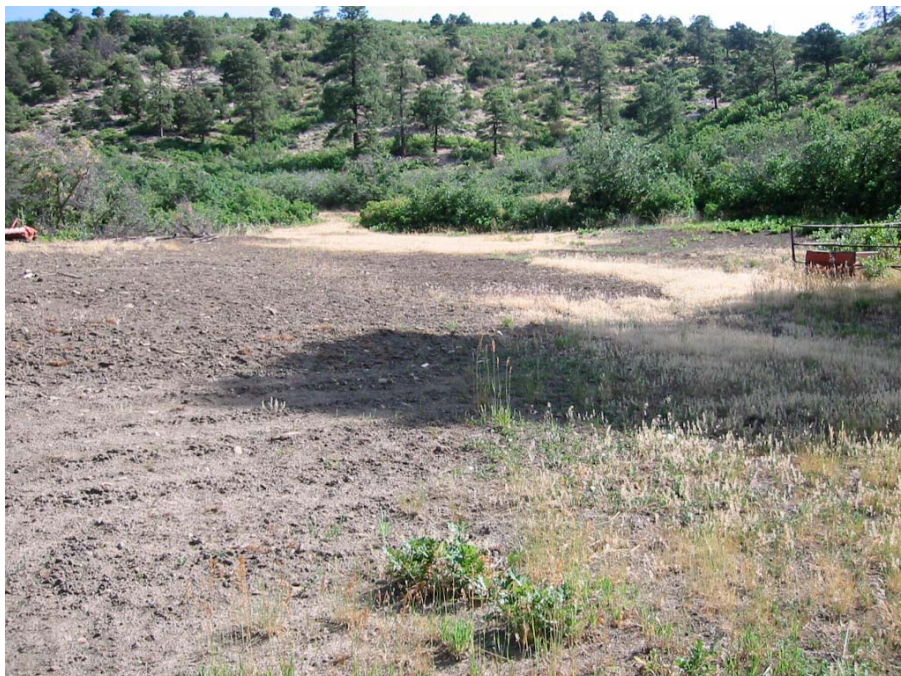
Hoier Property
Location M03-16

Upon arrival, LTE noted one specific area of significant vegetation mortality including pine trees, grass, scrub oak, and juniper trees (M03-16, Figure 23). Measurements collected in this area indicated elevated concentrations of methane. The highest methane concentration measured on the Hoier property was 91%. Other suspect areas noted on the IR image were determined to be areas of dead grass but not associated with methane seepage.

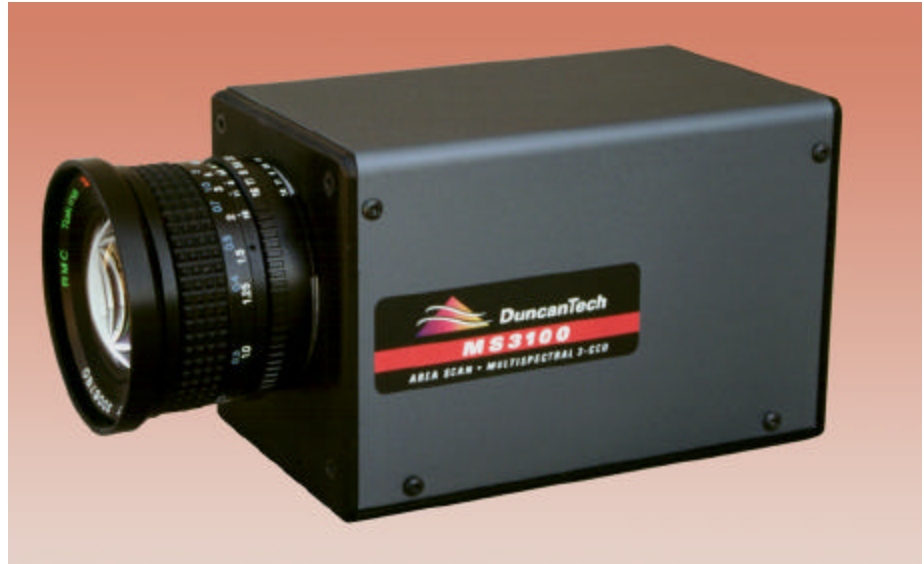
A common aperture and accurate alignment provide true color fidelity and optimum image quality.

Multispectral configuration options, smart camera features, and DirectView analog preview complete this unbeatable instrument.

- Color separating prism with three CCD imaging sensors
- 1392(H) x 1040(V) resolution (x3) for 4.3 Million pixels of data
- Image 3-5 spectral bands from 400-1100 nm
- Standard models for RGB, CIR, and RGB/CIR
- Custom multispectral configuration to meet your needs
- Frame rates up to 7.5 fps
- "Smart Camera" features for advanced control and processing
- Display composite, false color, or individual color plane images
- Digital Image Output - EIA-644 or RS-422
- Compact, rugged package
- Independent gain, offset, and exposure control for each channel
- External trigger input with three operating modes
- RS-232 input for configuration and control
- Optional *DirectView* video preview via NTSC/PAL or Progressive Scan
- Optional on-board image processing
- OEM Customization Available

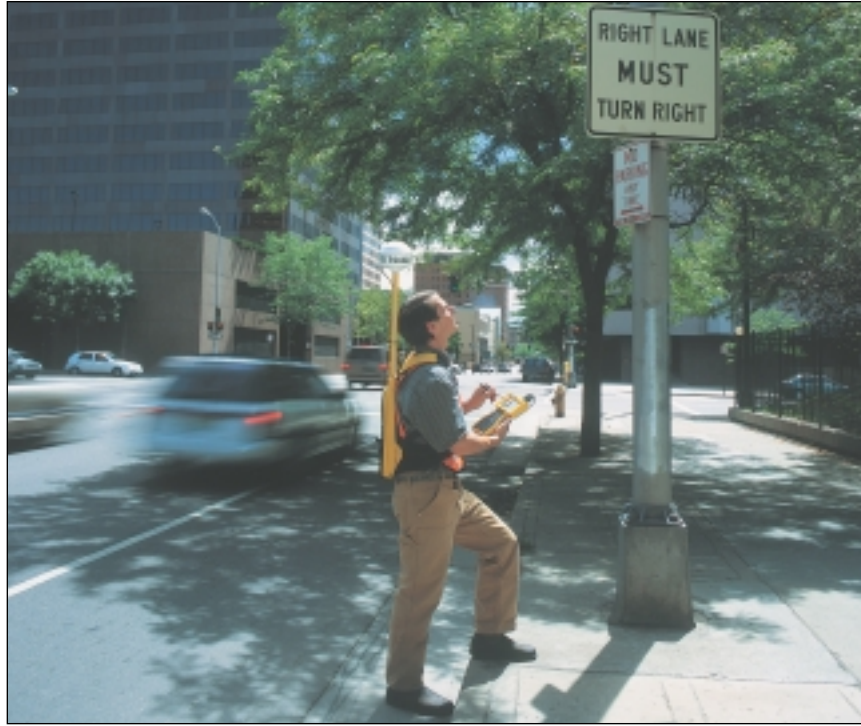
TerraSync™ software operates on Trimble's rugged GIS TSCe™ field device, or any Windows field computer.

Asset Surveyor® software runs on Trimble's rugged, field-proven TSC1™ data collector.

Trimble GPS Pathfinder Systems are rugged and field-proven

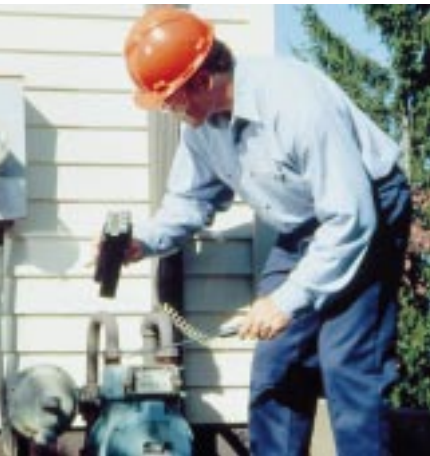
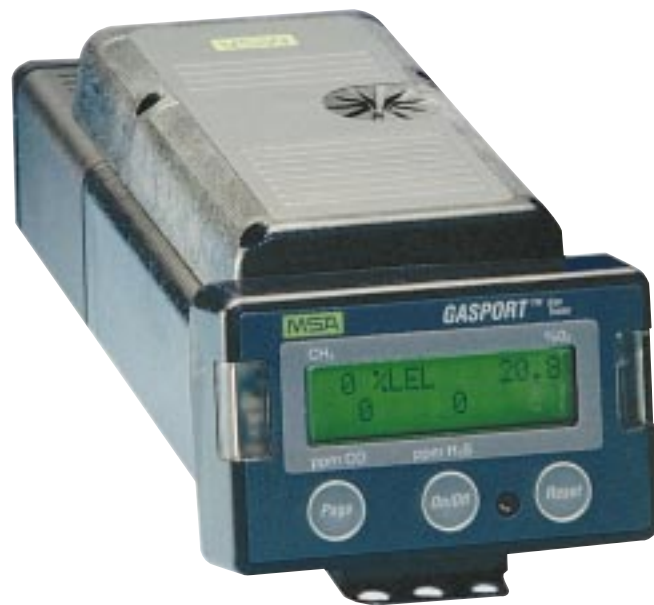
The Gasport Gas Tester is designed for gas utility workers to detect methane and certain toxic gases. It is a reliable, simple, versatile tool to help your service technicians get the job done quickly! With multiple ranges and sensing capabilities built into one rugged housing, the Gasport Tester simplifies your work by reducing the number of meters you have to carry on the job.

The Gasport Tester's poison-tolerant methane sensor provides three measurement ranges for your daily service needs:

- Open air, safety sampling
- Small, in-home leak detection
- Street/outdoor service line leak detection
