Ground Survey in Weld County for Methane Anomalies

June 28, 2016

S. E. McLaren
Apogee Scientific, Inc.
2895 W. Oxford Ave., Suite 1
Englewood, CO 80110-4397

Colorado Oil and Gas Conservation Commission
1120 Lincoln St. Room 801
Denver, CO 80203

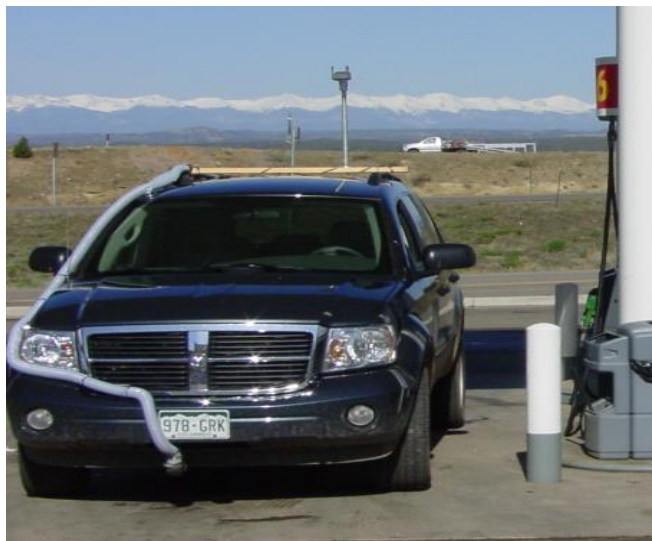
This survey was conducted using a 4-wheel drive vehicle, similar to the one pictured in Figure 1, that was equipped with an infrared-based gas detector developed by ASI. This type of gas detector was designed to find leaks in natural gas pipelines, and is referred to as the Apogee Leak Detection System (LDS). The LDS is a three-channel instrument capable of measuring methane (CH₄), total hydrocarbons (HC), and carbon dioxide (CO₂) at sub part per million (PPM) concentrations at a speed of 10 samples per second. The vehicle was also equipped with a high accuracy GPS and wind sensor that was used to mark the locations of seeps.

Figure 1. LDS-equipped ground survey vehicle.

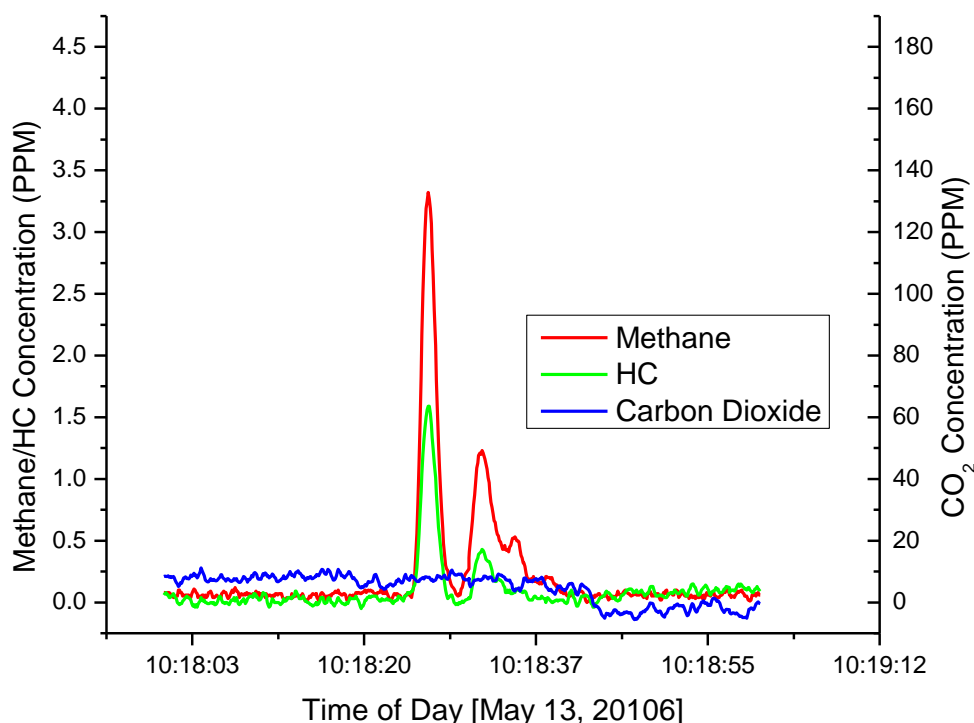
Over 100 methane plumes were encountered during the survey. The vast majority were the result of emissions from oil and gas production infrastructure. Other sources included agricultural activities and cattle. Approximately 5% of the methane plumes were attributed to non-oil and gas production operations. An example of the system response when driven downwind of a pad containing storage tanks and other natural gas processing equipment is shown in Figure 3. In this Figure, there are two distinct peaks due to two emission sources at the well pad. The methane to hydrocarbon ratio of the two peaks is slightly different, indicating two distinct emission sources. As expected for this type of emission source, there are no corresponding carbon dioxide peaks.

Figure 3. LDS response when driving through a plume caused by emissions from natural gas processing equipment. The two peaks are caused by two distinct emission sources.

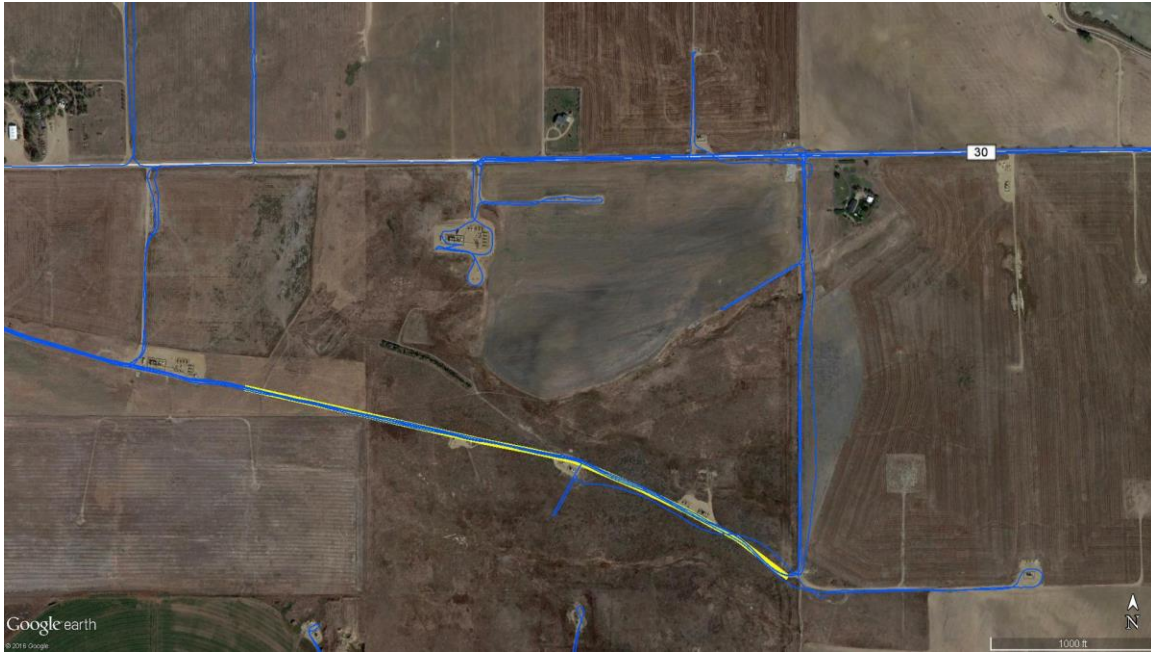
This potential seep was first detected on May 11, 2016 at 2:47 PM at 40.198005° north latitude and -104.796533° west longitude. The wind speed at the time of detection was 12 mph and the wind direction was 340 degrees. This potential seep was detected while driving along an approximately east-west oriented lease road as shown in Figure 4. Elevated concentrations of methane and hydrocarbons were detected along a 3600-foot-long section of the lease road indicated by the yellow line in Figure 4. The peak methane concentration measured was 4.1 ppm. A graph of the measured methane and HC concentrations while driving along the 3600-foot segment of lease road is shown in Figure 5. There is an oil and gas production facility approximately 1000 feet upwind of the seep location but detailed inspection of that equipment did not reveal any emissions that were large enough to account for the observed methane plume.

Immediately after finding the potential seep, County Road 30, which runs parallel to the lease road and approximately 1600 feet upwind was surveyed and no methane plumes detected. This indicated that the methane source was located between County Road 30 to the north and the lease road to the south. There are several pipelines located in this area that might have been leaking and causing the observed methane plume.

Figure 4. Map of Potential Seep A. The blue line is the track of the survey vehicle and the yellow line is the area where an elevated methane concentration was observed.

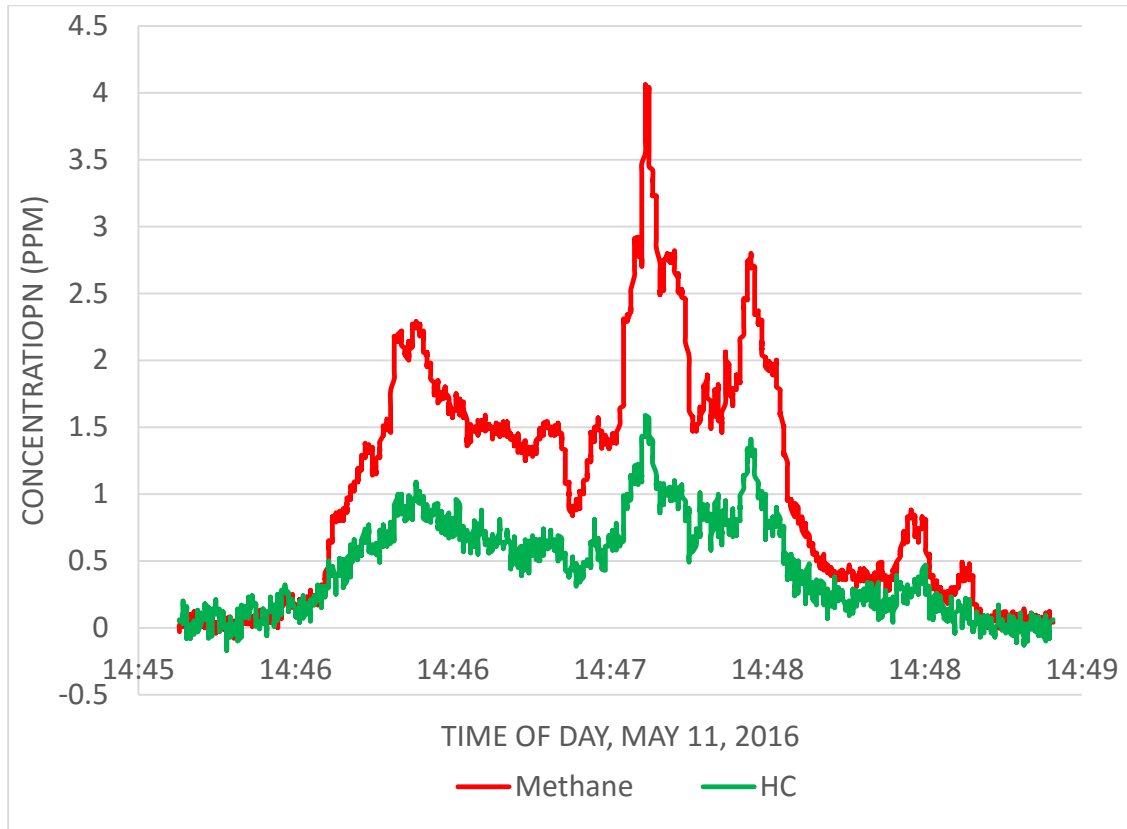
The site was visited again two days later on May 12. No methane plume from the potential seep was detected. The wind direction on this date was out of the north north-east compared to being out of the north north-west when the plume was originally detected. Based on these wind directions, we would expect that if the potential seep was still emitting methane during the second visit, it would have been detected.

Figure 5. Graph of methane and HC concentrations while driving through the plume from Potential Seep A.

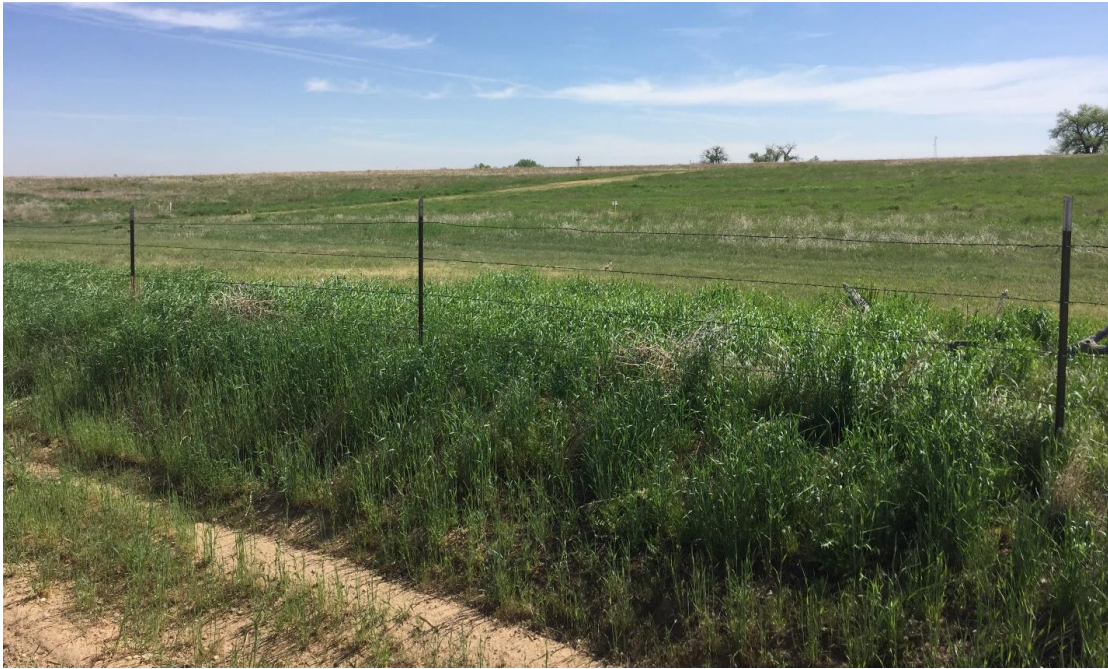
There were no obvious sources for the methane plume visible upwind of the potential seep location as shown in Figure 7. There is a gas well located approximately 1000 feet upwind of the seep location that was visited on May 11. At that time, there were no significant emissions from the well that could account for the potential seep plume observed on May 13. This site was resurveyed on June 1 and the plume from the potential seep could not be found at that time.

Figure 7. Photograph looking upwind (north-east) from Potential Seep B.

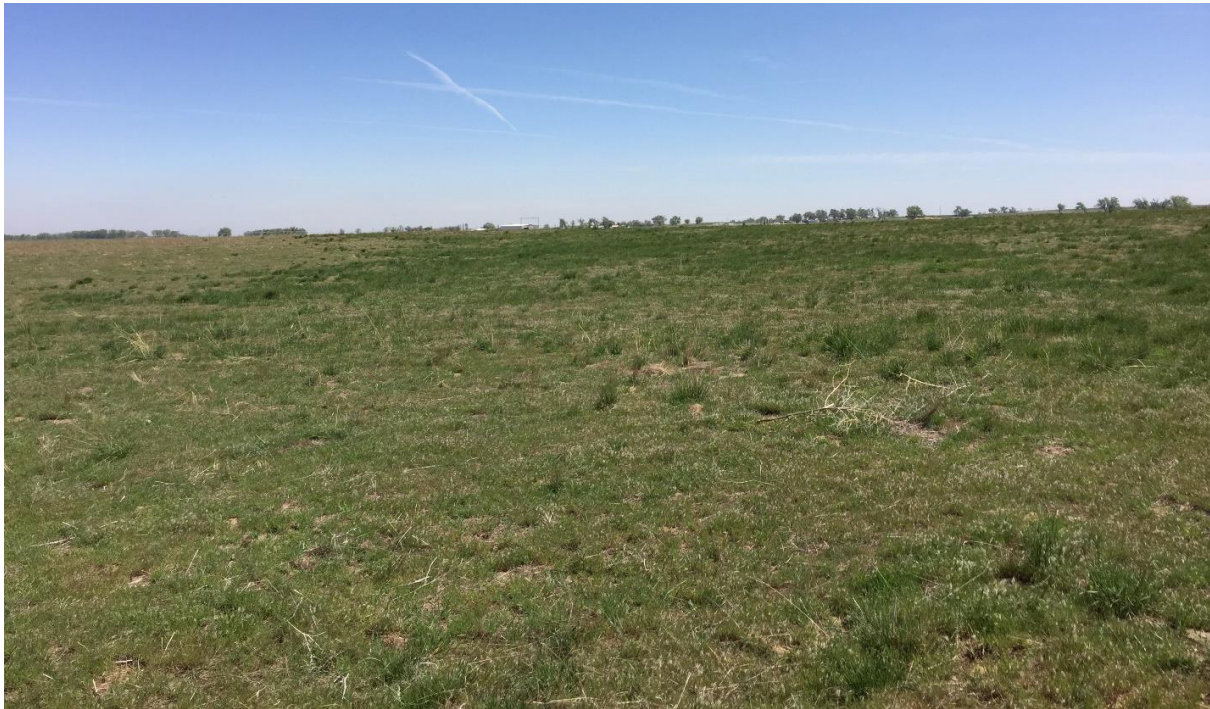
There were no obvious sources for the methane plume visible upwind of the potential seep location as shown in Figure 9. There is a gas well located approximately 750 feet upwind of the seep location that was not visited and could possibly be the source of the methane plume.

Figure 9. Photograph looking upwind (north-east) from Potential Seep C.
