# **Divide Creek Area Joint Study Summary Report South of Silt, Colorado**

September 8, 2011

*Walter* Project No.: 237-02-003

**WALTER ENVIRONMENTAL**  
GROUP INC.

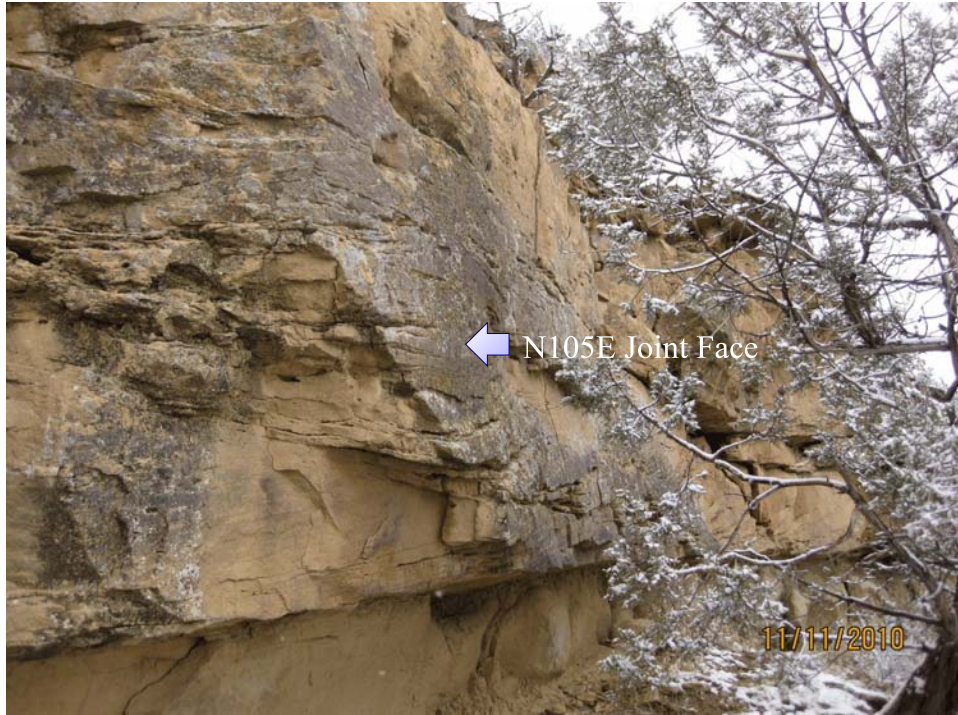
Photograph 1 - P3 Well Pad Outcrop  
View to the east of primary vertical joint set; oriented N105E.

Analysis of the outcrop resulted in the identification of two consistent vertical joint sets (Photographs 1 through 4):

- Primary Joint Orientation: 105 degrees east of north (N105E)
- Secondary Joint Orientation: 10 degrees east of north (N10E) (Older)

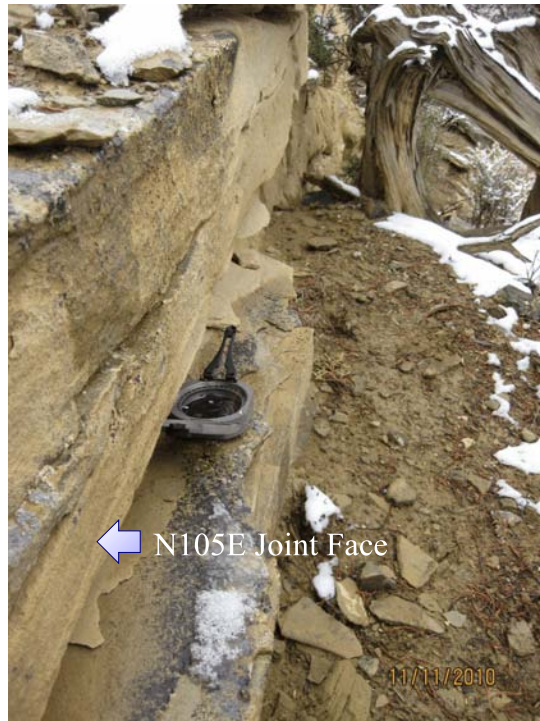
Photograph 2 - P3 Well Pad Outcrop  
View to the east of the primary vertical joint set; oriented N105E.

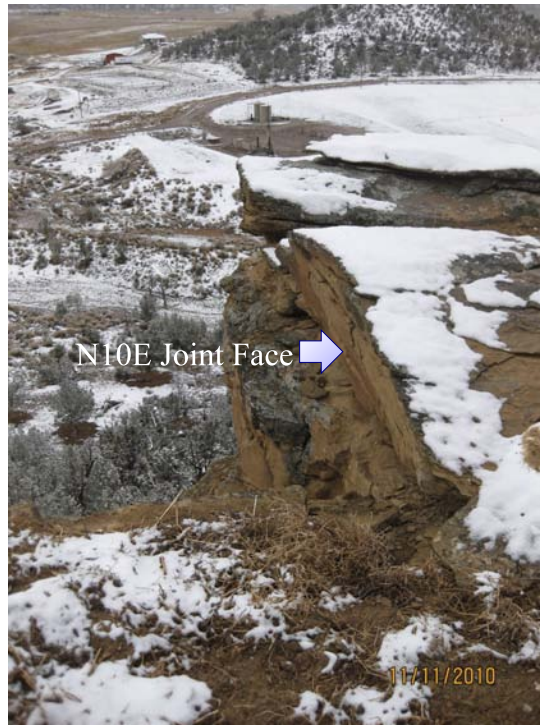
Photograph 3 - P3 Well Pad Outcrop  
View to the south of the secondary vertical joint set; oriented N10E.

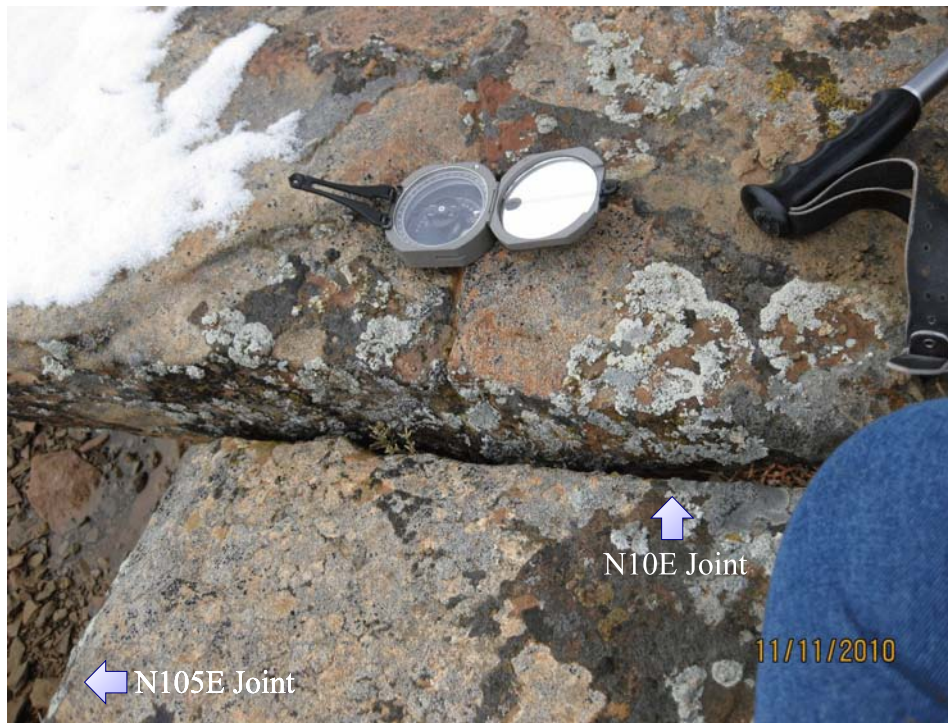
Photograph 4 - P3 Well Pad Outcrop  
View of the N105E joint set truncating against the N10E joint set.

Based on observed joint intersections (Photograph 4), the N10E (secondary) joint set is older than the N105E (primary) joint set. These joint sets are illustrated in Figure 3.

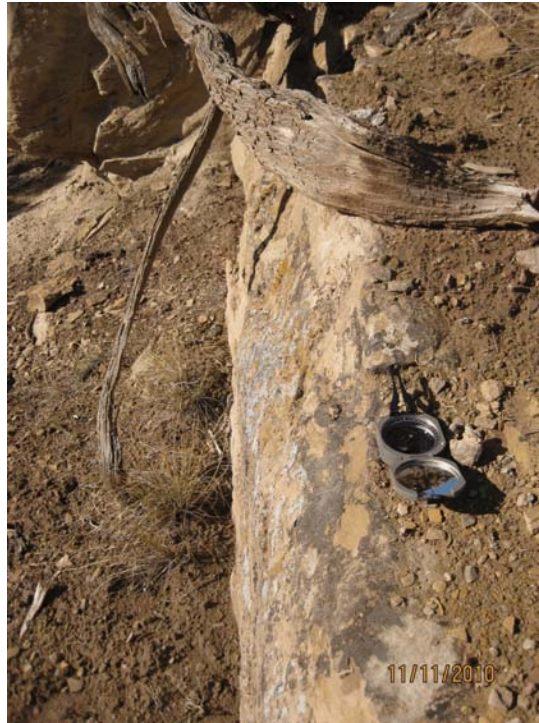
Photograph 5 - Brown Well Pad Outcrop  
View to the northwest of the primary vertical joint set; oriented N130E.

However, inspection of the available outcrop resulted in the identification of two consistent vertical (and near vertical) joint sets (Photograph 5):

- Primary Joint Orientation: N130E
- Secondary Joint Orientation: N40E (Older)

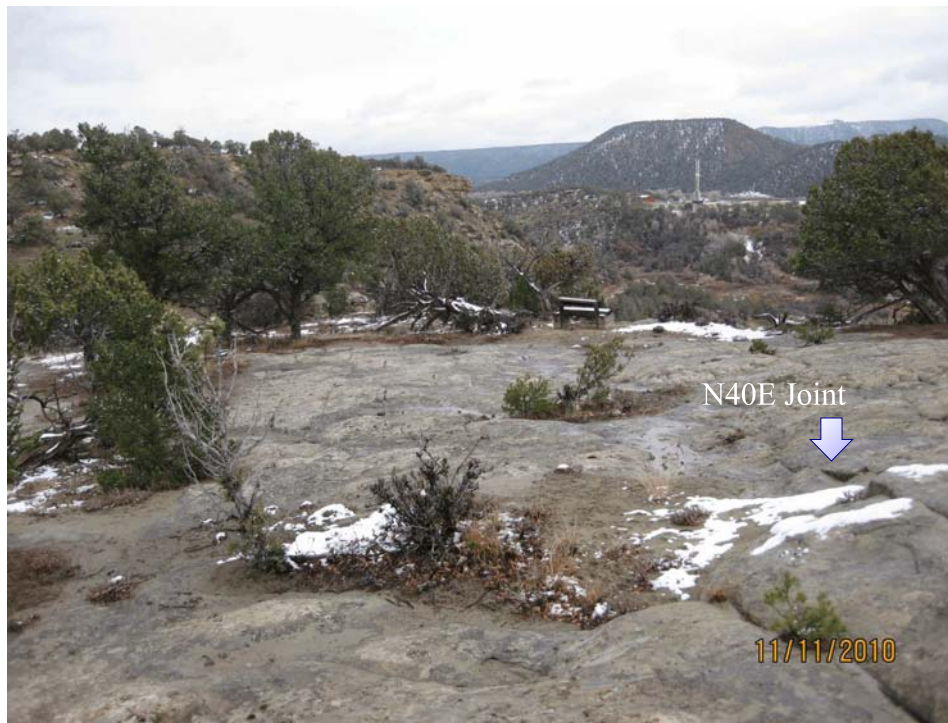
Photograph 6 - Bracken Outcrop  
View to the northeast from the top of the outcrop.

The Bracken outcrop is located east of the Bracken residence, on the cliffs overlooking West Divide Creek, south of the confluence of East and West Divide Creeks (Figure 2). The outcrop affords excellent exposure in both plan (Photograph 6) and cross-sectional (Photograph 7) views. Inspection of the outcrop resulted in the identification of two consistent vertical (and near vertical) joint sets (Photographs 8 through 10):

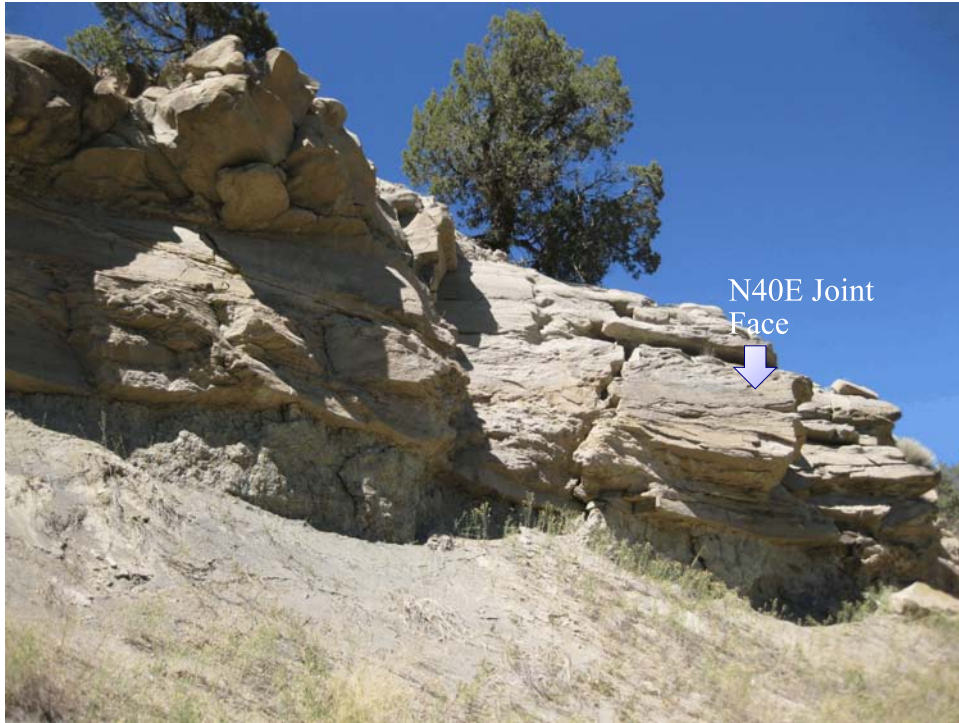
Photograph 7 - Bracken Outcrop  
View to the northwest from the road east of the outcrop.

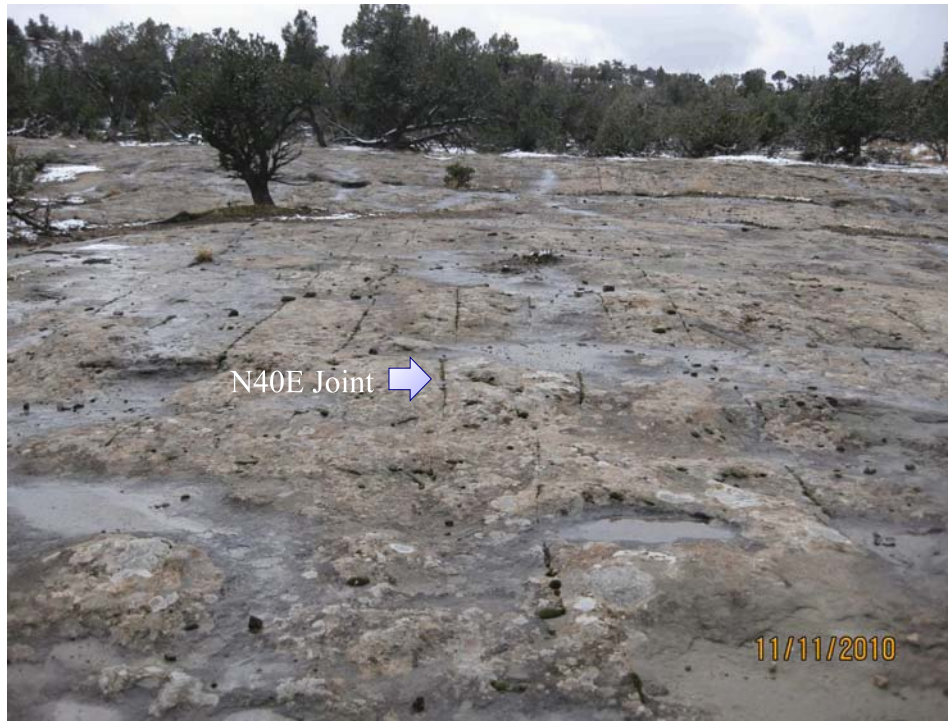
Photograph 8 - Bracken Outcrop  
View to the southwest of the surface expression of the N40E joint set.

- Primary Joint Orientation: N40E
- Secondary Joint Orientation: N105E (Older)

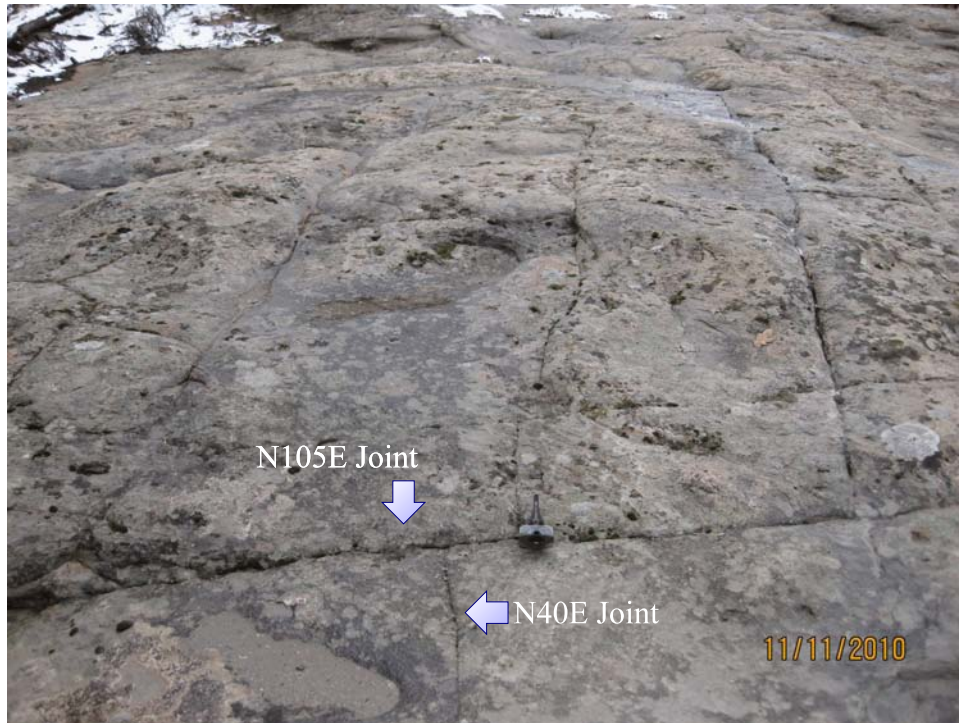
Photograph 9 - Bracken Outcrop

View to the southwest of the two pervasive joint sets. Note how the N40E joint set truncates against the N105E joint set.

Based on observed joint intersections (Photograph 9), the N105E (secondary) joint set is older than the N40E (primary) joint set. These joint sets are illustrated in Figure 3.

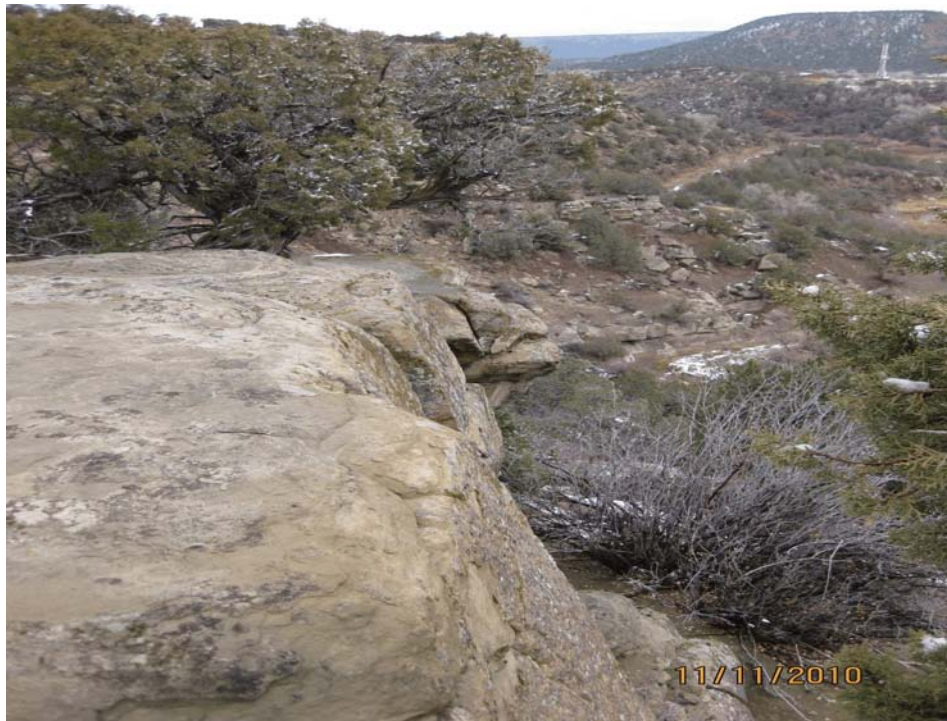
Photograph 10 - Bracken Outcrop

View to the northeast of the cliff face formed by the N40E joint set.
