# Ground Survey of Las Animas County for Methane Anomalies

June 30, 2015

Prepared by:

Prepared for:

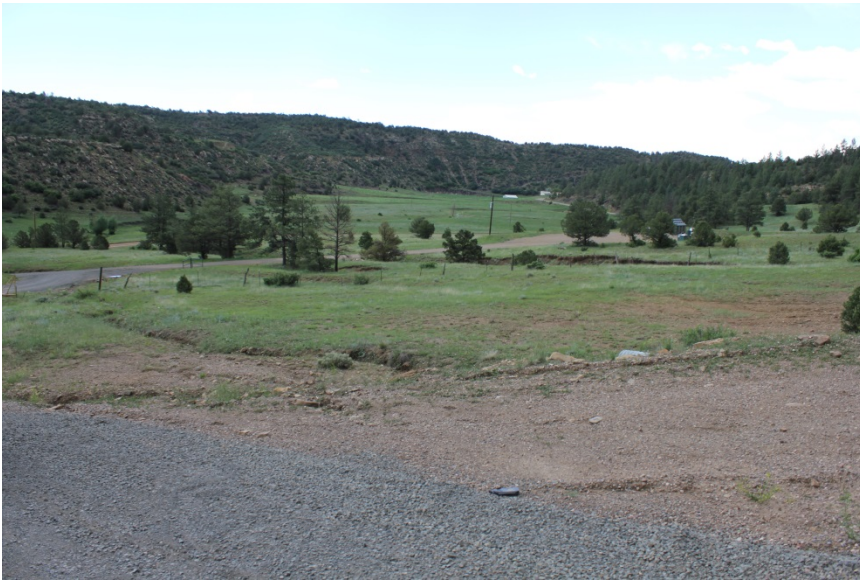
**Seep ID:** 1088

**Description:** An increase in ambient methane levels was detected on the southeast side of Ponderosa Dr. A small water runoff is located on the south side of the road which was dry at the time of this survey. Coal seams are located on the north side of the road.

Looking south from Ponderosa Dr.

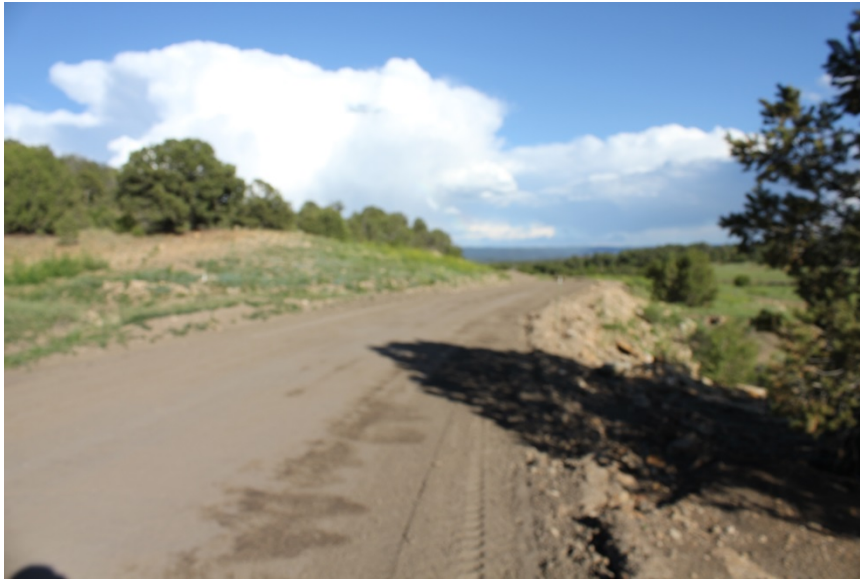
**Seep ID:** 1094

**Description:** An increase in ambient methane levels was detected coming from the southeast, parallel to Co. Rd. 53.5. A seep was discovered at this location in 2007, however now there is natural gas infrastructure in the area. Pipelines are located on both sides of the road and a well pad is located 400ft. to the east. Due to the lingering levels of methane and winds out of the southeast, the possibility of a seep cannot be ruled out.

Looking southeast on Co. Rd. 53.5.

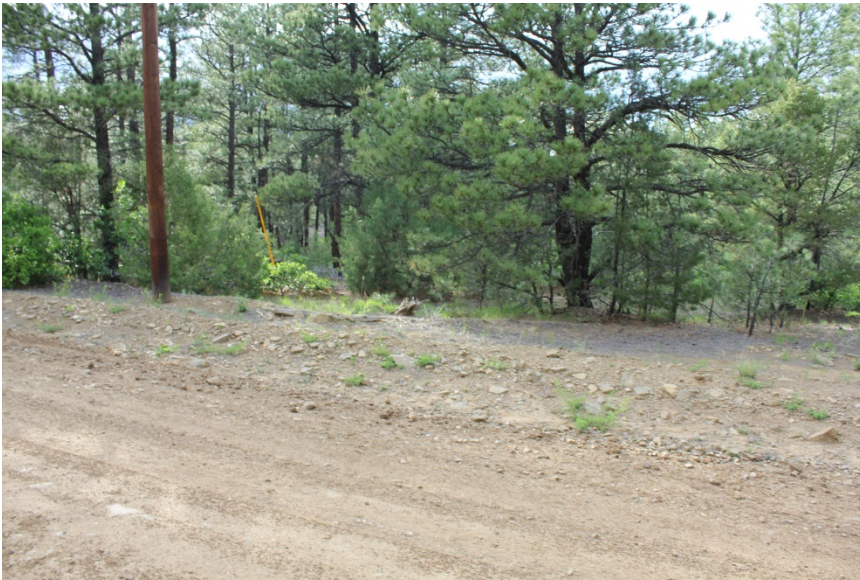
**Seep ID:** 1096

**Description:** An increase in ambient methane levels was detected coming from the west of Ridgeline Spur Rd. The abnormal readings occur when the road makes a shallow 180 degree bend. In-between the bend is a heavily wooded ravine.

Looking northwest on Ridgeline Spur Rd. The ravine is beyond the trees.

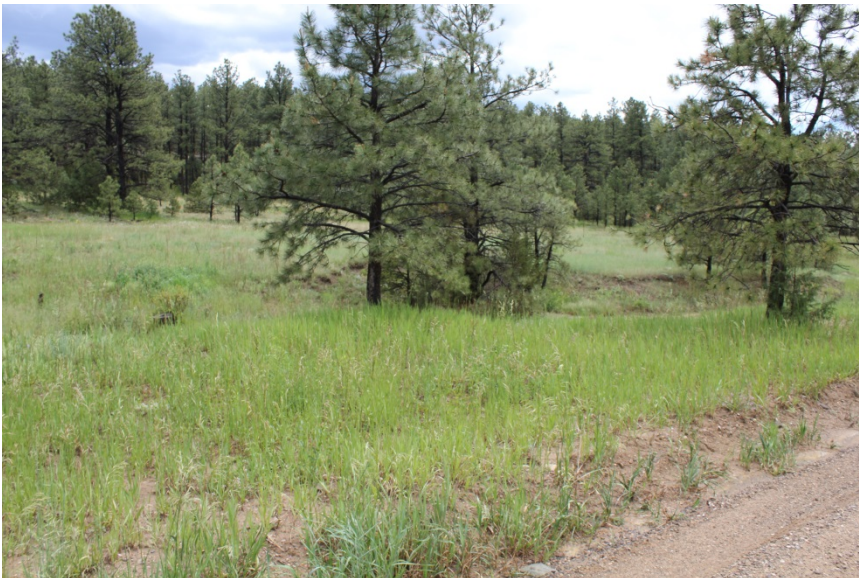
**Seep ID:** 1106

**Description:** An increase in ambient methane levels was detected coming from the east side of Co. Rd. 30.1. Located on the east side of the road is a creek bed. On the west side of the road is a buried natural gas pipeline.

Looking east on Co Rd. 30.1. The creek bed is in the depression in the center of the picture.

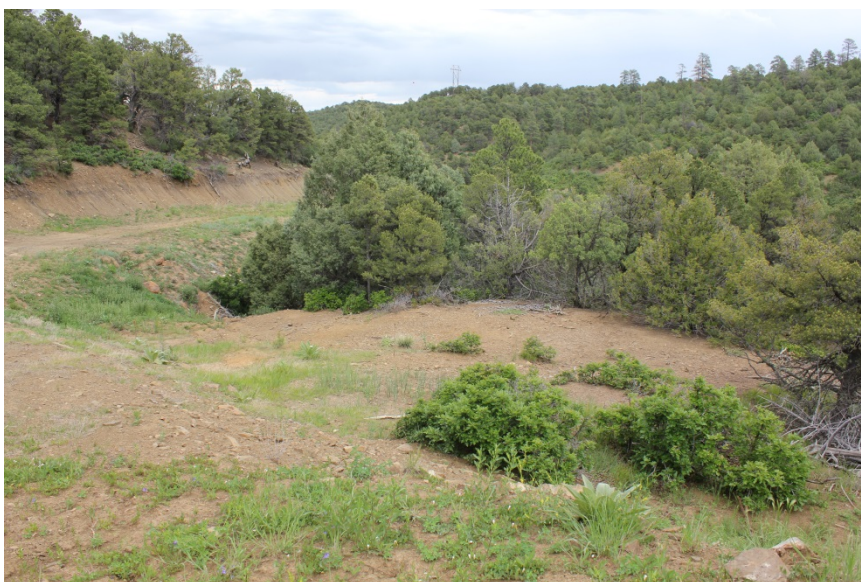
**Seep ID:** 1108

**Description:** An increase in ambient methane levels was detected coming from the northeast side of an unnamed road. Located on the northeast side of the road is a ravine that drops off into a dry creek bed. This seep is at the same location as a previous identified seep from the 2007 survey.

Looking northeast of the unnamed road where the ravine begins to drop off.

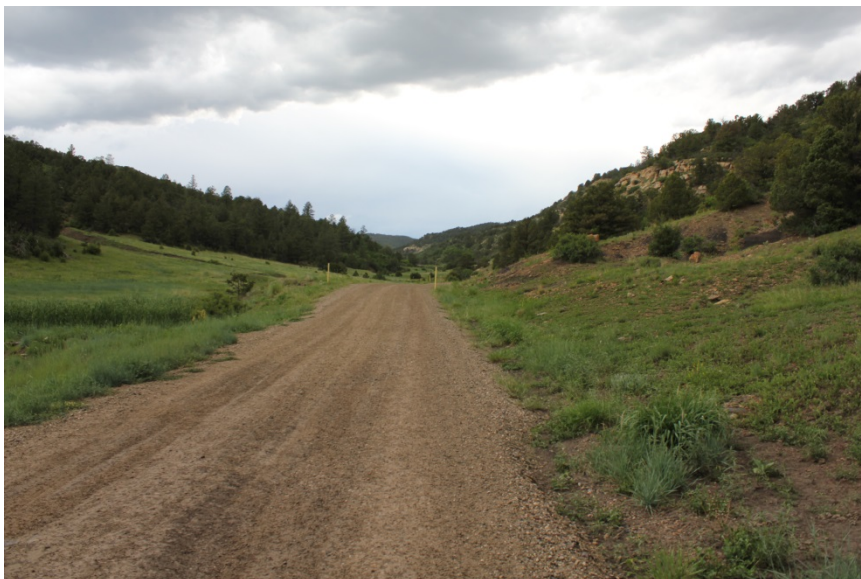
**Seep ID:** 1123

**Description:** An increase in ambient methane levels was detected coming from the west which is parallel to an unnamed leased road. A pond was located on the south side of the road and on the north side of the road was a buried natural gas pipeline as well as a coal seam. This seep is about 500ft west of a previous identified seep from the 2007 survey.

Looking west on the unnamed leased road. The pond is just off to the left of the picture.

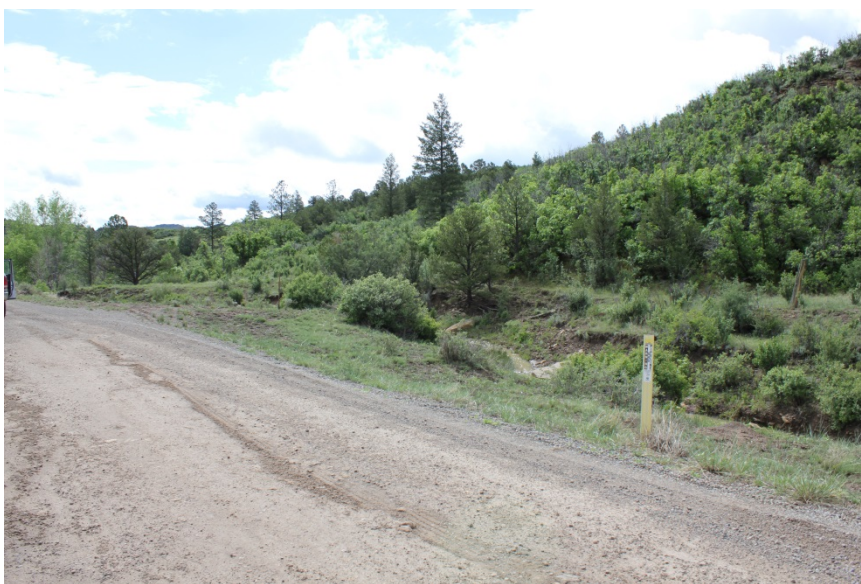
**Seep ID:** 1128

**Description:** An increase in ambient methane levels was detected coming from the east which is parallel to an unnamed leased road. Both a creek and a natural gas pipeline are located on the southeast side of the road. Located on the north side of the road is a mine vent.

Looking southeast at a creek and pipeline marker on the unnamed leased road.

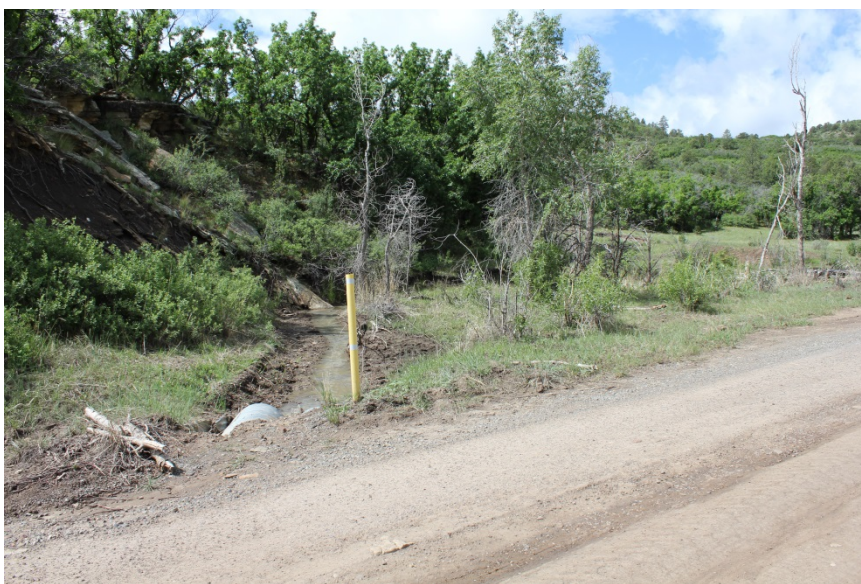
**Seep ID:** 1130

**Description:** An increase in ambient methane levels was detected coming from the east which is parallel to an unnamed leased road. This seep is on the same road and creek as Seep ID 1128. The natural gas pipeline is now on the other side of the road.

Looking southeast at a creek on the unnamed leased road.

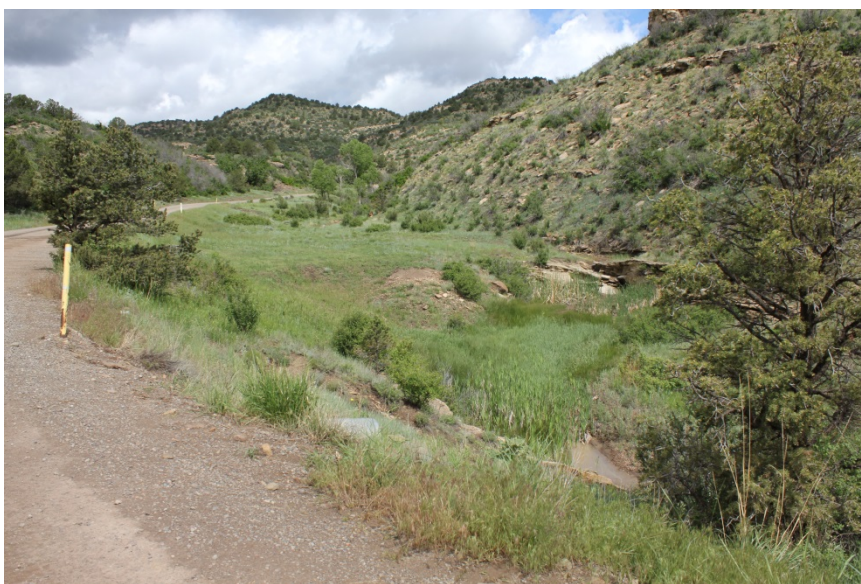
**Seep ID:** 1131

**Description:** An increase in ambient methane levels was detected coming from the northeast side of an unnamed leased road. This seep is on the same road and creek as Seep ID 1128 and Seep ID 1130. The pipeline and creek are now on the north side of the road.

Looking north at a creek on the unnamed leased road.

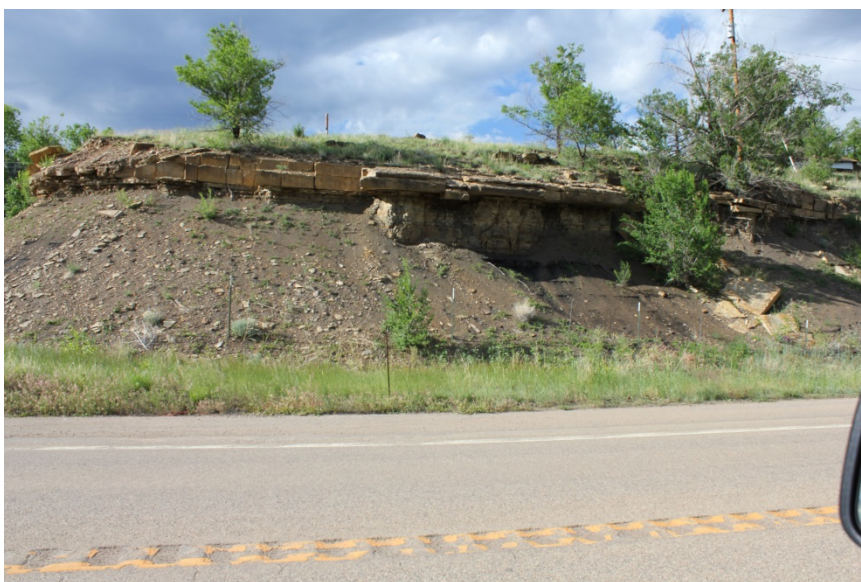
**Seep ID:** 1142

**Description:** An increase in ambient methane levels was detected coming from the northeast side of CO Highway 12. Located north of the highway is a rock formation with exposed coal seams. The potential seep is located in the middle of a cluster of homes. This seep is about 300ft south of a previous identified seep from the 2007 survey.

Looking northeast at the rock formation on CO Highway 12. A home is just beyond the embankment.

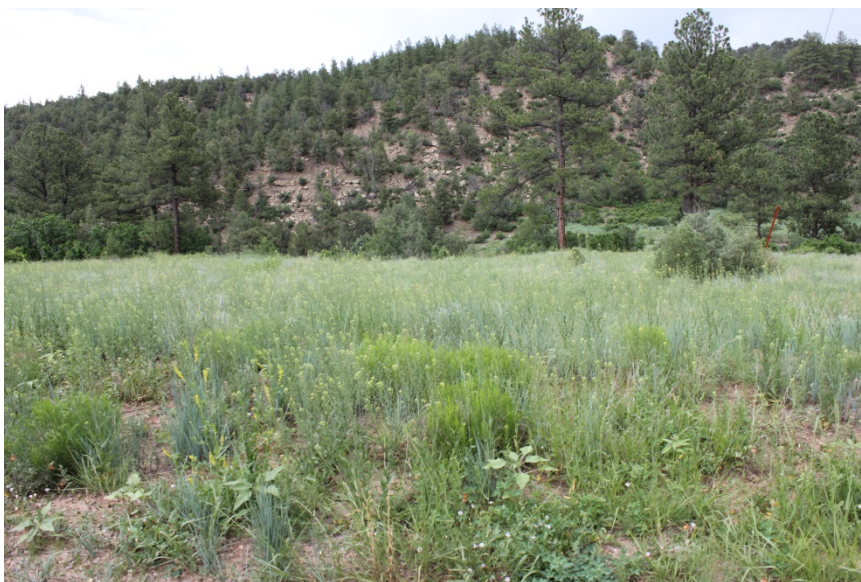
**Seep ID:** 1153

**Description:** An increase in ambient methane levels was detected coming from the north which is parallel to an unnamed leased road. A dry creek bed runs parallel to the road.

Looking northeast on the unnamed leased road. The creek bed is hidden by vegetation.
