COLORADO
Energy & Carbon Management
Commission
Department of Natural Resources
1120 Lincoln Street, Suite 801
Denver, CO 80203

February 16, 2024

K.P. Kauffman Company, Inc.
Attn: Ross Watzman
1700 Lincoln Street, Suite 4550
Denver, CO 80203

DIRECTOR'S ORDER PURSUANT TO RULE 901.a.

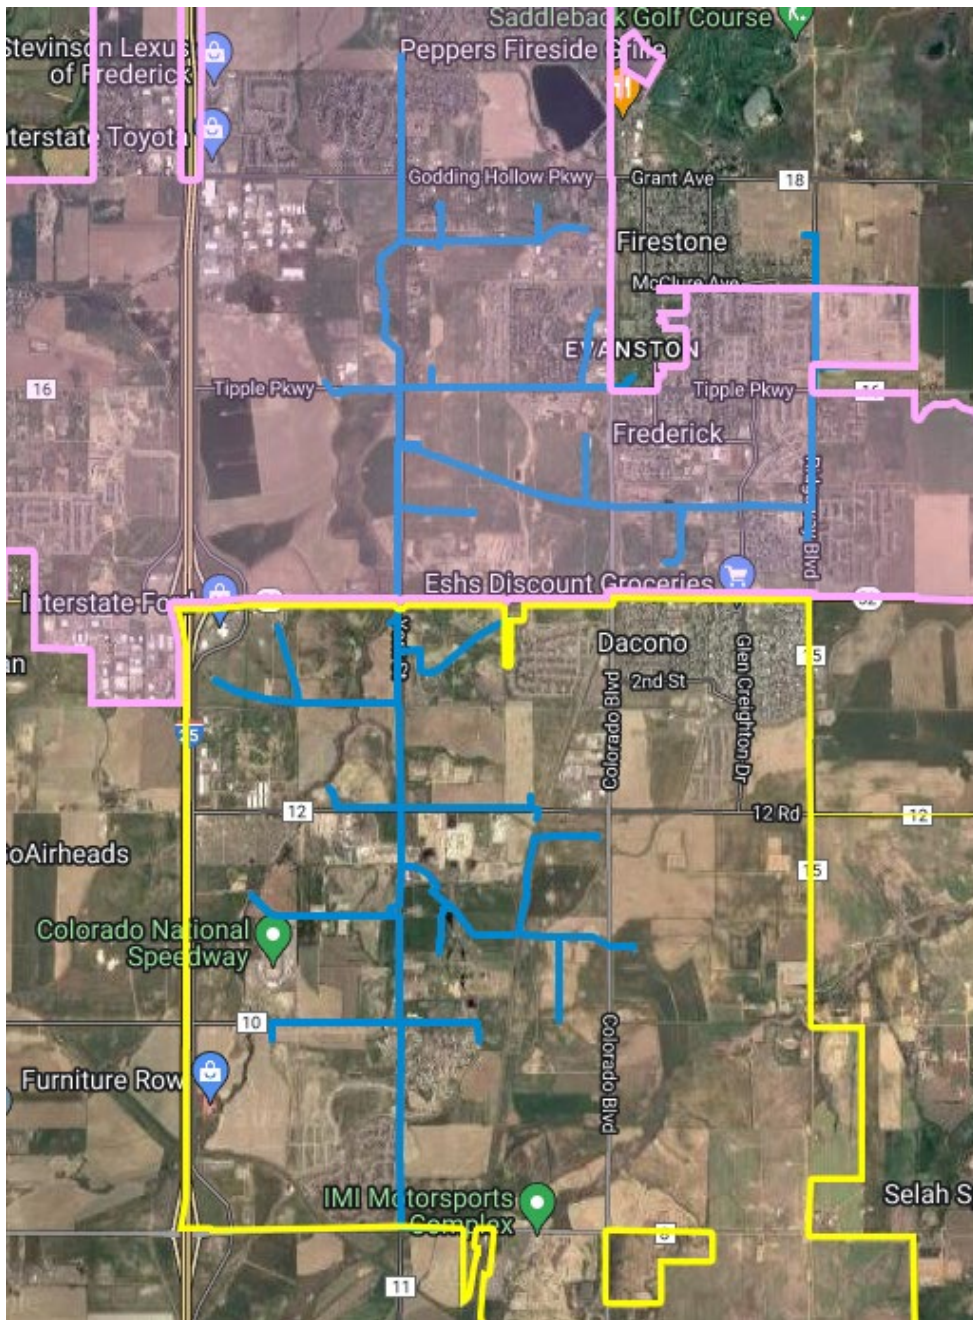
Flowline Facility 479608 (blue line) is situated entirely within the municipal boundaries of Frederick (outlined and shaded pink) and Dacono (outlined in yellow), as show below:

1. By close of business on February 6, 2024, deactivate and depressurize Flowline Facility 479608.
2. Provide documentation describing the cause of the Spills, including, but not limited to, an evaluation of possible internal or external corrosion, external force, design and installation deficiencies, third party, or overpressure damage as a root cause of failure.
3. Develop and provide a detailed description of the measures that will be taken to prevent reoccurrence of the mechanisms of failure identified in the root cause analysis.
4. Provide documentation of repairs conducted in response to the Spills from Flowline Facility 479608 and include the relevant manufacturer's specifications or applicable technical standard.
5. Conduct ECMC-witnessed post-repair pressure testing of Flowline Facility 479608. Submit documentation of successful test(s).
