Divide Creek Area Joint Study Summary

Report prepared by The Walter Group
(To be finalized the week of 9/5/2011)

COGCC Presentation prepared for
Landowners and Garfield County 9/7/2011

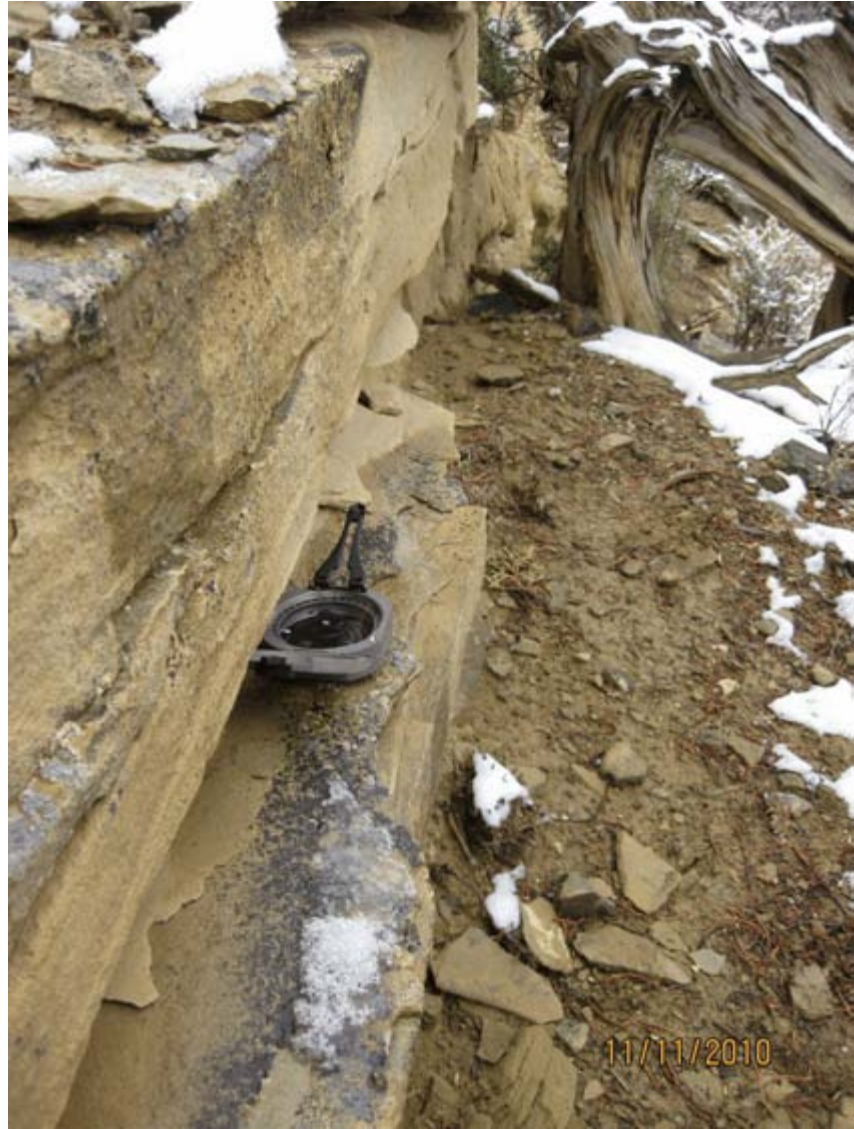
- The Walter Group visited outcrops in the study area, and recorded strike and dip measurements of the visible joints (the surface of a fracture or parting in a rock without displacement) in undisturbed bedrock.
- The next photo shows a an outcrop with a Brunton compass oriented parallel to the face of a nearly-vertical joint. Brunton compasses are used to measure magnetic bearings of linear features.

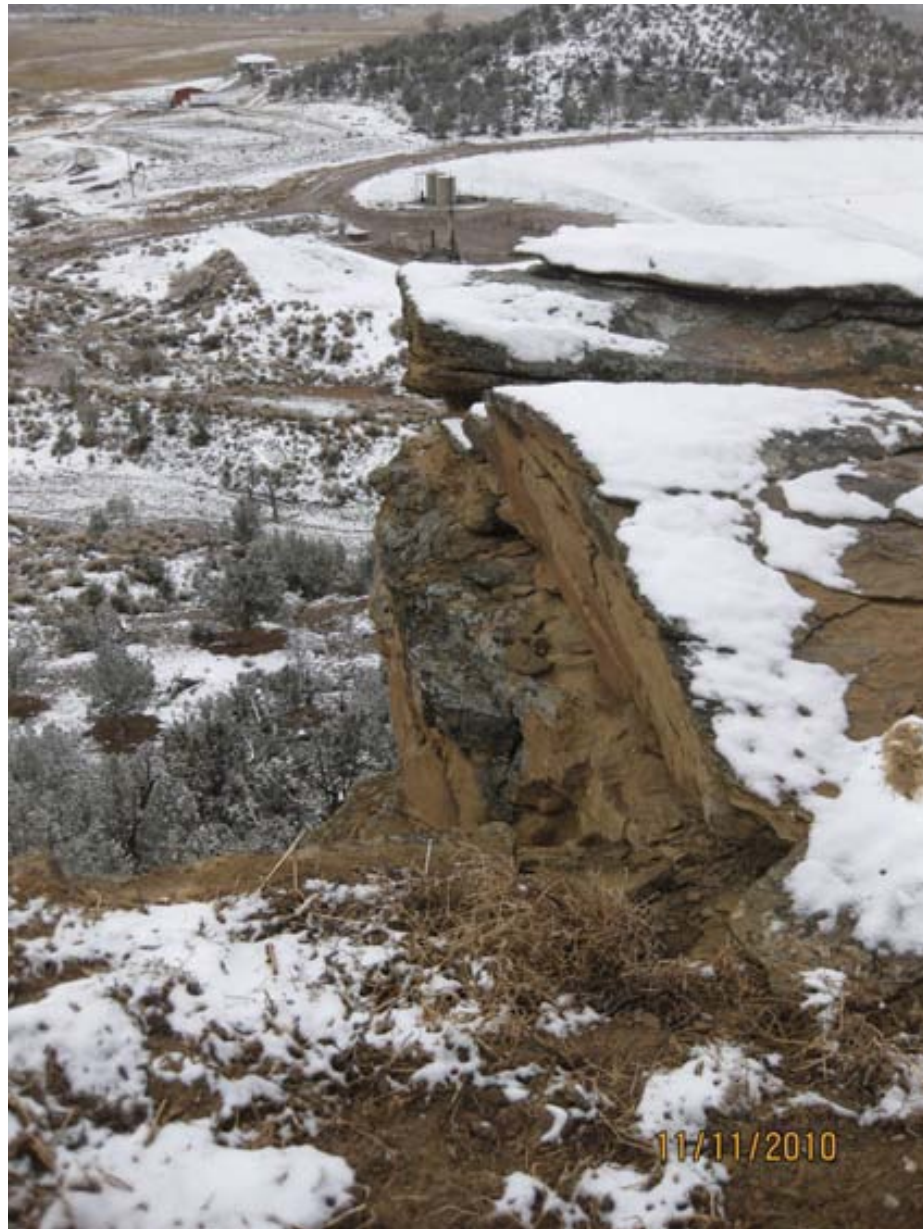
- Accessible, visible rock outcrops within the study area were measured in the same manner. The next photo is of an exposed joint face north of the Arbaney (P3) well pad.

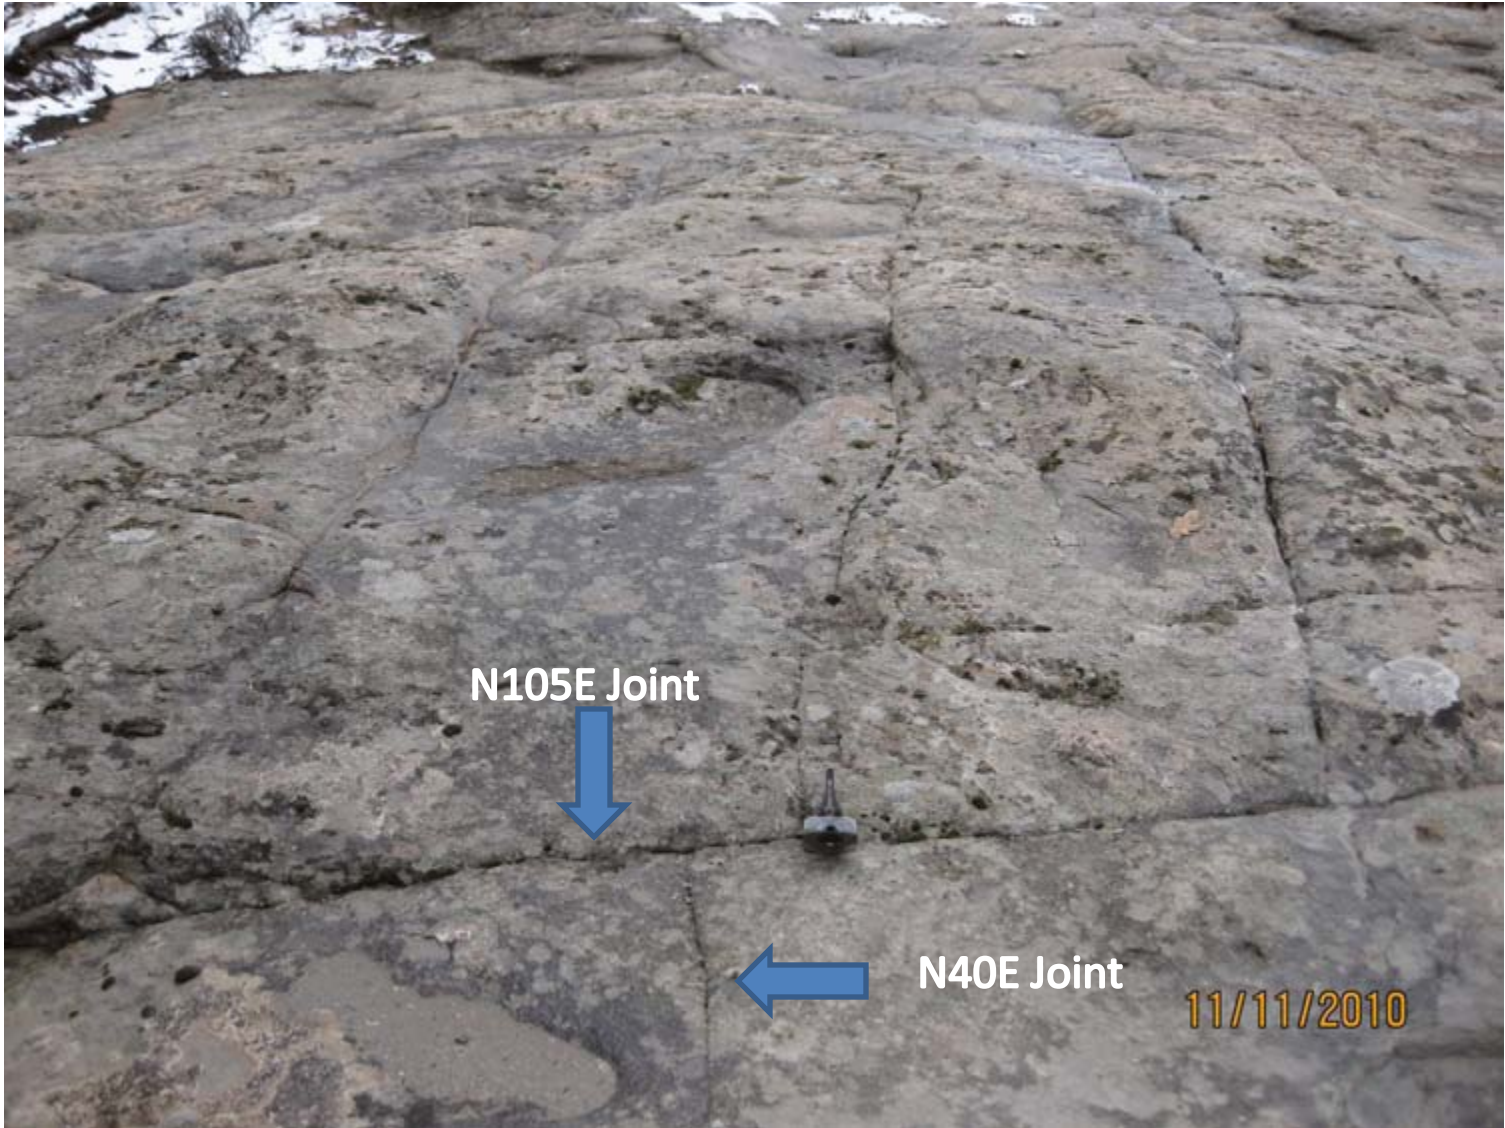
Next is a photo of joint sets. Note the Brunton compass in the photo.

The gray housing of a Brunton compass is approximately 3 inches by 3 inches, for scale.

N105E Joint

N40E Joint
